NATIONAL TRANSPORTATION SAFETY BOARD

AIRCRAFT ACCIDENT REPORT

SKY TRAIN AIR, INC.
GATES LEARJET 24, N44CJ
FELT, OKLAHOMA
OCTOBER 1, 1981

NTSB-AAR-82-4

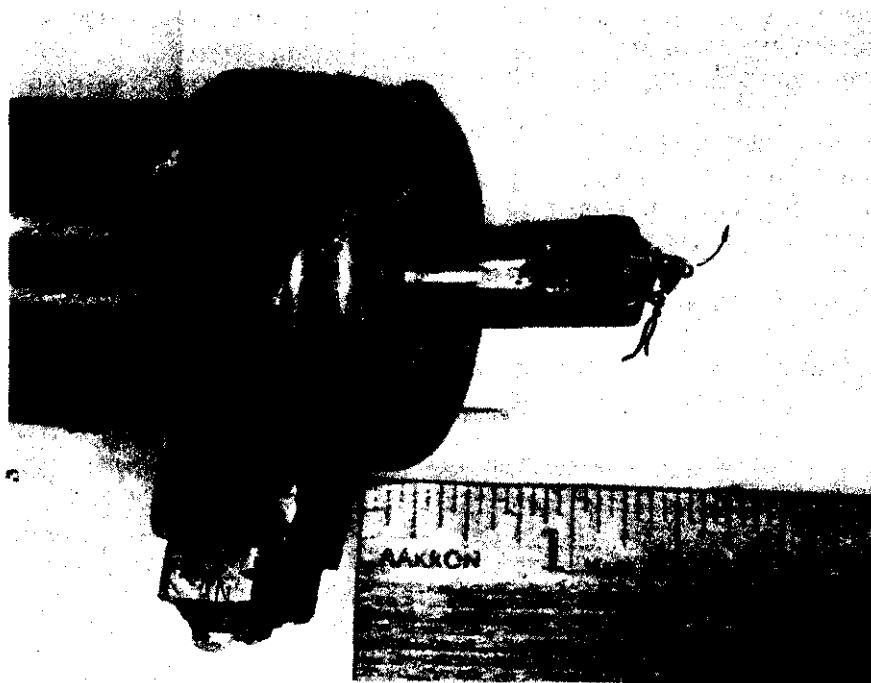
Examination of the wing spoiler actuator by the Safety Board's metallurgical laboratory disclosed that the piston rod-end broke from overload bending forces (figure 2). The actuator gland was driven sufficiently into the cylinder to shear the setscrew. Impact marks on the exterior of the actuator barrel (see figure 3) had deformed the inside wall of the barrel (see figure 4). The piston (see figure 5) was jammed within the distorted area 0.65 inch from its fully retracted position which indicates that the actuator piston had been moved by impact forces into the spoiler retract direction when the piston became jammed. The position in which it was jammed correlated with an extended spoiler deflection angle of 20.5°. The deflection angle, in turn, corresponded to the position the spoiler would seek due to opposing air loads at an airspeed of 369 knots. This speed is 69 knots above the maximum airspeed (V_{mo}) for the aircraft. However, it was not possible to determine what portion of the distance that the piston had moved from the progressive forces associated with the impact breakup sequence.

Figure 2.—Closeup view of the piston rod end in position in the actuator. Arrow indicates direction of bending of piston rod.

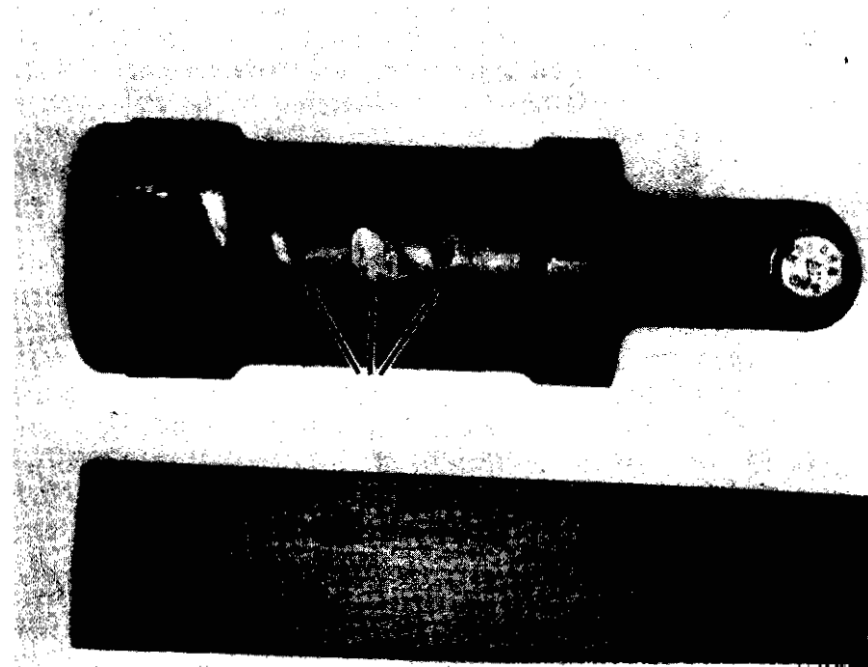
Figure 3.—Arrows indicate impact damage on the barrel.
