AIRCRAFT ACCIDENT REPORT

EASTERN AIRLINES FLIGHT 935
LOCKHEED L-1011-384, N309EA,
NEAR COLTS NECK, NEW JERSEY,
SEPTEMBER 22, 1981

NTSB-AAR-82-5

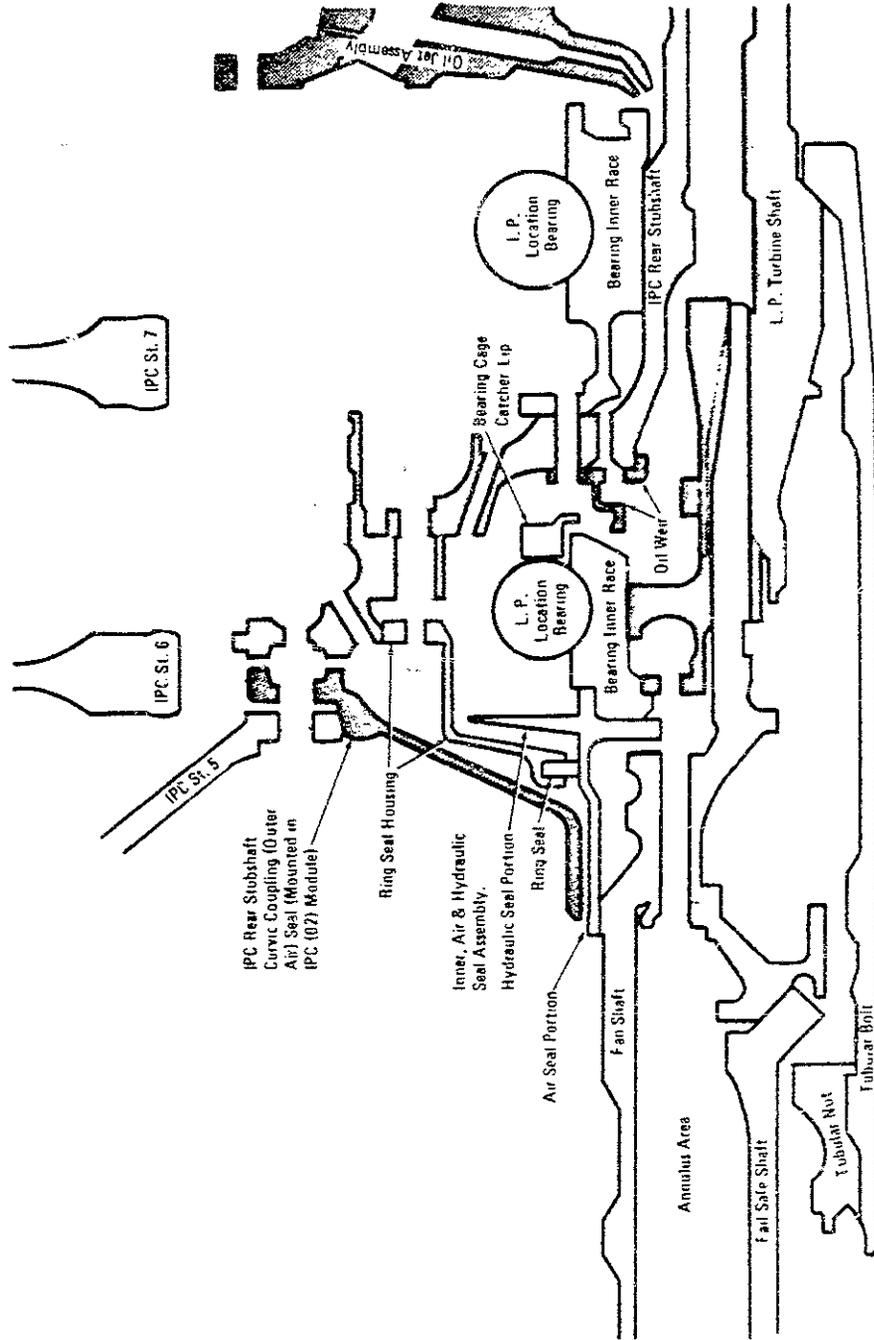
Figure 5. -- Installed Position of Components Associated with LPLB Failure

The low-pressure location bearing had deteriorated from intermittent spalling of the Searing's outer race that encompassed 250° of its circumference. The area of apparent fatigue spalling was biased toward the rear side of the Searing's race track. The profile of the LPLB's inner race track was worn heavily and was elongated axially to a width of 1.250 to 1.375 inches; the forward and rear lands of the inner race adjacent to the track profile were also heavily worn. The bearing cage was extensively overheated. The bearing location lands were worn and the bearing cross grooves were filled with debris. The front half of the bearing cage was heavily rubbed on its front face from contact with the base of the hydraulic seal fin. Molten material produced from the inner track ball wear and breakup had been deposited onto the front half cage bore for 160° of its circumference. The cage ball pockets were heavily worn. The rear oil catcher lip was distorted rearward from wear and rearward movement of the inner race; it had come in contact with the retention bolt heads of the low pressure location bearing oil weir. The main surface areas of the location bearing balls showed minor primary skidding type damage with wear ranging between 0.007 to 0.012 inches on the diameter of the ball. The individual ball's wear pattern was uniform and the balls generally maintained their sphericity. None of the balls had any visual appearance of secondary fatigue. All of the balls had randomly located sliding flats, some of which were reoriented. The flats' approximate diameter ranged from .125 of an inch to .75 of an inch; these flats could be related to the inner race movement in the fore and aft thrust directions.

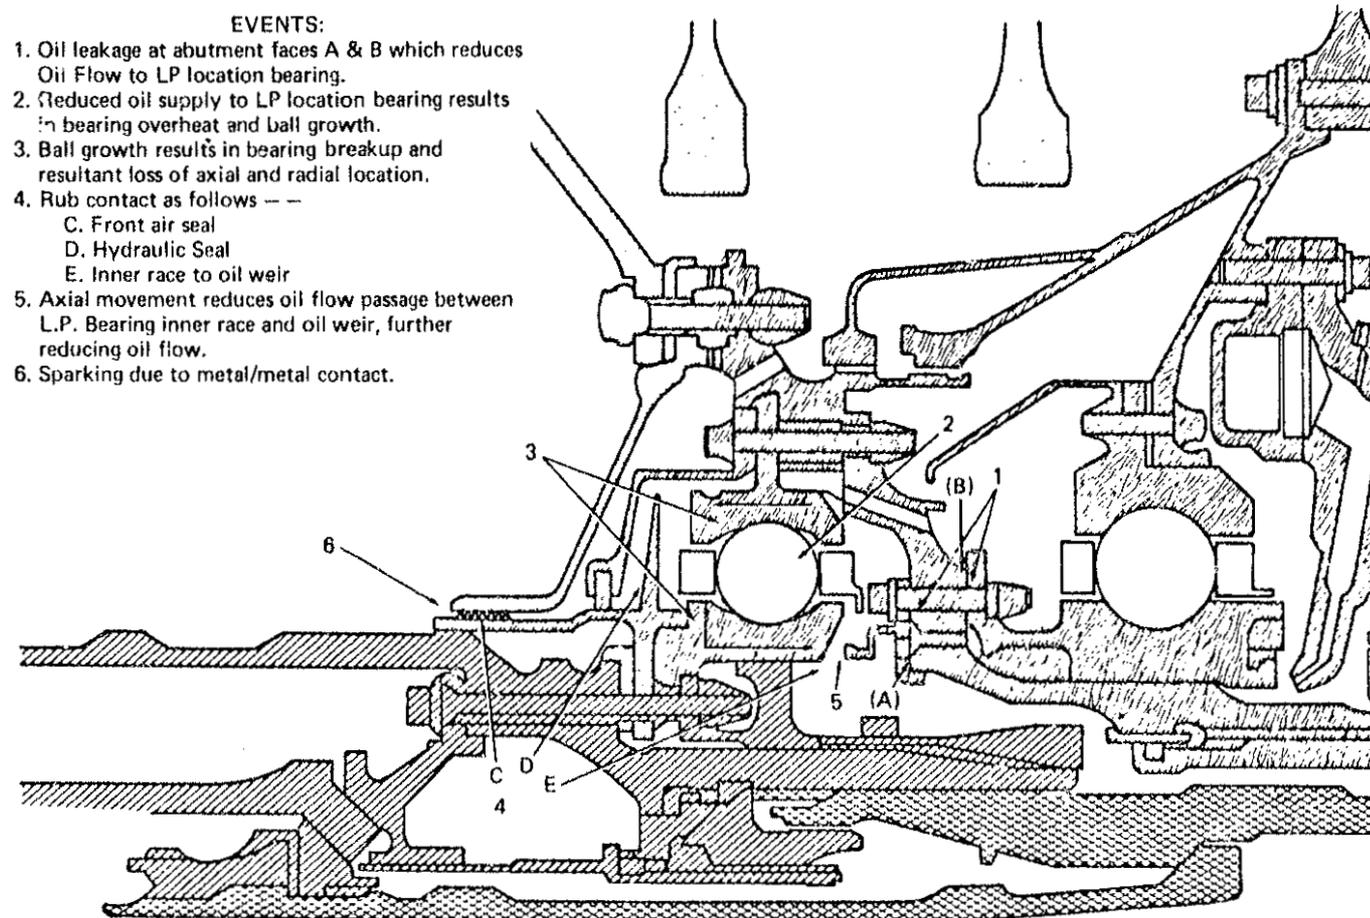
Figure 7. -- Initial Failure Sequence.

The initiating event in the LPLB failure was an inadequate oil supply to the bearing because of oil leaks between abutment faces of the IPC rear stubshaft and the LPLB oil weir and leaks between the abutment faces of the LPLB inner race locating flange and the IPC rear stubshaft. Each of these interfaces had evidence of oil leakage path stains and foreign debris entrapment. (See figure 7.) The LPLB oil supply system does not provide a positive oil feed to the bearing, but rather a "slinger" type is used to lubricate the bearing. Since the oil supply jet was not positive and since leaks occurred across the flanged abutment faces, probably as a result of poor mating of these surfaces following overhaul, the LPLB inner race flange may have become distorted at high power settings. The Safety Board believes that the "slinger" oil supply and oil leaks at the abutment faces are major factors in LPLB distress situations.

The inadequate supply of oil allowed the LPLB assembly to overheat and provided a temperature high enough to induce bearing outer race fatigue spalling, which in turn would have induced ball tightening and rubbing in the bearing cage pockets. The

bearing cage and the bearing inner race lands also would have rubbed together, causing the cage to expand. These factors, in addition to high centrifugal force loadings, would allow the balls to grind and skid. The condition of the bearing's inner race and balls indicated that the balls were skidding and grinding into the bearing's inner race track in both the fore and aft directions, as shown by the contour match of the balls relative to the bearing's inner race track.

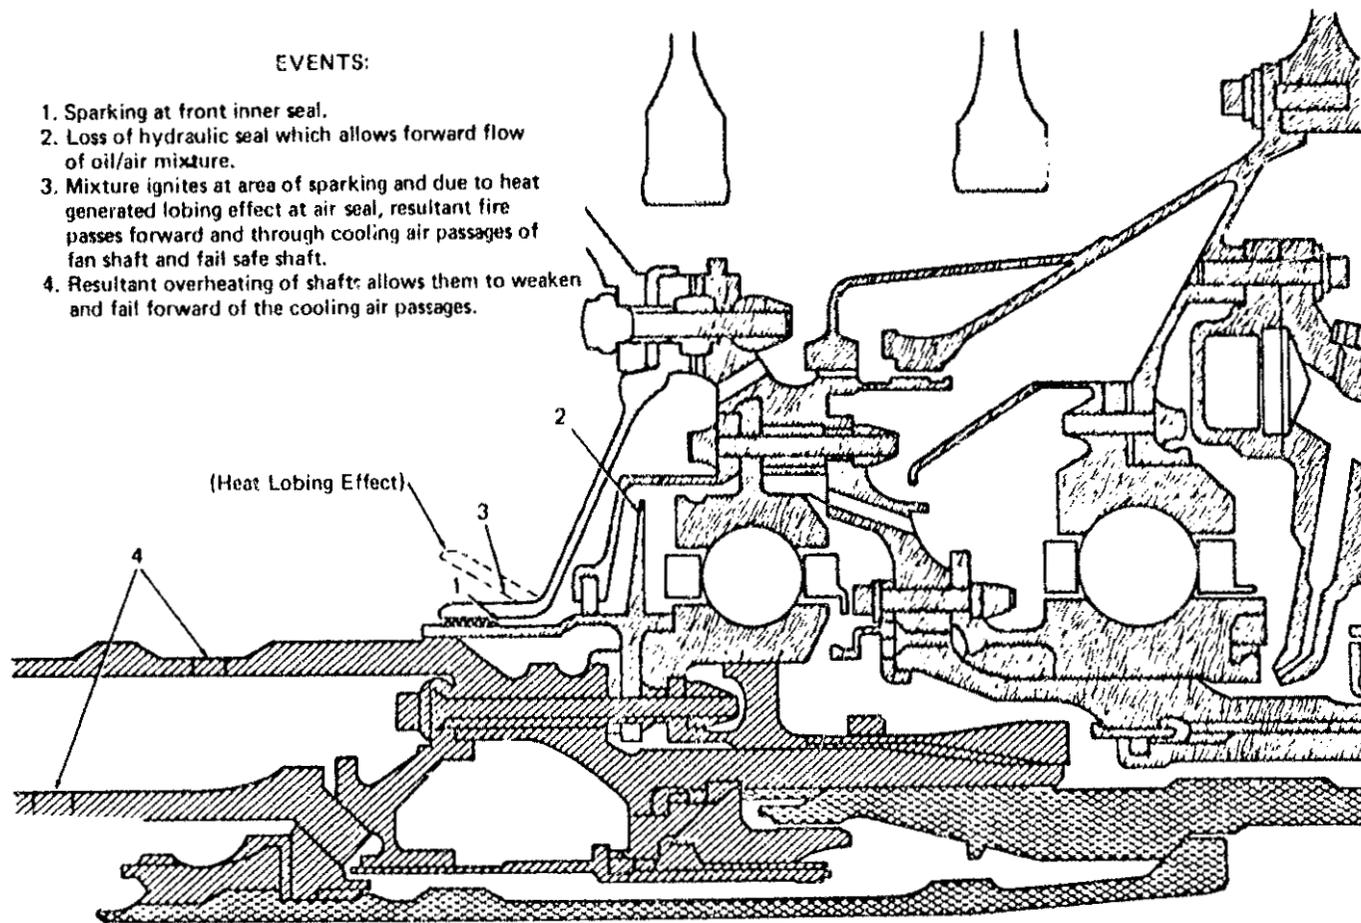
Figure 8. -- Engine Fire Sequence.

The ring (piston) seal housing and the ring (piston) seal which is adjacent to the hydraulic seal fin were also rubbed heavily. Oil level-type marks present on the rear face of the ring seal housing/arm suggest that different levels of oil were present in the ring seal housing/hydraulic seal cavity. The differences in oil levels indicated that the normal capillary-type seal between the hydraulic seal and the ring seal housing had been compromised, thus allowing LPLB oil to eject into the fan shaft area. The oil that escaped was mixed with pressurized air from two sources and was injected into the fan shaft annulus area. The first source was the oil scavenge cavity, located between the LP and IP location bearings, which is pressurized by 7th stage compressor air to 39 psig with the engine operating at climb power. Additional pressurized air is provided from the IPT pressure seal; it is pressurized to 24 psis. The oil was vaporized and was ignited by contact with the hot seal members, resulting in a stabilized fire in the fan shaft and the fail-safe shaft annulus area. (See figure 8.)

The stabilized fire degraded the material properties of the retained section of the fan shaft and caused the shaft to fail in a torsional and shearing mode. The degradation of material properties was evident by the discoloration patterns on the fan shaft fracture surface which indicated that the area adjacent to the fail-safe shaft fracture also reached a temperature probably in excess of 900° C. The recovered section of the fail-safe shaft exhibited rapid tensile/torsional overload fractures which also occurred as a result of exposure to these high temperatures.
