NATIONAL TRANSPORTATION SAFETY BOARD

AIRCRAFT ACCIDENT REPORT

PILGRIM AIRLINES FLIGHT 458
deHAVILLAND DHC-6-100, N127PM
NEAR PROVIDENCE, RHODE ISLAND
FEBRUARY 21, 1982

NTSB-AAR-82-7

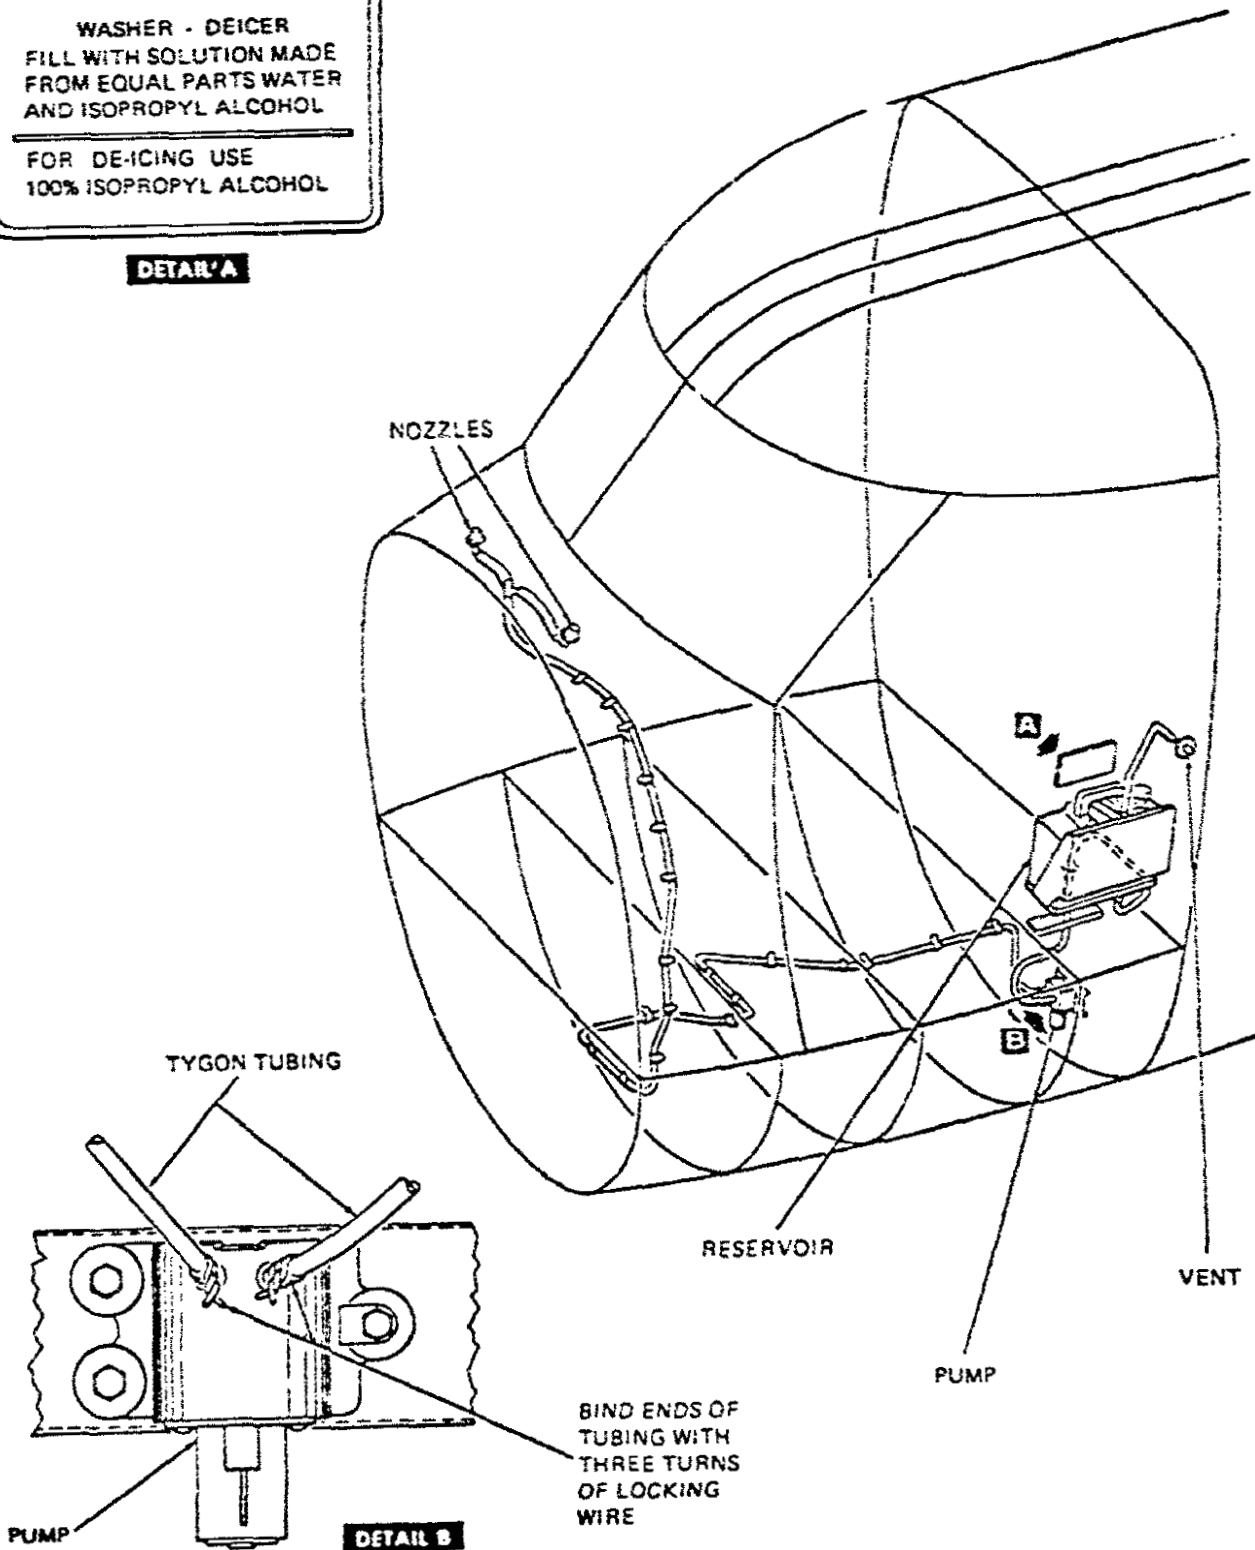
Figure 1.--Diagram of the windshield washer/deicer system installed on the accident aircraft.

The bottom of the reservoir opposite to the filler neck was found in the burned cockpit area during the postaccident inspection. The edges were melted and deformed from heat and fire. No other deicer system components (pump and lines) were found.

The tests demonstrated that with the tubing not properly fastened on the outlet pressure side of the pump, isopropyl alcohol could have leaked through the pump and accumulated in the compartment beneath the cockpit floor without the washer/deicer system having been activated, and once the system was activated, alcohol would have been sprayed from the pump outlet forward into the compartment area which contained numerous ignition sources.

Tests demonstrated that if the outlet side of the pump was disconnected from the tubing, fluid would flow through it into the compartment beneath the cockpit, even when the pump was not running. The most insidious form of leak or disconnect would be with the tubing on the outlet side of the pump disconnected and the alcohol under pressure sprayed into the compartment area and forward under the instrument panel into the avionics and radar component bays. The tests demonstrated that the pump could force fluid out of its outlet port for a distance of about 7 feet. The pump's position was less than 7 feet from the nose of the aircraft; consequently, any leakage under pressure would have sprayed alcohol onto several potential ignition sources including:

The pressure tubing probably disconnected from the pressure side of the pump at some time before the first officer activated the windshield washer/deicer system. Fluid could have accumulated beneath the cockpit floor as small amounts of alcohol leaked through the pump when it was not running. When the windshield deicing system was activated twice, about 20 minutes after the aircraft departed Groton, alcohol probably was sprayed from the discharge side of the pump into the compartment beneath the cockpit floor. The fire probably originated within the compartment and spread to the forward cabin area by burning into and through the left fiberglass heating duct.

6. A leak in the windshield washer/deicer system had allowed isopropyl alcohol to accumulate in the compartment below the cockpit floor. When the tubing disconnected from the pressure side of the pump and the pump was activated, alcohol was sprayed through the compartment where it was ignited.

Issue an Airworthiness Directive to require a redesign and modification of isopropyl alcohol windshield deicing systems installed on DHC-6 aircraft to eliminate the potential for alcohol leakage or, if practicable, to require replacement of these systems with the electrically heated windshields offered by the manufacturer as an alternative installation. (Class II, Priority Action) (A-82-56)
