NATIONAL TRANSPORTATION SAFETY BOARD

AIRCRAFT ACCIDENT REPORT

LUFKIN INDUSTRIES, INC.,
BEECHCRAFT SUPER KING AIR,
BE-200, N456L
'NEAR PARKER, COLORADO
MARCH 27, 1980

NTSB-AAR-82-9

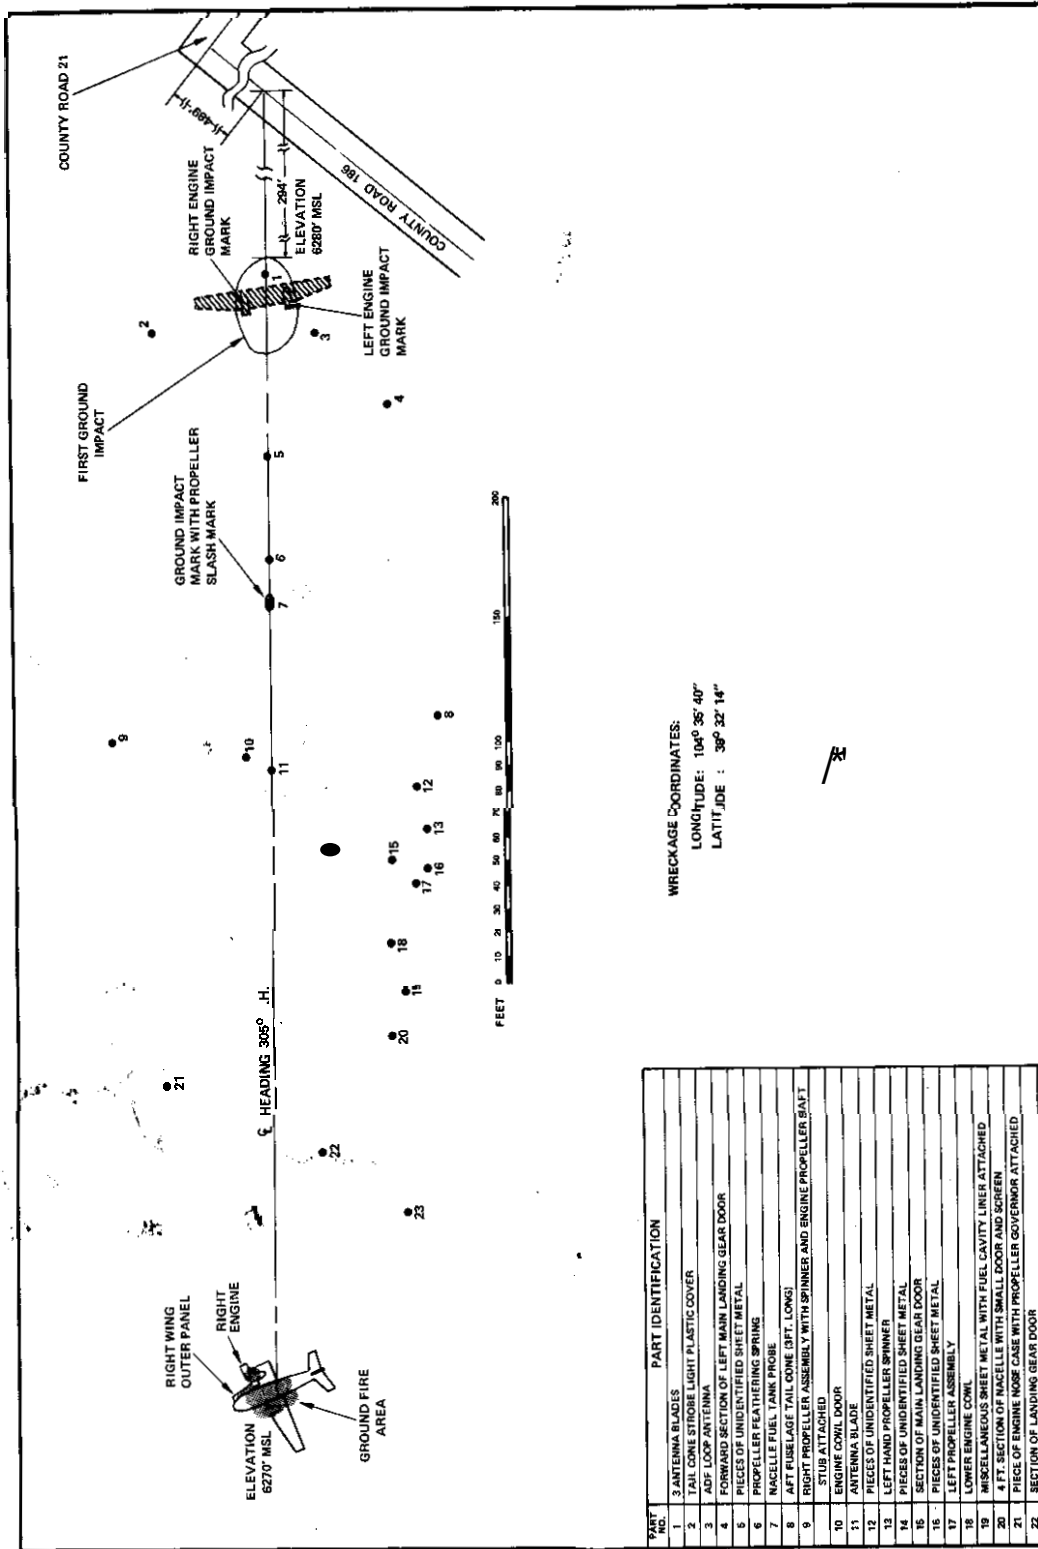
APPENDIX D WRECKAGE DISTRIBUTION CHART

Marks in the ground made by the left and right engine nacelles, fuselage, and wings were visible at the initial impact area. Various components of the aircraft were located along a 35° magnetic bearing. None of the separated aircraft components found along the wreckage path bore any evidence of preimpact fire damage.

The left wing and wing center section remained attached to the fuselage. The left engine was in place but nearly burned away from the engine nacelle. An ice formation about 3 feet long was found on the left wing inboard deicer boot. The iced area was between 0.25 inch and 0.375 inch thick. (The ambient temperature had remained at or below freezing from the time of the accident until the arrival of the investigators the next day.) The right wing outer panel had separated from the wing center section, which remained attached to the fuselage. The right engine had separated from the nacelle and was found close to the engine nacelle. A small area of ice about 0.5 inch thick had formed at the junction of the right engine nacelle's inboard side and the wing leading edge. Both engine propellers with the blades attached had separated from the engines and were found along the wreckage path. The entire fuselage, from the nose aft to near the aft pressure bulkhead, was damaged extensively by ground fire. The fuselage structure above the lower edge of the passenger window frames, beginning from the lower edge of the cockpit windshield aft to near the aft pressure bulkhead, was consumed by postimpact ground fire. The entire fuselage interior was gutted by fire. There was no evidence of preexisting structural damage. All fractures observed were typical of those caused by overloads.
