# NATIONAL TRANSPORTATION SAFETY BOARD

## AIRCRAFT ACCIDENT REPORT •

EMPIRE AIRLINES  
FLIGHT 141, PIPER PA-31, N546BA  
ITHACA, NEW YORK  
JANUARY 5, 1982

NTSB-AAR-82-11

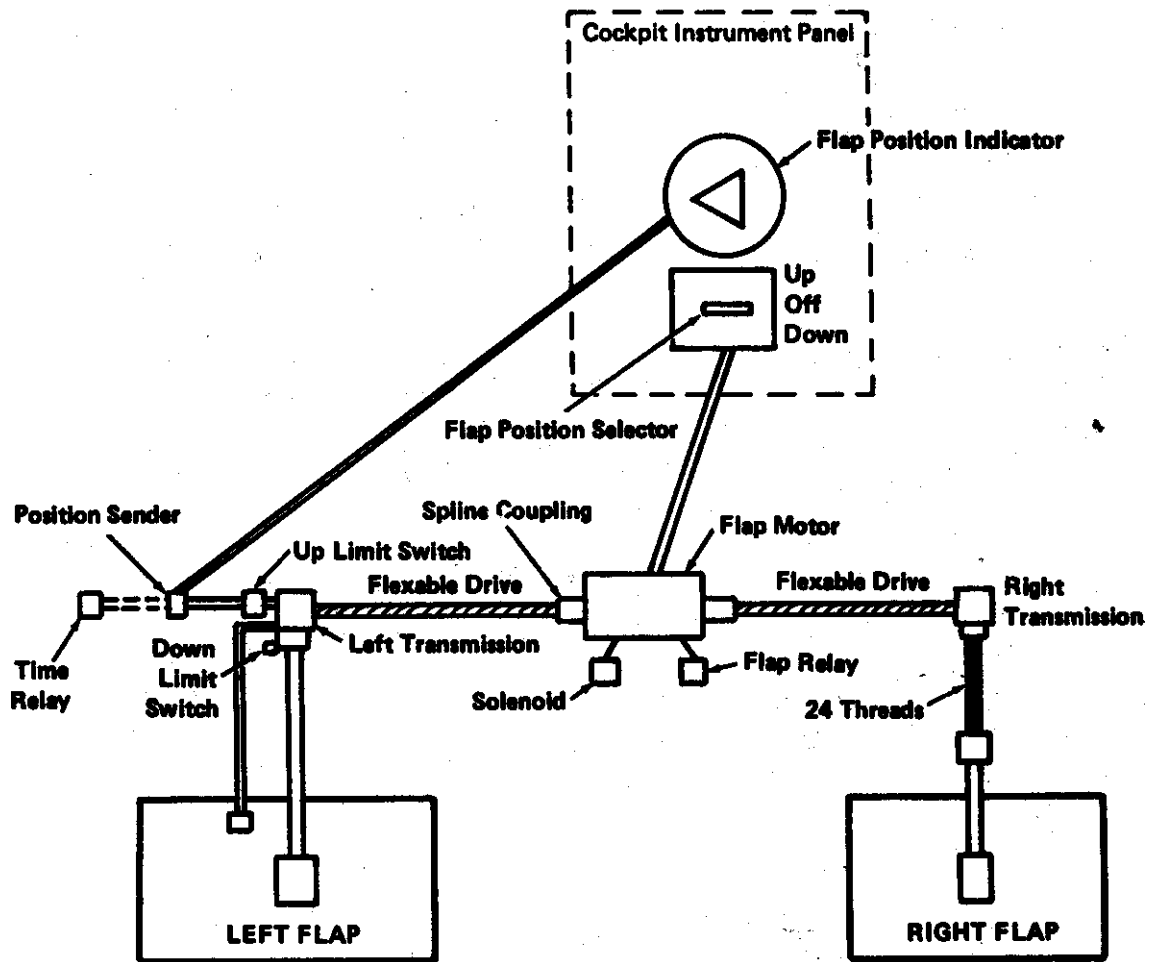
Figure 1.—PA-31-310 (Navajo) flap system.

Microswitches located in the left wing limit flap up and down travel. A rheostat, also located in the left wing, actuates the flap position indicator located above the flap selector switch in the cockpit. A time-delay relay located near the flap motor stops the motor if an asymmetric flap condition occurs when the flaps are selected to the down position. If the flaps do not extend together (the left flap does not leave the up limit switch), the time delay relay will turn the flap motor off within 1 second (about 9° of flap travel), and the flap selector will become inoperative until the time-delay relay is reset. The time-delay relay can be reset by pulling the flap control circuit breaker, located in the cockpit, and resetting it. The time-delay relay does not affect flap motor operation if the left flap is not at the up or down limit.

Examination of the wreckage confirmed that the left wing flap was on the up position and the right wing flap was extended to about 4. The flap system design is such that when the selection for flap extension is initiated a time relay is activated. Should the left flap fail to extend from the full up position, the flap motor will deactivate after 1 second during which the right flap will extend about 9. Therefore, the Safety Board must conclude that when the crew selected flap extension, both flaps began to extend. However, as the air loads began to oppose flap travel, the worn left spline coupling, which normally transmitted torque from the flap motor to the left flap transmission, began to slip thus slowing or stopping the extension of the left flap at an intermediate position. The right flap continued to extend at its normal rate.

A In summary, the Safety Board believes that the most probable accident sequence was as follows. The flightcrew made a flap-down selection before intercepting the ILS final approach. The worn female fitting of the left flap motor flexible drive spline prohibited the left flap from fully extending during this flight. Thereafter, symmetry of the flaps could not be attained because of the system design and the flightcrew declared an emergency and asked for vectors to the Tompkins County Airport. The flightcrew was not able to maintain altitude and had to use full aileron control, asymmetrical power, and rudder to maintain wings level flight. Airplane control was tenuous, and moderate to severe turbulence, along with transient low level wind shear, added to airplane handling difficulties. Although the Safety Board could not determine what initiated the final control loss, about 09.49 control was lost and the airplane could not be recovered by the flightcrew because of the split flap condition.

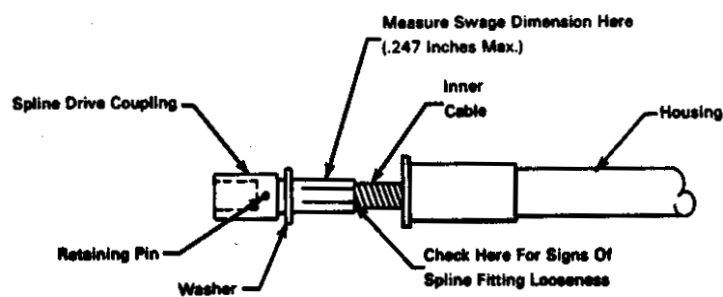
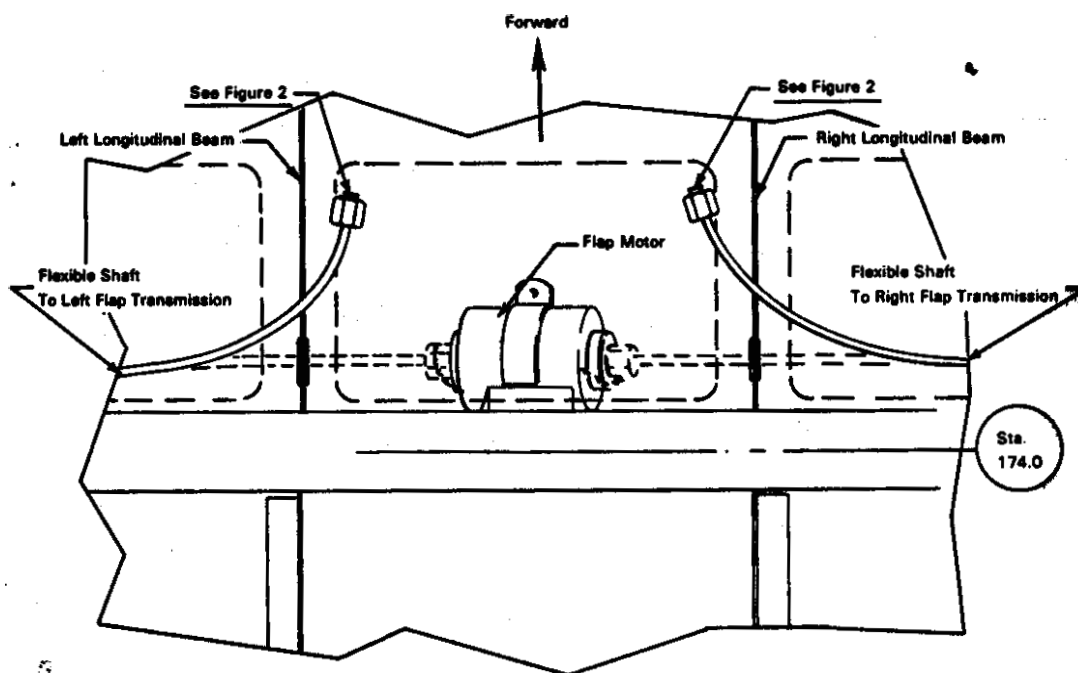
SKETCH D

4. Visually inspect the flexible shaft splined drive coupling and retaining pin for evidence of looseness on the cable swage fitting. (Ref Sketch D, Figure 2.) If any looseness is apparent, replace the flexible shaft assembly.

5. Inspect the swaged fittings at both ends of the flexible shaft as follows:
  - a. Expose the swaged portion of the inner cable at the motor end by twisting the outer housing two (2) turns clockwise. The swaged portion of the cable should have eight (8) flats clearly visible and free from deep scratches or wear marks, (Ref Sketch D, Figure 2.)

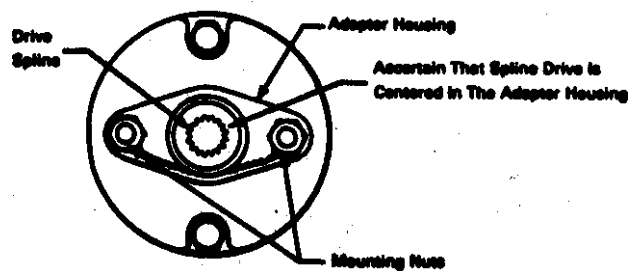
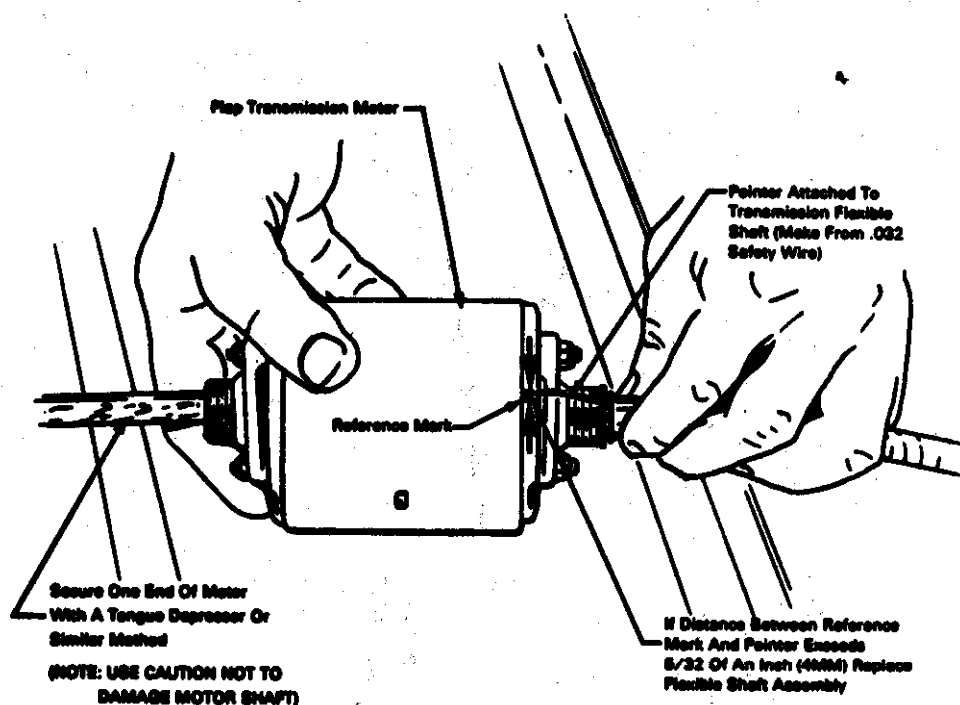
SKETCH F

6. Inspect the internal splines of the drive coupling for evidence of wear. If splines are distorted or significantly worn, replace the drive shaft. Use the following method to determine if the amount of spline wear is acceptable.

- b. Hold the spline end of the flexible shaft securely with one hand, and gently turn the flap motor to remove rotational play in the splines. Place a reference mark on the motor housing adjacent to the wire pointer (Ref Sketch F, Figure 5). Turn the flap motor gently in the opposite direction to remove rotational play and place another reference mark on the motor housing. If any distance between these two marks exceed 5/32 of an inch (4 mm) replace the flexible shaft assembly (Ref Sketch F, Figure 5).
