AIRCRAFT ACCIDENT REPORT

SUN WEST AIRLINES FLIGHT 104,
PIPER PA-31-350 (T-1020), N41070
DURANGO-LaPLATA COUNTY AIRPORT,
DURANGO, COLORADO
DECEMBER 31, 1981

NTSB-AAR-82-13

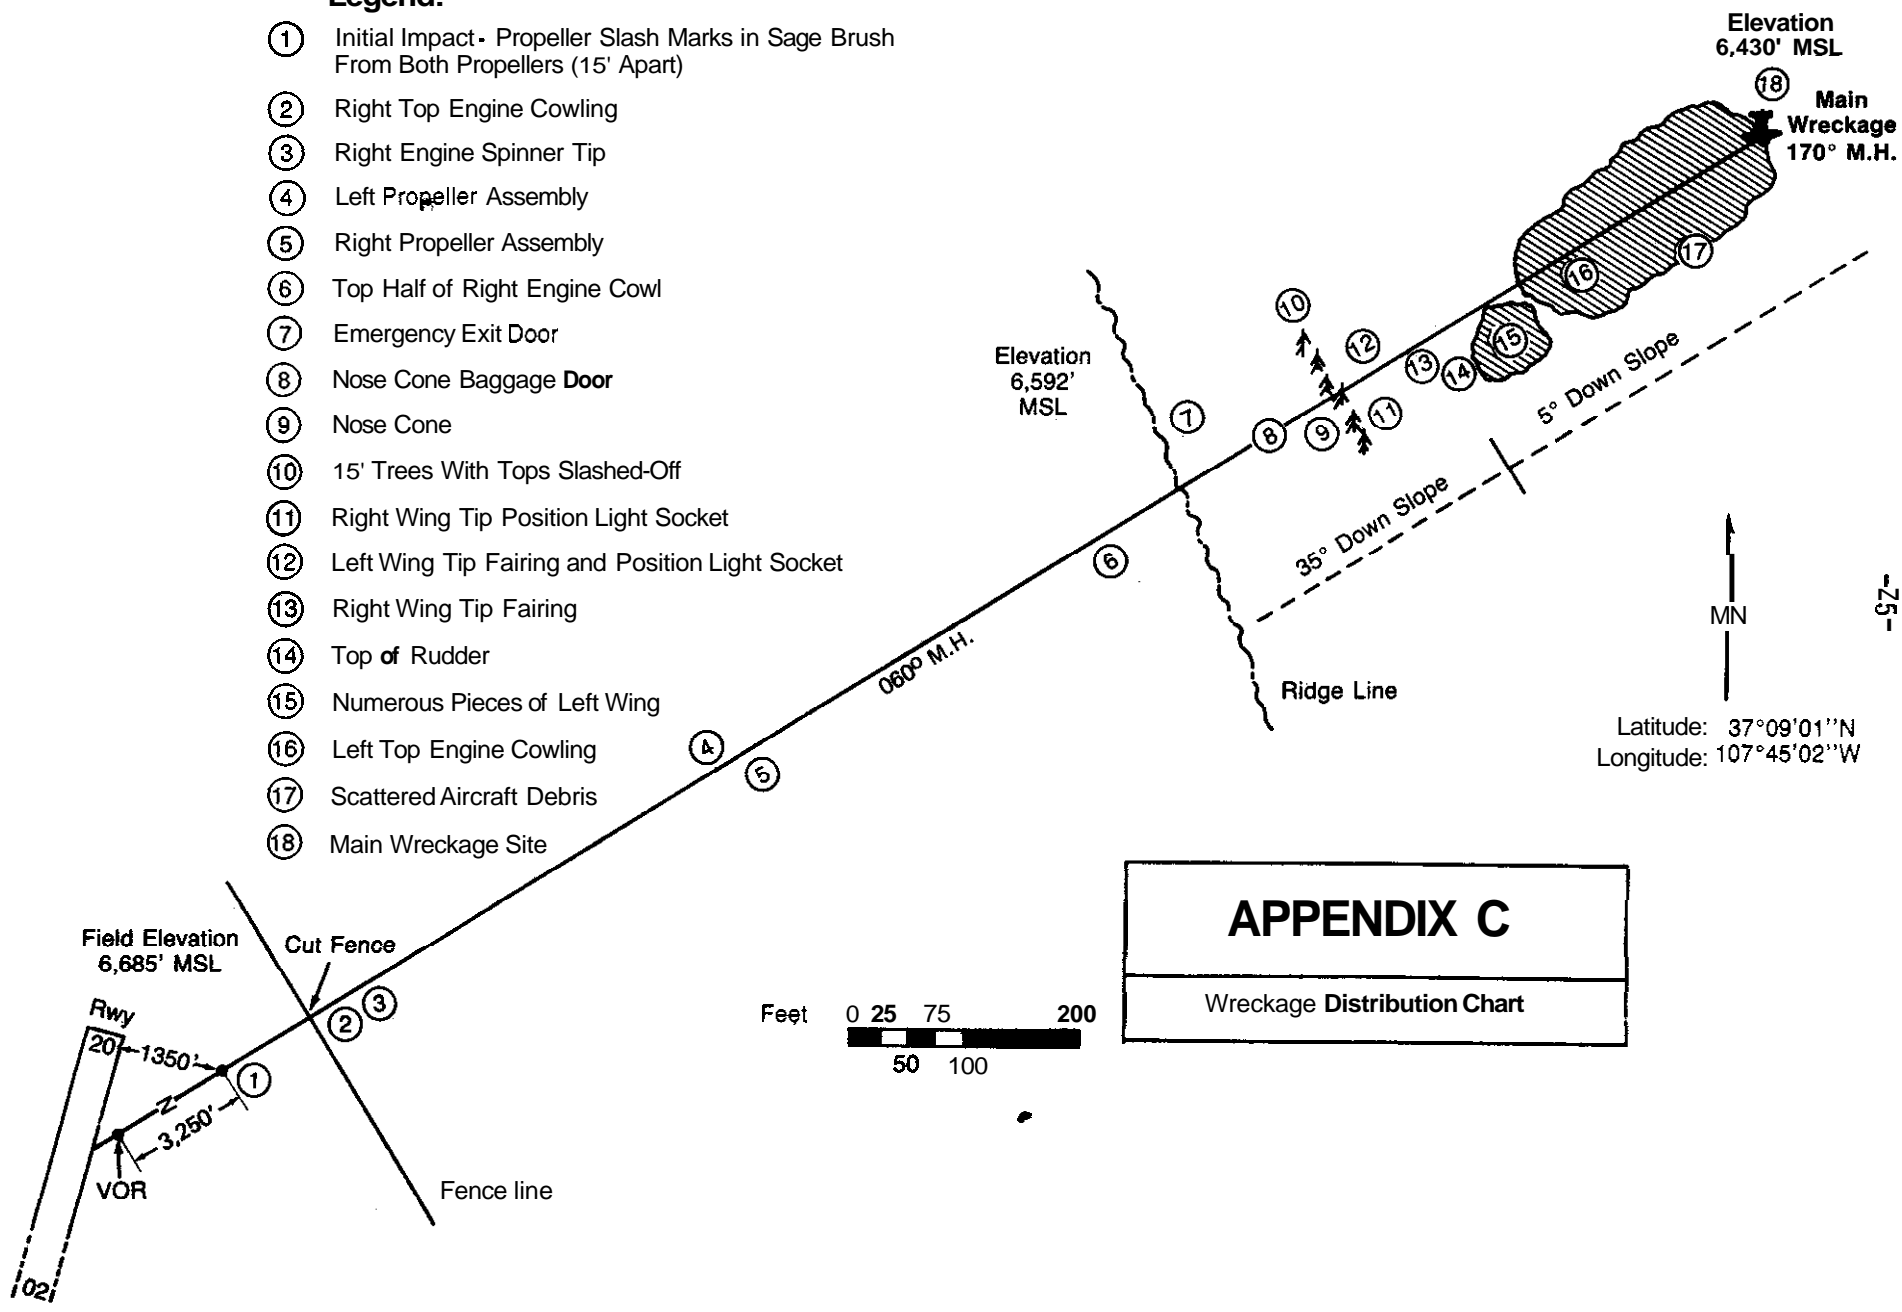
Wreckage Distribution Chart

The wreckage and ground impact scars were confined to an area about 1,600 feet long and about 100 feet wide along a path oriented 060° magnetic. (See appendix C.) The first evidence of ground impact was about 1,350 feet from the north end of runway 2 in level terrain covered with snow and sagebrush. The first marks noted were propeller slashes in the sagebrush. These marks continued for about 100 feet, where the airplane struck a barbed wire fence. The elevation at the initial impact area was about 6,600 feet. The right-engine propeller dome and a piece of right-engine cowling were found near the fence and two broken fence posts were nearby. There were no definite indications of ground impact at this point or for the next 400 feet. About 425 feet beyond the initial ground contact point, the left and right propeller assemblies were found. There were

Snow obscured most ground scars along the wreckage path except at the bottom of the 35° slope where considerable dirt and sand was disturbed. Numerous pieces of left wing structure were found in this area which was also sooted by ground fire. Gouges were evident from that point to where the main wreckage came to rest oriented on a 170° magnetic heading.
