AIRCRAFT ACCIDENT REPORT

COIN ACCEPTORS, INC.
CESSNA MODEL 551, CITATION II, N2CA
MOUNTAIN VIEW, MISSOURI
NOVEMBER 18, 1982

NTSB/AAR-83/04

Adopted: July 19, 1983

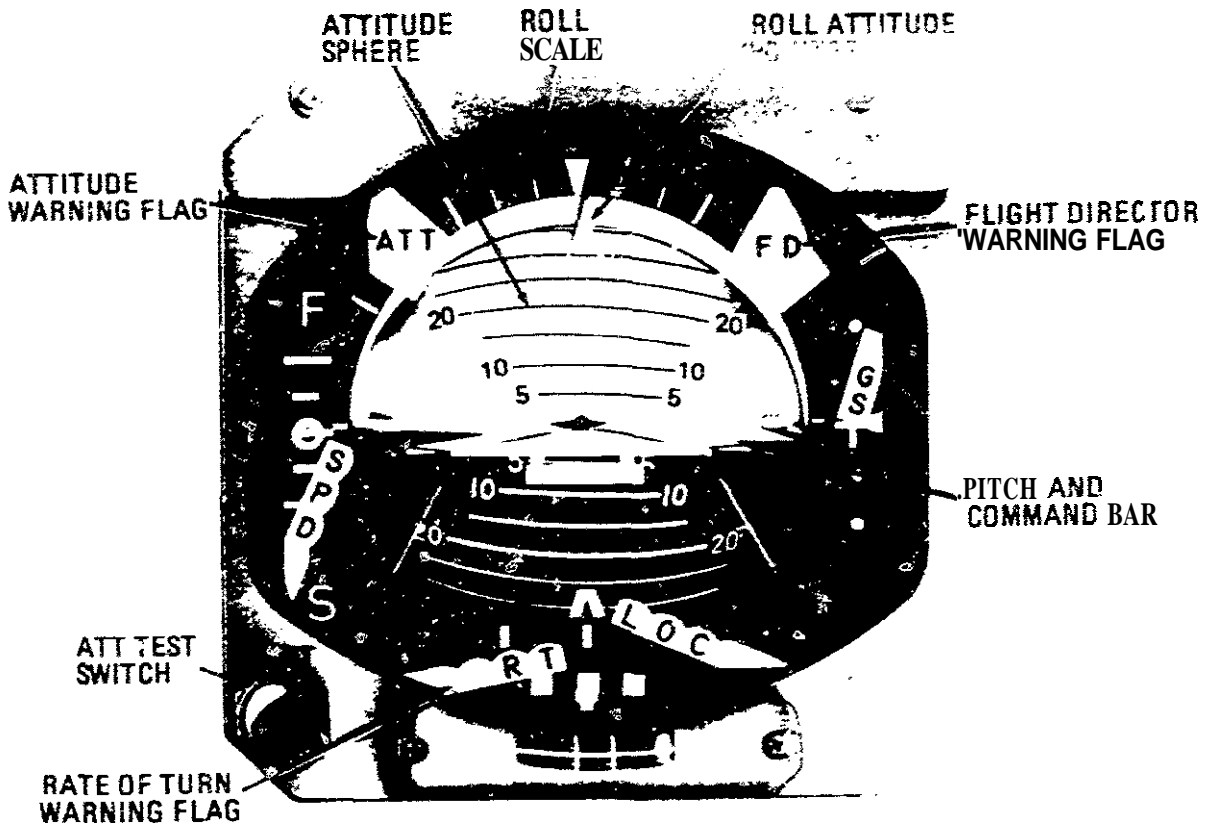
Figure 1.—Pilot's AD-600 Attitude Director Indicator.

If no power is applied to the ADI or if power is interrupted during normal operation, the attitude sphere will indicate a left bank. The roll-attitude pointer will be in the horizontal position with the blue portion of the sphere to the right of the pointer.

The tolerance of the ADI in the unpowered state is 90° left bank $\pm 25^\circ$. Once power is applied to the system and the vertical gyro reaches operating speed to drive the ADI, the attitude sphere will move to a position where the roll attitude pointer aligns with the zero mark on the roll scale. At that time, the attitude warning flag disappears, and the pitch and roll command bar appears. The flight director warning flag disappears when power is applied to the flight director and will remain concealed unless the command bar information is unreliable. The attitude warning flag will also remain concealed unless the attitude information is unreliable. The autopilot can be engaged only when the gyros, which drive the ADI and the HSI, are operating properly.

The Safety Board believes that the position of the attitude sphere of the pilot's ADI indicated the actual attitude of the airplane at impact -- 90° banked attitude to the left. The Safety Board realizes that the attitude sphere would have gone to the left bank position if there had been a power failure. However, it is unlikely that the attitude sphere would have gone precisely to the 90° point, since the tolerance of the RD-600 was $90^\circ \pm 25^\circ$. Furthermore, the physical evidence near the impact site and the location of portions of the airplane wreckage in the impact site support the conclusion that the pilot's ADI essentially portrayed the *Sank* attitude of the airplane at impact. This finding, and the absence of a history of ADI problems, leads the Safety Board to conclude that the pilot's ADI was functioning properly at the time of the accident.

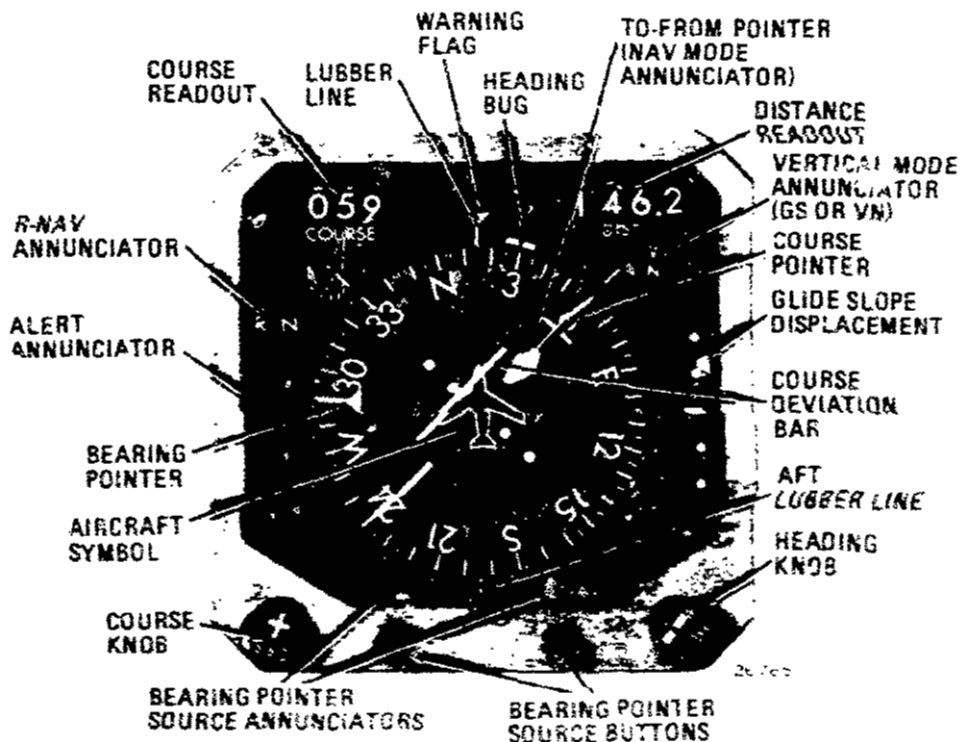
Figure 3.--Pilot's RD-800 Horizontal Situation Indicator.

Both the pilot's and the copilot's horizontal situation indicator (HSI) received extensive impact damage. The pilot's HSI indicated a heading of 20° on the compass card, and had a course pointer reading of 355°. Both NAV mode annunciator flags were in view. There were no pointers or flags remaining on the copilot's HSI. The compass card was in place and indicated a heading between 90° and 120°.

The pilot's HSI was a RD-600 5-inch display. (See figure 3.) The instrument is powered by a C-14 Gyrosyn Compass System (directional gyro), which provides primary

Although both HSI's were damaged severely, the copilot's compass card indicated a heading of 90° to 120°, which was generally coincident with the airplane's heading at impact. The pilot's HSI indicated 20°. If the gyro which drove the pilot's HSI was slow in bringing the HSI up to speed, as had occurred according to the chief pilot in previous flights, the difference between the two compass readings can be explained. It was concluded that the copilot's HSI was operating properly and providing accurate heading information to the pilot, while the pilot's HSI had not become completely operationally usable at impact. A difference in the times required for the HSI's to come up to speed had been noted by the chief pilot, who also said that the pilot had used the copilot's HSI for heading information on the previous day because the pilot's HSI was slow in becoming operationally usable. In summary, the evidence points to a conclusion that the two HSI's on the airplane were not completely functional. However, it appears that the copilot's HSI was providing accurate heading information and that the pilot's ADI probably was providing accurate attitude information at impact.

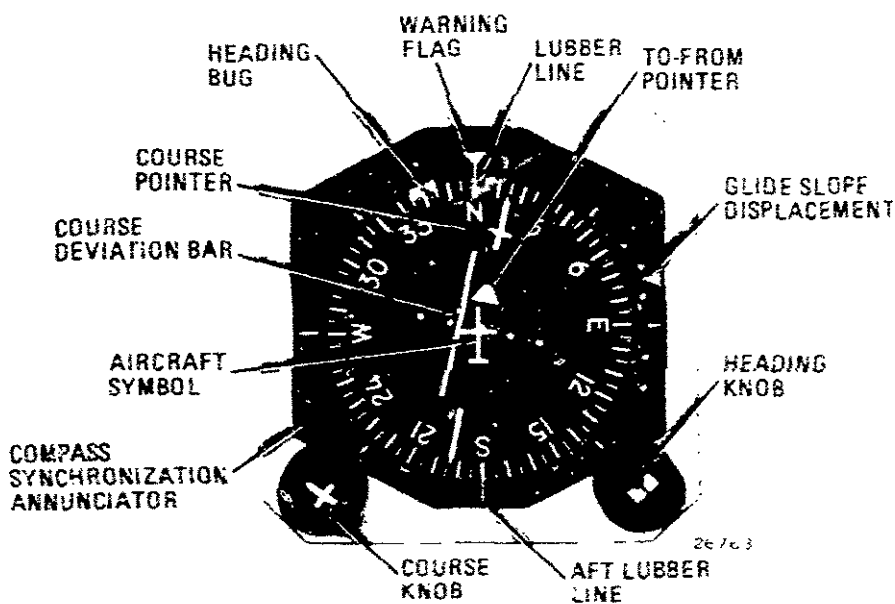
Figure 4.--Copilot's RD-44 Horizontal Situation Indicator.

Both HSI's have warning flags which appear if the heading information is not reliable, or if the gyro is not providing adequate power to the HSI.
