AIRCRAFT ACCIDENT REPORT

COIN ACCEPTORS, INC.
CESSNA MODEL 551, CITATION II, N2CA
MOUNTAIN VIEW, MISSOURI
NOVEMBER 18, 1982

NTSB/AAR-83/04

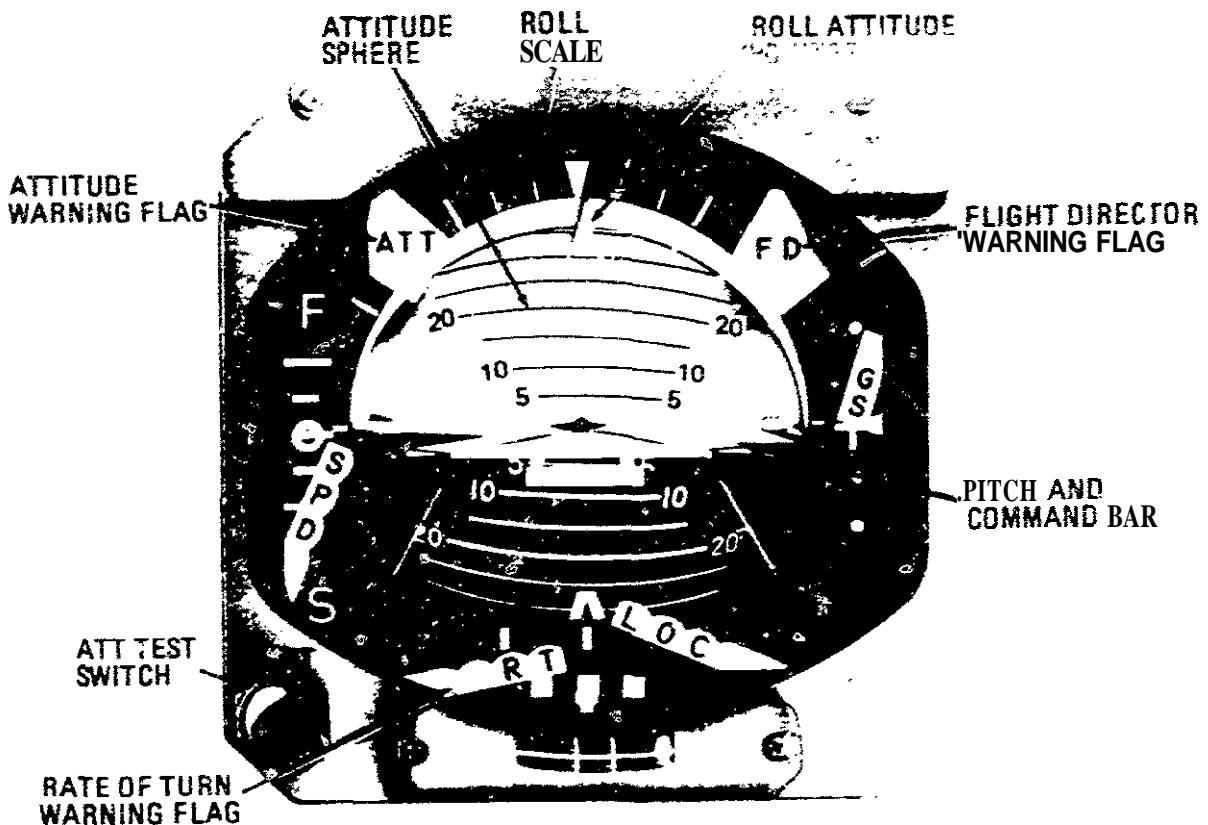
Figure 1.—Pilot's AD-600 Attitude Director Indicator.

The cockpit instruments received severe impact damage. The encoding altimeter was damaged internally and the pointer was detached from the shaft. The barometric dial read 30.11 inHg and 1020 mb. The plastic sphere on the pilot's ADI was broken into many small sections, and the pieces were contained within the unit case. The horizon line was in the vertical position from the zero bank indicies on the roll scale to the bottom of the indicator. The blue portion of the attitude sphere was on the right side and the brown portion was on the left side. All pointers, warning flags, and command bars were missing. There were no marks which would indicate pitch or bank attitude at impact. The copilot's ADI was not located.

If no power is applied to the ADI or if power is interrupted during normal operation, the attitude sphere will indicate a left bank. The roll-attitude pointer will be in the horizontal position with the blue portion of the sphere to the right of the pointer.

The tolerance of the ADI in the unpowered state is 90° left bank $\pm 25^\circ$. Once power is applied to the system and the vertical gyro reaches operating speed to drive the ADI, the attitude sphere will move to a position where the roll attitude pointer aligns with the zero mark on the roll scale. At that time, the attitude warning flag disappears, and the pitch and roll command bar appears. The flight director warning flag disappears when power is applied to the flight director and will remain concealed unless the command bar information is unreliable. The attitude warning flag will also remain concealed unless the attitude information is unreliable. The autopilot can be engaged only when the gyros, which drive the ADI and the HSI, are operating properly.

The Safety Board believes that the position of the attitude sphere of the pilot's ADI indicated the actual attitude of the airplane at impact -- 90° banked attitude to the left. The Safety Board realizes that the attitude sphere would have gone to the left bank position if there had been a power failure. However, it is unlikely that the attitude sphere would have gone precisely to the 90° point, since the tolerance of the RD-600 was $90^\circ \pm 25^\circ$. Furthermore, the physical evidence near the impact site and the location of portions of the airplane wreckage in the impact site support the conclusion that the pilot's ADI essentially portrayed the *Sank* attitude of the airplane at impact. This finding, and the absence of a history of ADI problems, leads the Safety Board to conclude that the pilot's ADI was functioning properly at the time of the accident.

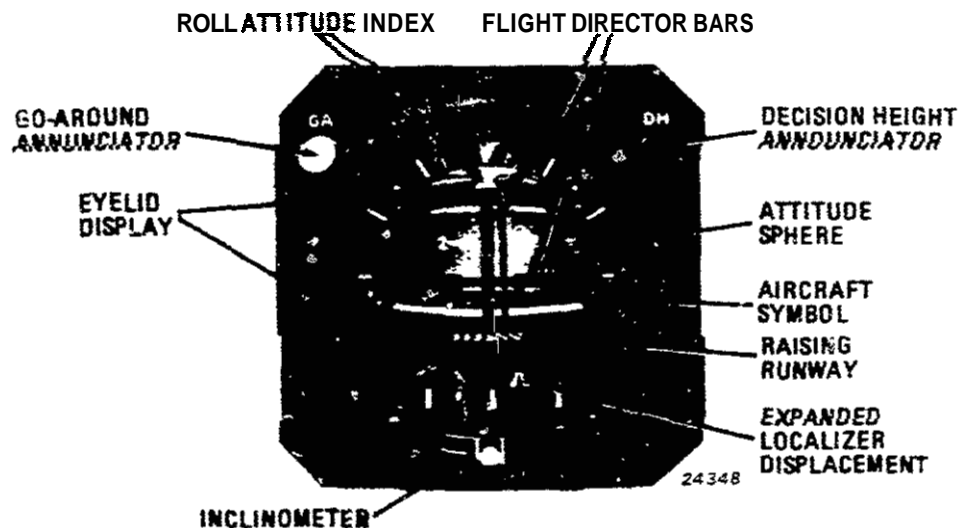
Figure 2.--Copilot's GH-14 Gyro Horizon Attitude Director Indicator.

The copilot's ADI, a GH-14 Gyro Horizon, was a double cue, 4-inch instrument, with a self-contained vertical gyro. (See figure 2.) It required the same time to become operationally usable as the AD-600.

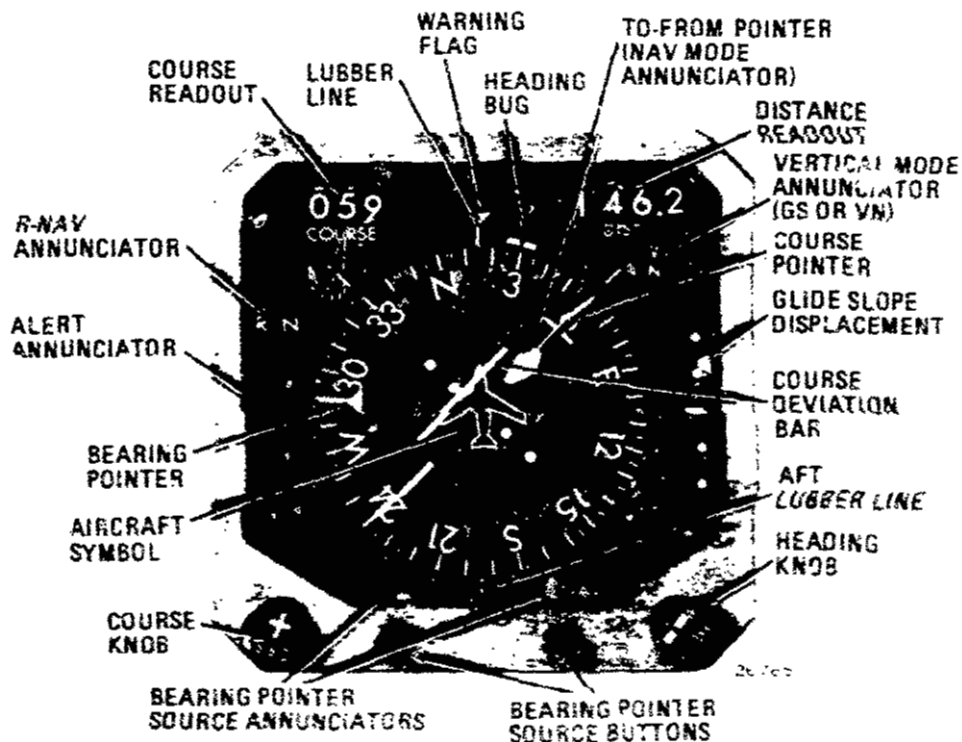
Figure 3.--Pilot's RD-600 Horizontal Situation Indicator.

Both the pilot's and the copilot's horizontal situation indicator (HSI) received extensive impact damage. The pilot's HSI indicated a heading of 20° on the compass card, and had a course pointer reading of 355°. Both NAV mode annunciator flags were in view. There were no pointers or flags remaining on the copilot's HSI. The compass card was in place and indicated a heading between 90° and 120°.

Although both HSI's were damaged severely, the copilot's compass card indicated a heading of 90° to 120°, which was generally coincident with the airplane's heading at impact. The pilot's HSI indicated 20°. If the gyro which drove the pilot's HSI was slow in bringing the HSI up to speed, as had occurred according to the chief pilot in previous flights, the difference between the two compass readings can be explained. It was concluded that the copilot's HSI was operating properly and providing accurate heading information to the pilot, while the pilot's HSI had not become completely operationally usable at impact. A difference in the times required for the HSI's to come up to speed had been noted by the chief pilot, who also said that the pilot had used the copilot's HSI for heading information on the previous day because the pilot's HSI was slow in becoming operationally usable. In summary, the evidence points to a conclusion that the two HSI's on the airplane were not completely functional. However, it appears that the copilot's HSI was providing accurate heading information and that the pilot's ADI probably was providing accurate attitude information at impact.

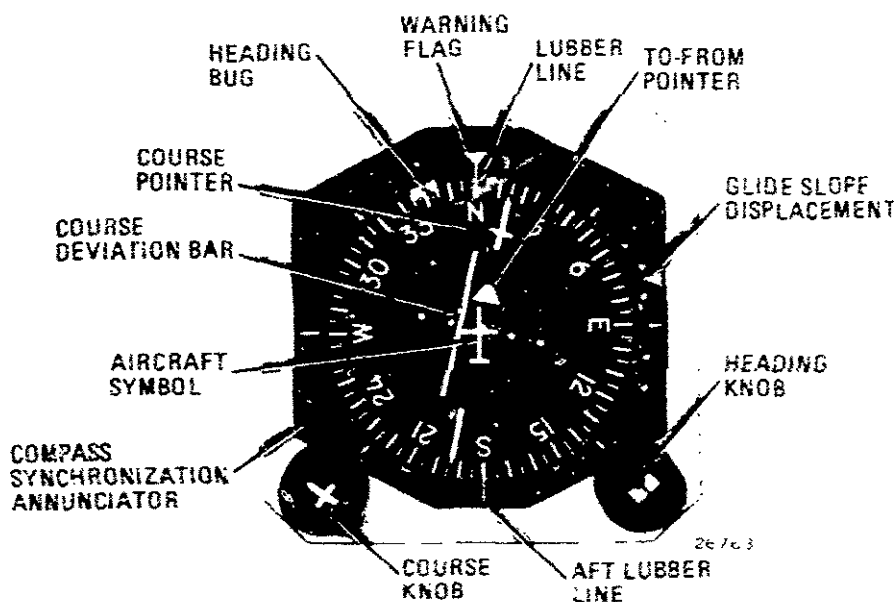
Figure 4.--Copilot's RD-44 Horizontal Situation Indicator.

Both HSFs have warning flags which appear if the heading information is not reliable, or if the gyro is not providing adequate power to the HSI.
