# **NATIONAL TRANSPORTATION SAFETY BOARD**

## **AIRCRAFT ACCIDENT REPORT**

**REPUBLIC AIRLINES, INC.  
CONVAIR 580, N844H  
BRainerd, MINNESOTA**

**JANUARY 9, 1983**

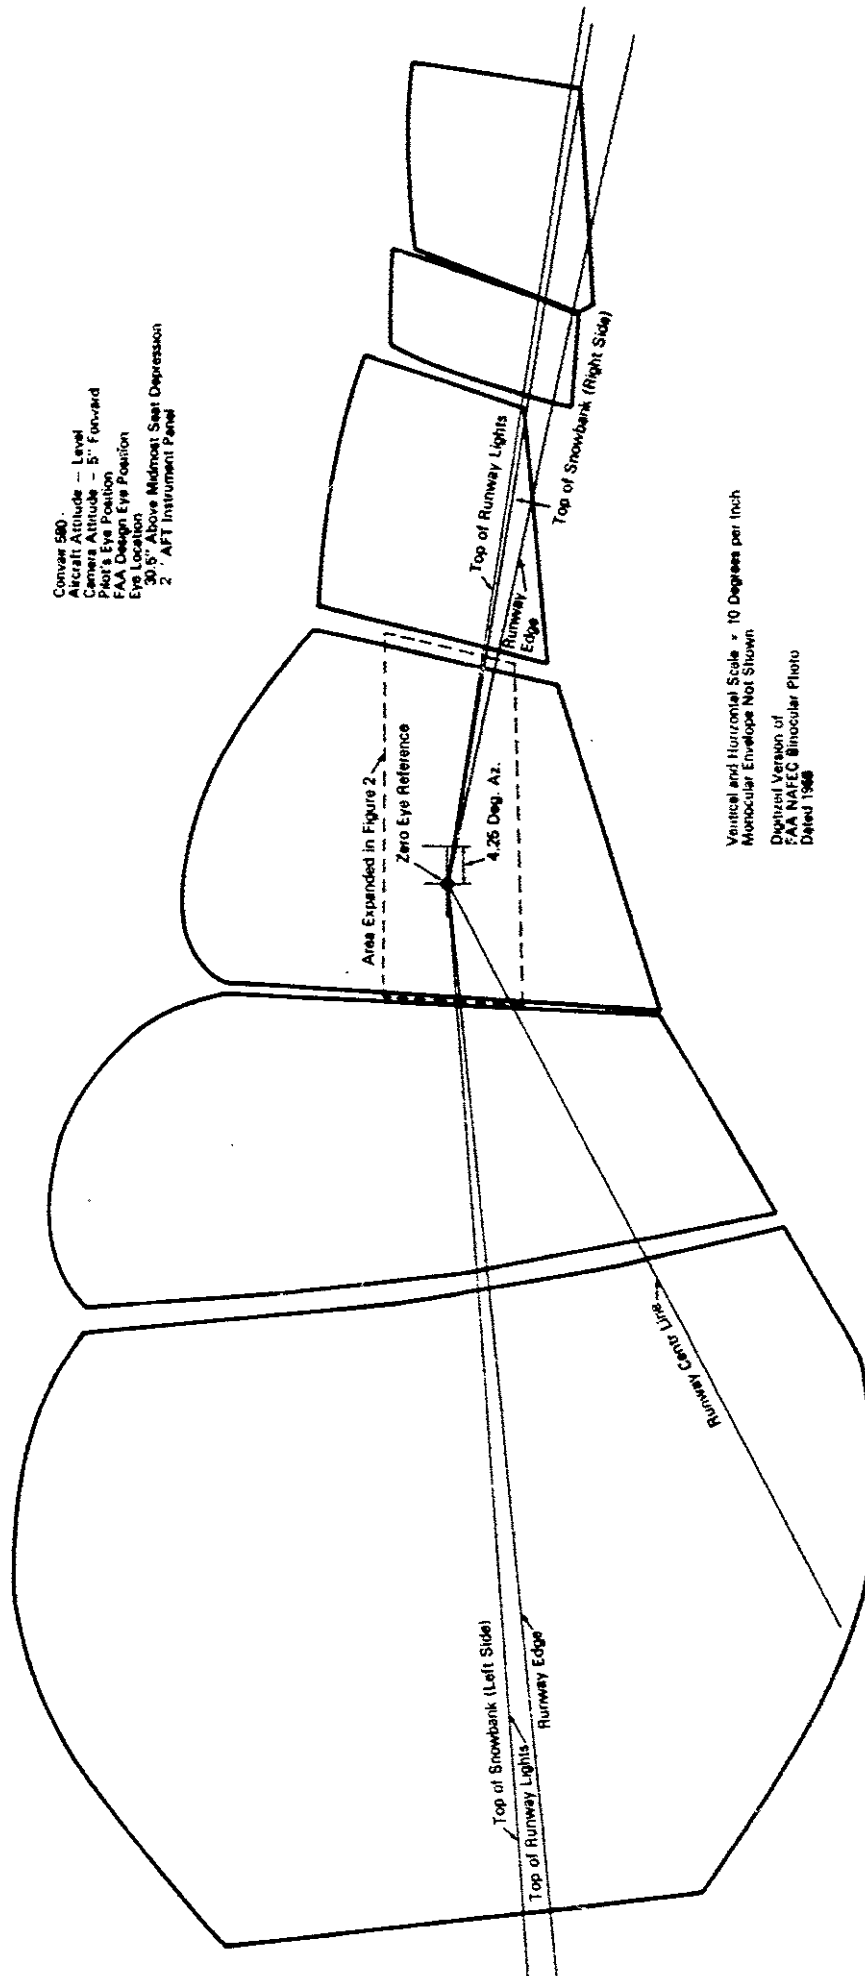
Figure 1.—Full vision envelope at touchdown.

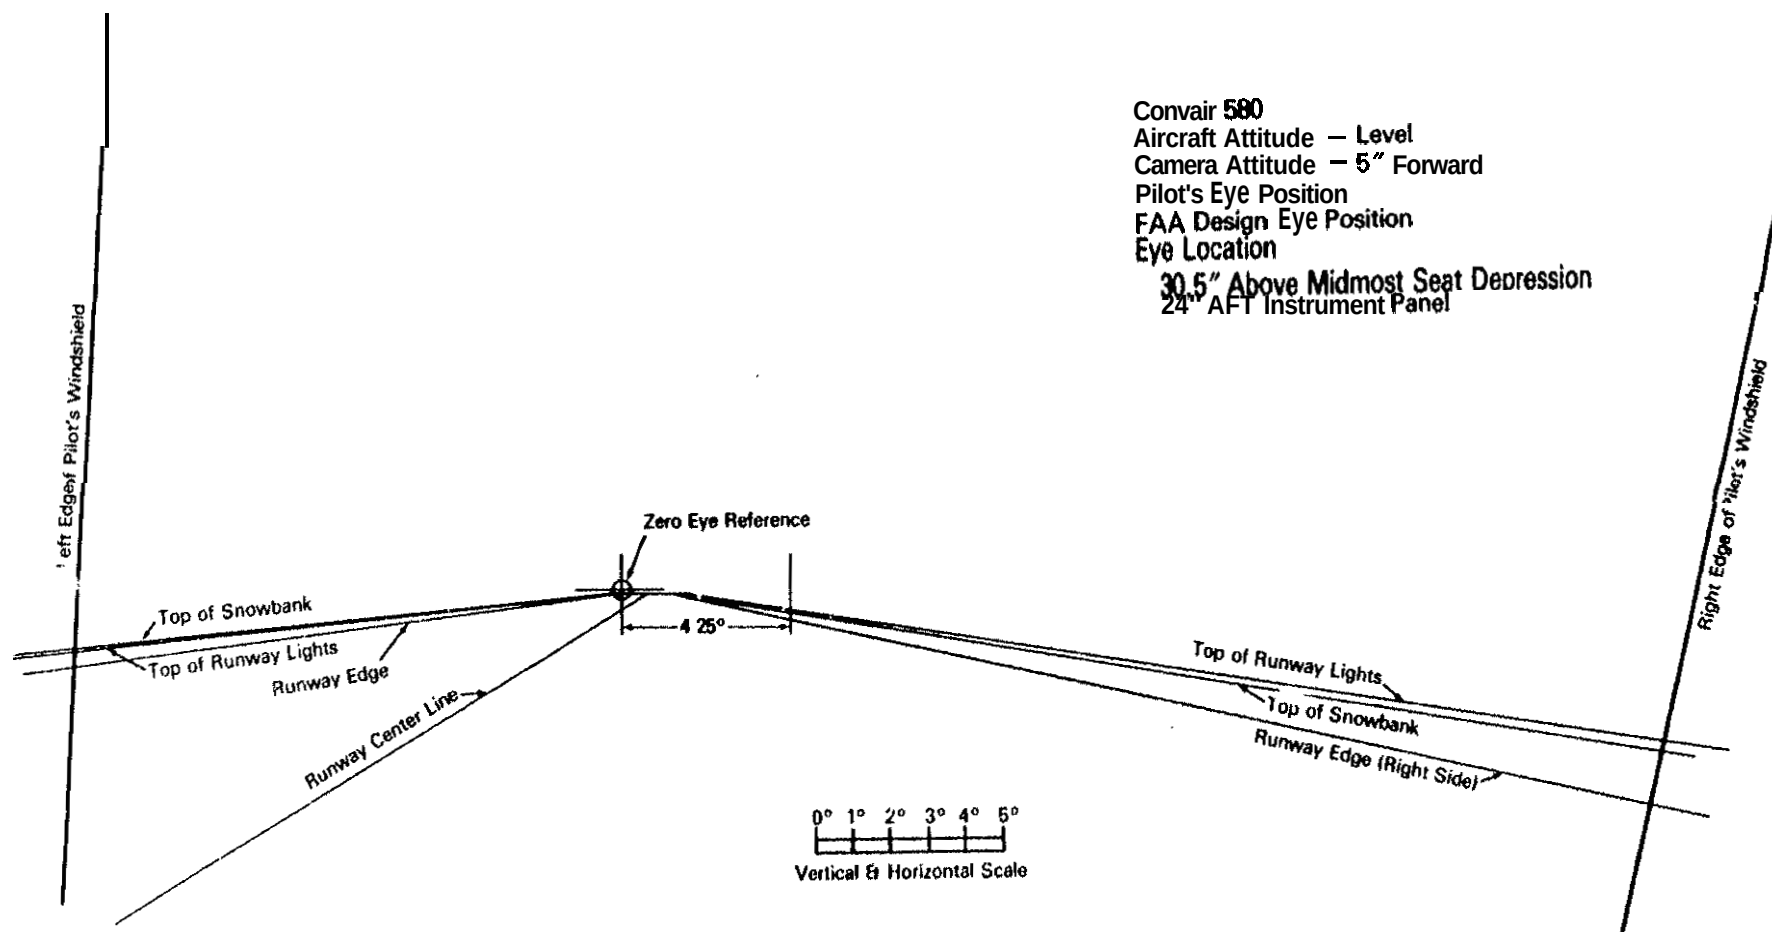
Figure 2.—Expanded view of runway at touchdown.

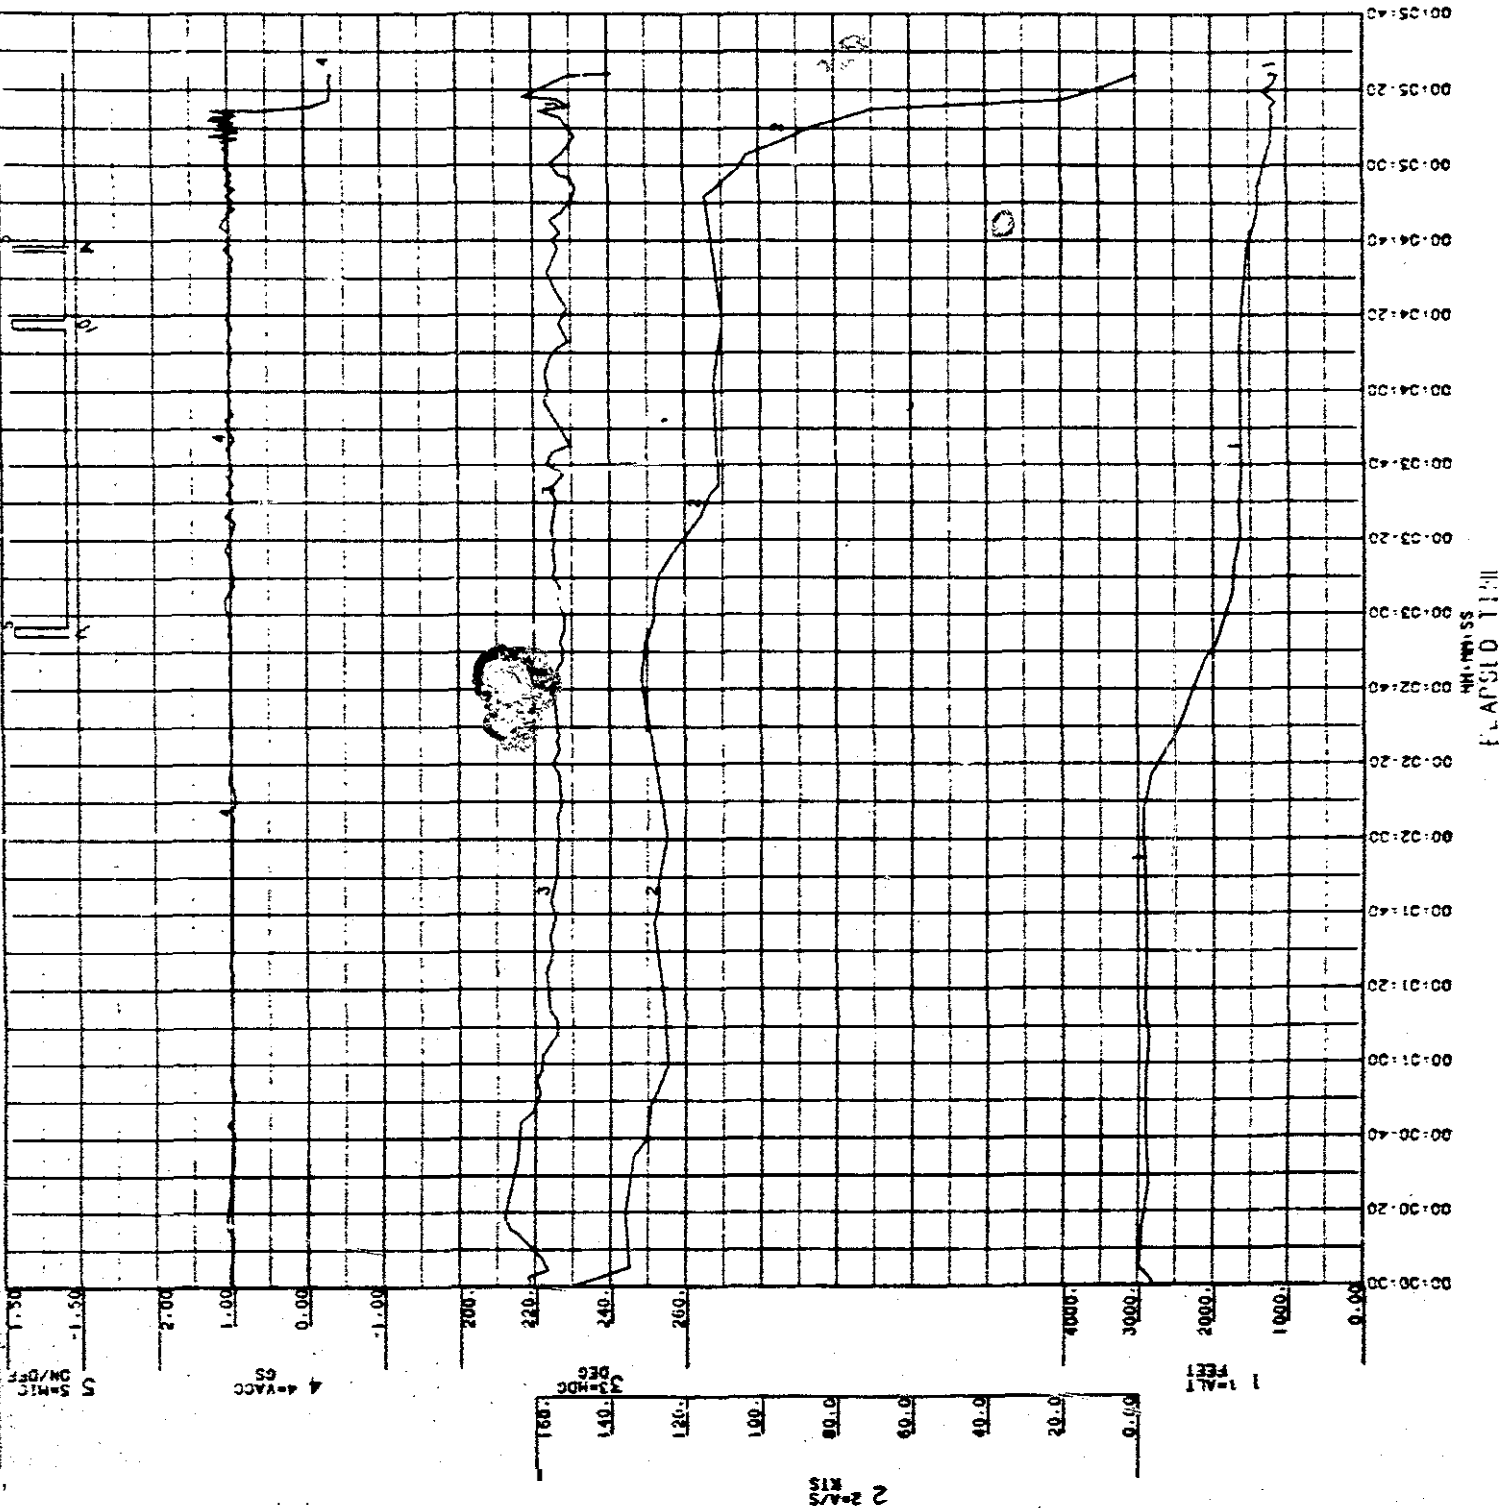
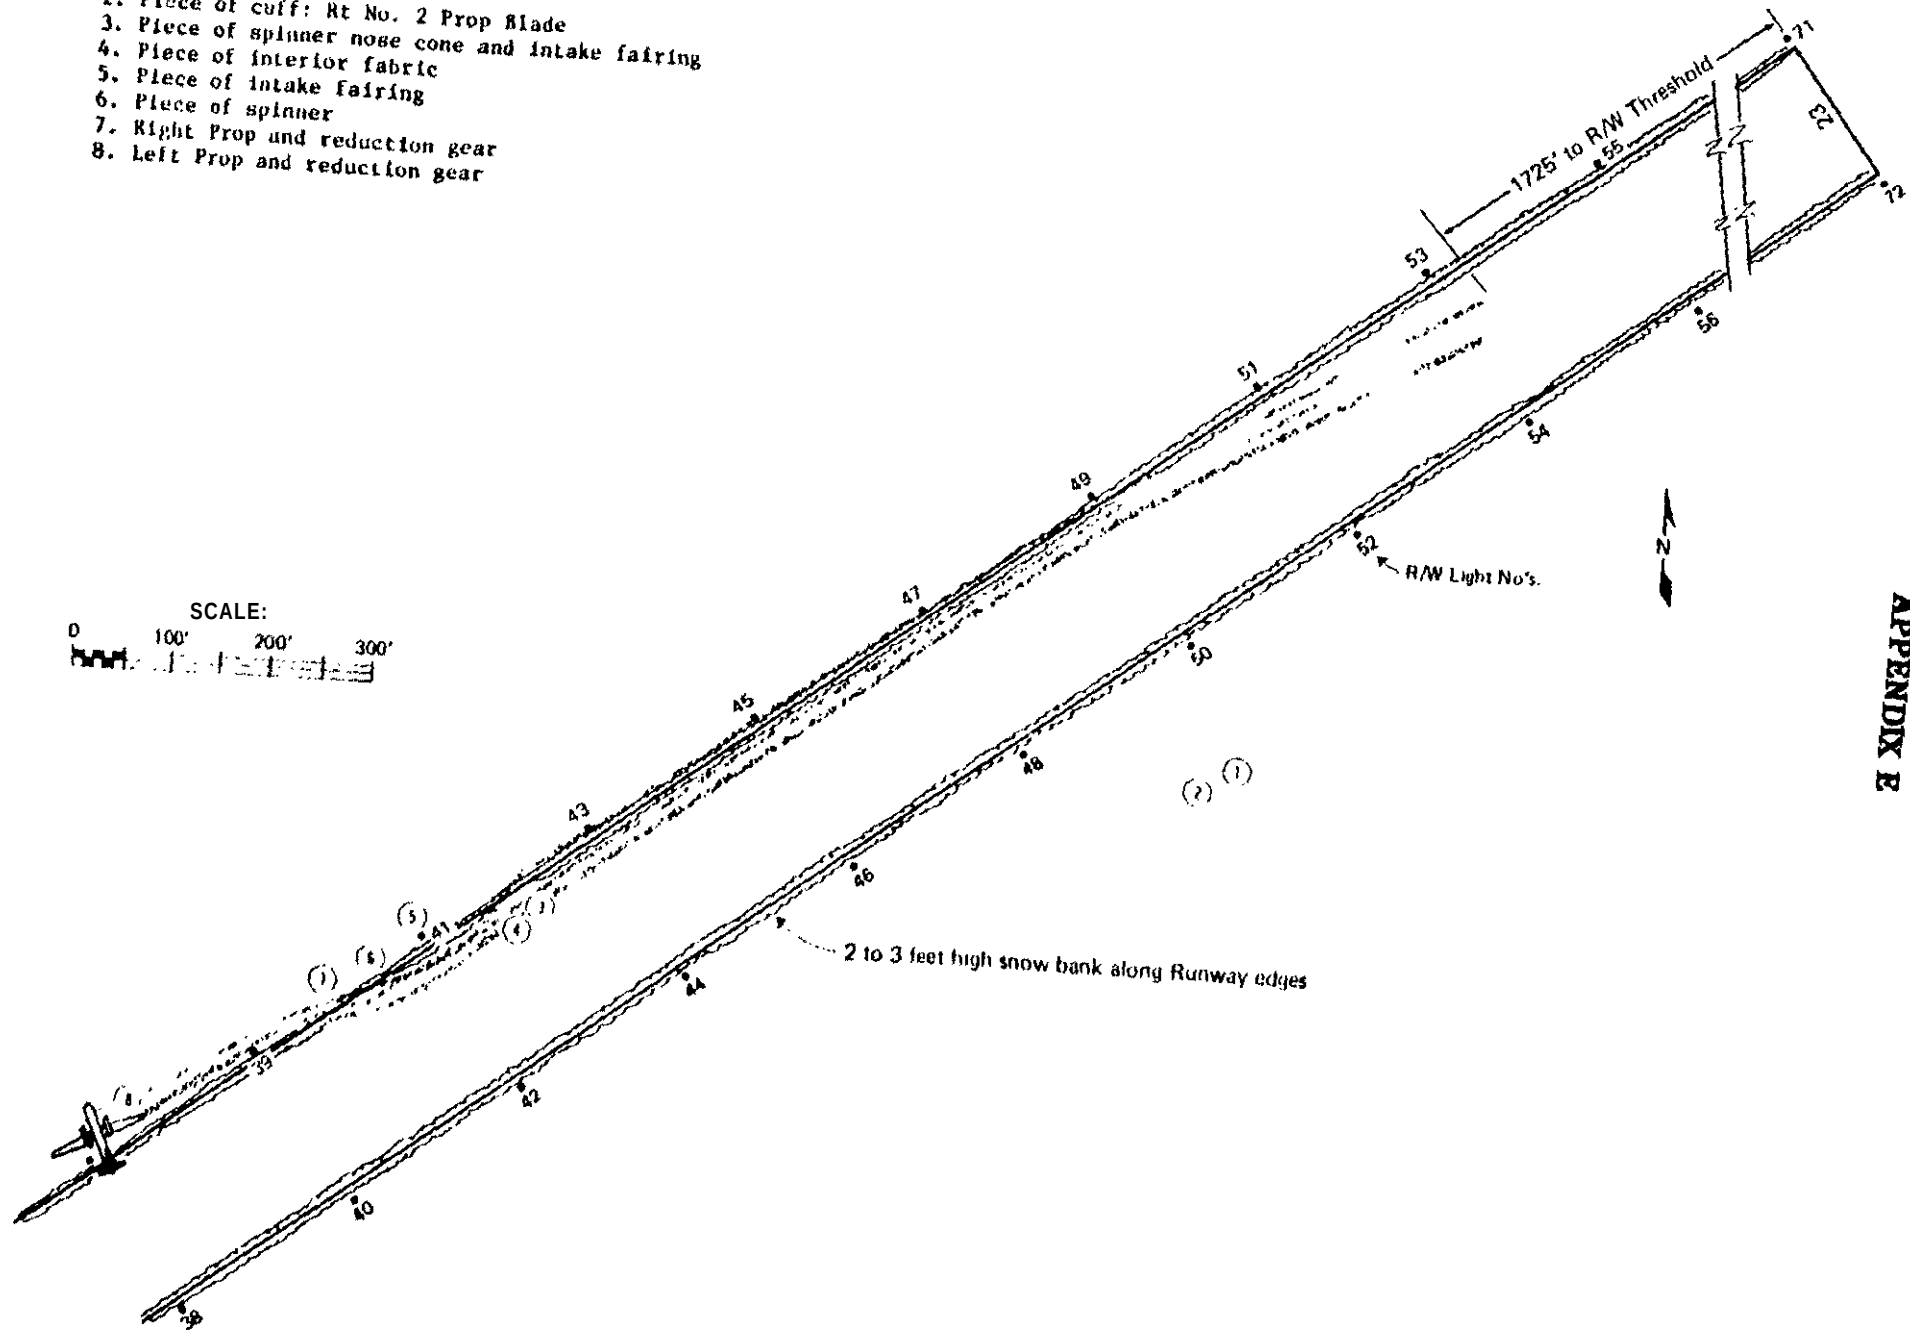
# WRECKAGE DISTRIBUTION CHART

The wreckage distribution data showed that the No. 2 blade of the right propeller was found about **540** feet down the runway from the point of initial touchdown. This location was close to the point where the airplane first struck the snowbank, and at the time there were power interruptions to the CVR and FDR. The right propeller struck the snowbank and the No. 1 blade separated and penetrated the airplane cabin on the right side between seat rows 1 and 2, injuring passengers in the cabin. It **is** likely that the **right** propeller failed and separated instantaneously after striking the snowbank, creating an imbalance which **resulted** in the separation of the engine reduction gearbox at the parting flange. It is likely also that the left propeller failed in a similar manner as the airplane veered to the right **and** again passed through the snowbank.
