# NATIONAL TRANSPORTATION SAFETY BOARD

## AIRCRAFT ACCIDENT REPORT

McCAULY AVIATION, INC.  
MITSUBISHI MU-213, N72B,  
NEAR JEFFERSONVILLE, GEORGIA  
MARCH 24, 1983

NTSB/EAR-84/01

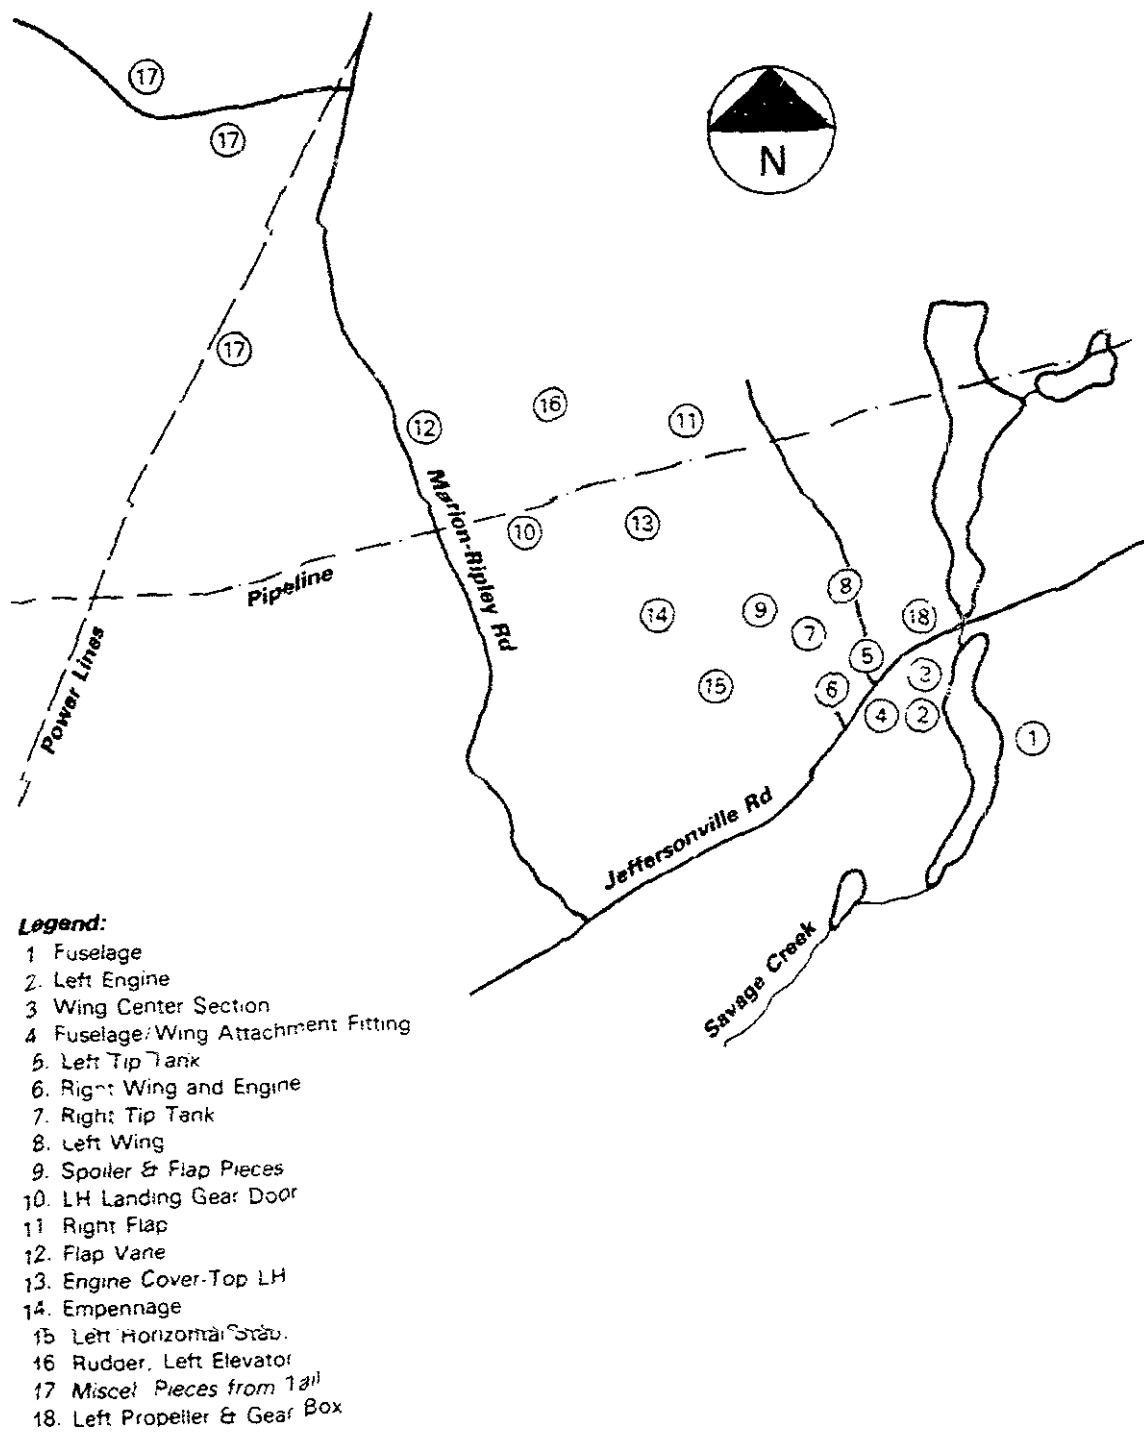
Figure 1.—Wreckage distribution chart.

Pieces of the airplane were scattered over a 2-mile area along a bearing of about 305°. (See figure 1.) The ground terrain was relatively level and consisted of forest, fields, and swamps. The fuselage section was the largest item recovered along the wreckage path and was found at the greatest distance from where the target disappeared from radar in a wooded swamp where the water was about 1 to 2 feet deep.

The widespread distribution of the wreckage indicates that the airplane broke up while in flight. The relatively small scatter pattern of the heaviest pieces of wreckage--fuselage, outer wings, center wing, and engines—indicates that there was not a long descent after breakup. If the airplane had broken up at high altitudes, the components would probably have been more widely separated. The lightest pieces of wreckage, most affected by winds, were the farthest away from the main wreckage and to the northwest of it. A meteorological analysis of the winds revealed that at the cruising altitude 18,000 feet, they were southwesterly at 55 knots, at 3,000 to 6,000 feet they were from the southeast at about 30 knots, and below 3,000 feet they were easterly with velocities of 4 to 6 knots at the surface. Because the wreckage was scattered along a southeast to northwest line, it can be concluded that the airplane broke up 6,000 feet or below. The lighter fragments, most subject to the influence of wind, were scattered away from the heaviest piece, the fuselage, in a northwest direction. If the break up had occurred above 6,000 feet, the higher velocity southerly and southwesterly winds would have produced a more widespread, less directional scatter pattern.

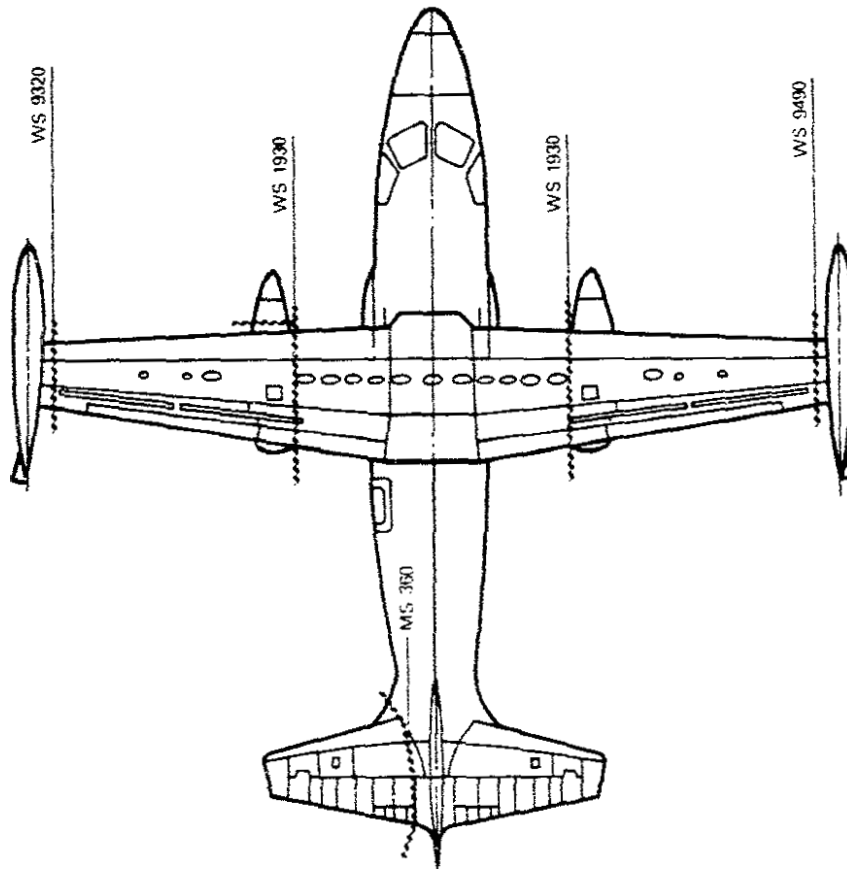
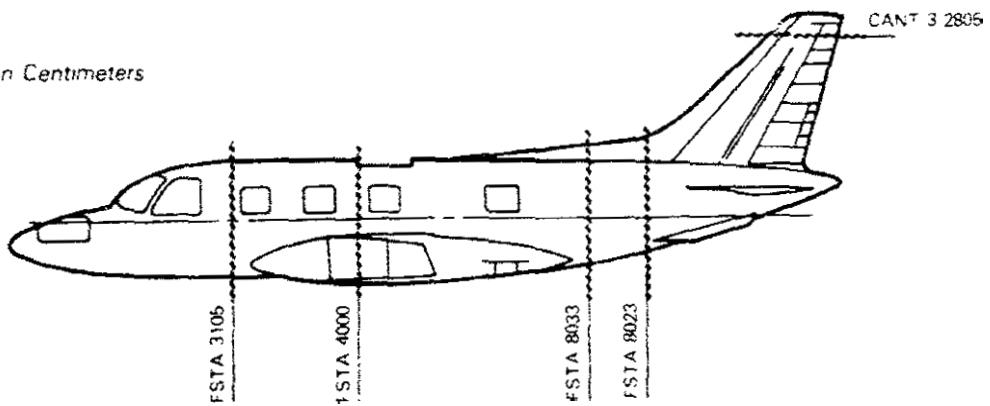
Figure 2.—Airplane Wing and Fuselage Station Diagram.

The fuselage came to rest on its left side and was broken into three sections all of which remained interconnected by loose cables, cabin interior, furnishings, and broken structure. The upper fuselage assembly between fuselage stations (FS) 4610 and 4850, which contained the forward attachment fittings for the wings, was separated from the fuselage and was recovered scattered along the path. (See figure 2.) The left forward wing attachment fitting was partially attached to the frame and was bent to the left. The right forward wing attachment fitting was broken off and remained with the wing center section.

The right wing was separated at Wing station (WS) 1950 just inboard of the nacelle, and was recovered relatively intact with the right engine and propeller assembly attached. The right tip tank had separated from the wing.

The right wing upper surface had several chordwise compression buckles along the leading edge. The surface contained several spanwise tension buckles just aft of the leading edge. The upper skin *'along the separation line at WS 1950 was pulled from rivets at the forward area and was sheared off at the rear area.* The structure in this area was bent upward. The fracture surfaces appeared typical of overload.

The right forward wing-to-fuselage attachment assembly was torn away from the fuselage frame and remained with the wing center section. The left forward wing-to-fuselage attachment assembly was separated toward the right at the bolt hole on the wing center section. The rear wing-to-fuselage attachment assemblies had separated from the spar attachment rivets on the right side and were broken at the clevis holes on the left side. The spar fractures at WS 1950 appeared typical of overload. The chordwise rivet attachment lines for the wing skin at WS 1950 had failed due to tension on both the top and bottom wing surfaces.
