NATIONAL TRANSPORTATION SAFETY BOARD

AIRCRAFT ACCIDENT REPORT

SIERRA PACIFIC AIRLINES
deHAVILLAND DHC-6-300, N361V
HAILEY, IDAHO
FEBRUARY 15, 1983

NTSB/AAR-84/03

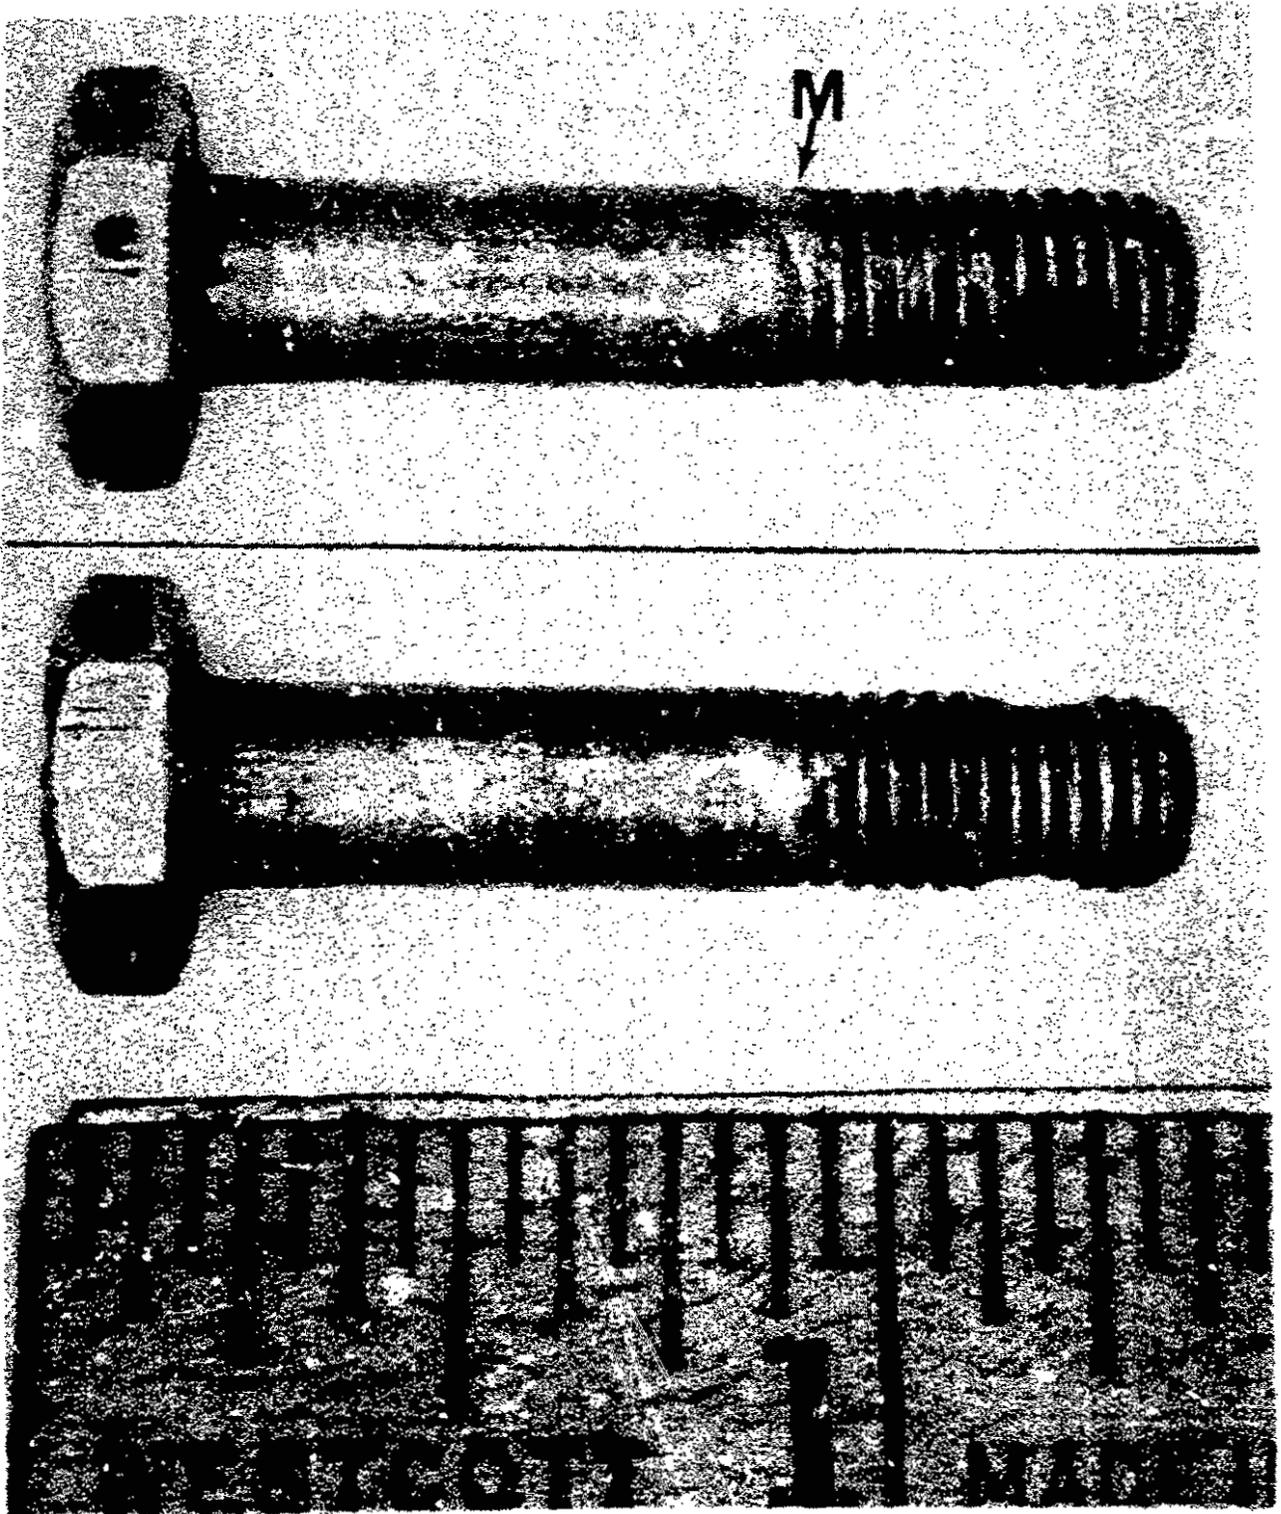
Bolt Found in Empennage.--Figure 11 shows two views of the bolt found loose in the empennage area. The bottom view shows the bolt rotated about 45° relative to the top view. The overall length of the bolt from the underside of the head measured 1.16 inches, and the diameter of the shank was 0.245 inch. An AN 174-12 bolt is 0.2487 to 0.2492 inches in diameter by about 1.27 to 1.31 inches in length. Arrow "M" in figure 11 shows an area of the bolt with metal apparently smeared onto the bolt. Figure 12 shows this area in greater detail.

Figure 11.--Two views of the bolt that was found in the empennage.
"M" indicates a metal smear.

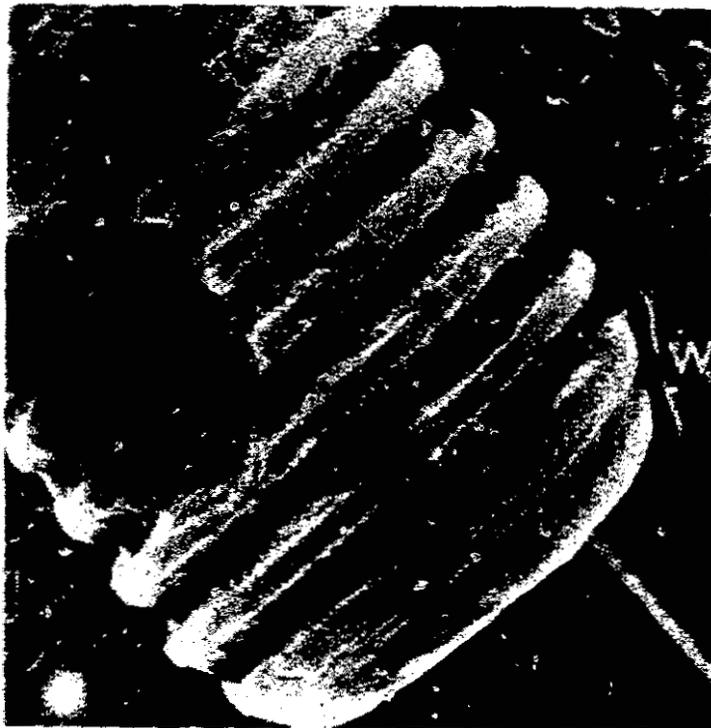
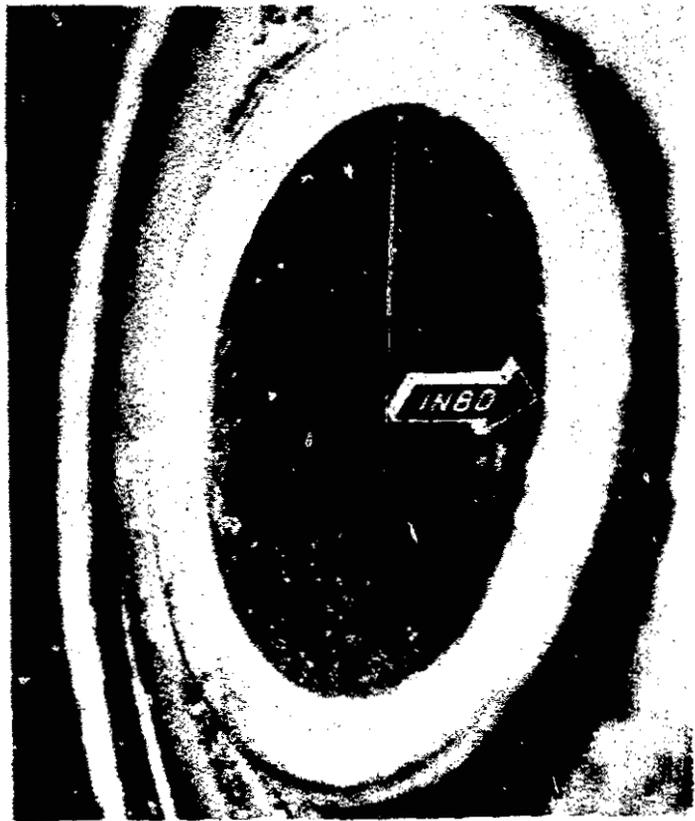
Figure 14.--Detached bolt (left) with thread crowns worn at bolt's end (bracket "W"); metal debris in thread roots. Hole wall (right) in spherical bearing of control rod; debris is smeared flakes. "Inboard" arrow refers to left side of bearing. Both photographs about X10.

Examination of the threads of the nonstandard bolt revealed an embedded metal flake with the same chemical composition as the metal of the torque tube clevis ears. In addition, the first few thread crowns of the bolt were noticeably worn. From this evidence the Safety Board concludes that at some time the bolt came in contact with a component having the same chemical composition as that of the torque tube clevis. Had the specified bolt been used to connect the control rod, a washer and nut could not have been securely fastened onto the bolt and secured with a cotter pin.

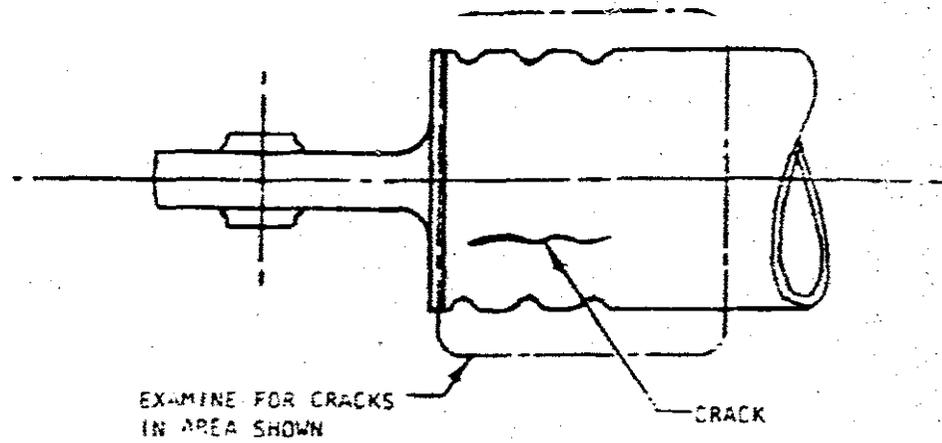
TYPICAL TUBE WITHOUT SLEEVE

ANY CRACK WITHIN THE INSPECTION AREA SHOWN IS REASON FOR REJECTION OF ROD.

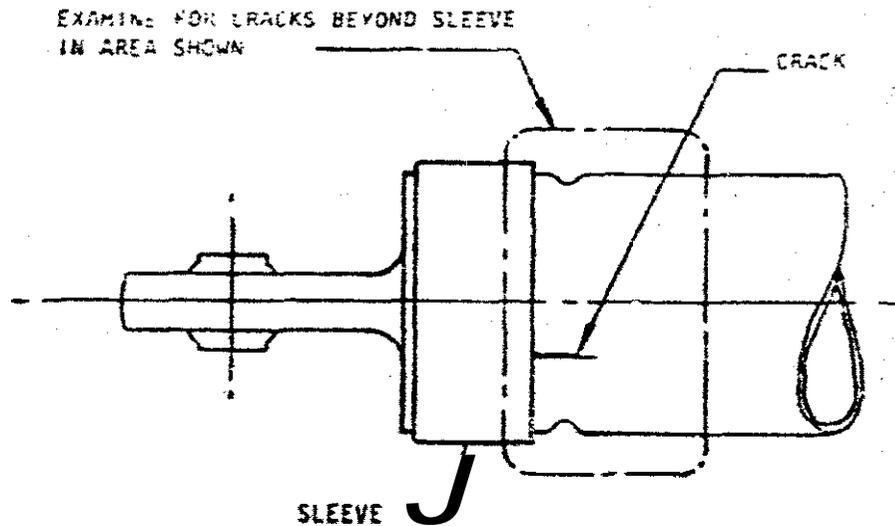
TYPICAL TUBE WITH SLEEVE

ANY CRACK WITHIN THE INSPECTION AREA SHOWN IS REASON FOR REJECTION OF ROD.
