## AIRCRAFT ACCIDENT REPORT

MIDAIR COLLISION  
McDONNELL DOUGLAS F-4C /  
BEECH D-55 BARON  
CHERRY POINT, NORTH CAROLINA  
JANUARY 9, 1983

NTSB/AAR-84/07

MIDAIR COLLISION  
McDONNELL-DOUGLAS F-4C/BEECH D-55 BARON,  
CHERRY POINT, NORTH CAROLINA,  
JANUARY 9, 1983

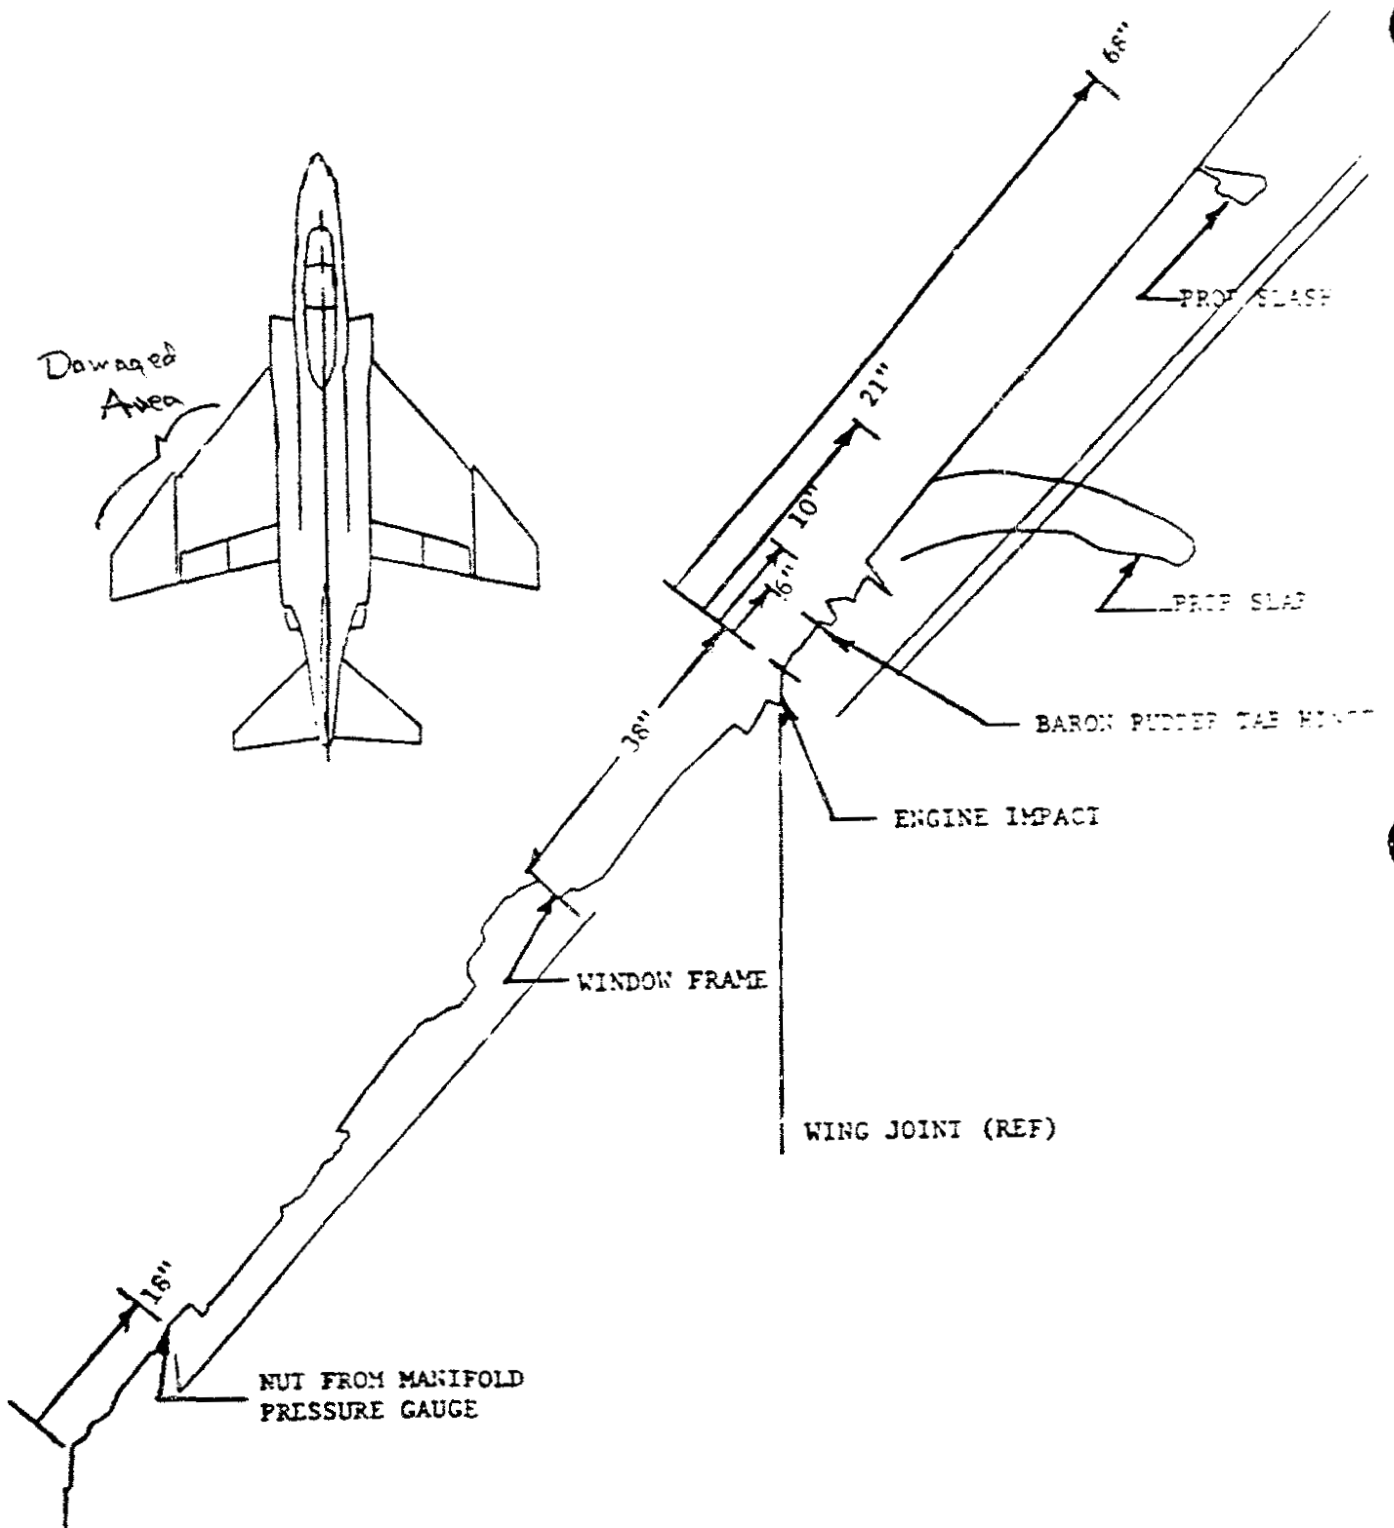
The major damage to the F-4C consisted of leading edge damage to the left wing and its fuel tank. Damage to the left wing leading edge consisted of propeller slashes and other impact damage. Parts and debris from the Beech Baron were embedded in the damaged leading edge. Using the wing joint as a reference and measuring parallel to the wing leading edge, the following was noted: (See figure 3.)

1. A propeller slash was found which began 68 inches inboard from the wing joint and progressed into the wing to a distance of 10 inches perpendicular to and aft of the leading edge. The slash ended 72 inches from the wing joint.
2. A V-shaped propeller slap mark was found from 10 inches to 21 inches inboard of the wing joint along the leading edge. The leading edge of the mark was 31 inches long, and its trailing edge was 36 inches long.
3. The wing joint forgings were damaged by impact.
4. A section of a Beech Baron window frame was found embedded in the leading edge of the F-4C's wing, 38 inches outboard from the wing joint.
5. A nut from the Beech Baron manifold pressure gauge was found embedded in the leading edge of the F-4C's wing, 18 inches inboard from the wingtip. The manifold pressure gauge was the top instrument in the center of the instrument panel.

Figure 3.--Damage to McDonnell-Douglas F-4C Left Wing.

6. A Beech Baron rudder tab hinge wire was found embedded in the leading edge of the F-4C wing 6 inches inboard from the wing joint. The pin would have been located in the trailing edge of the Baron rudder 8 to 32 inches from the bottom.

Four radar-guided Sparrow missiles were mounted on the fuselage of the F-4C. The two front missiles were positioned forward near the junction of the wing leading edge and fuselage. Each was about 1 1/2 feet off the airplane centerline. The two aft Sparrow missiles were positioned longitudinally just aft of the main gear and each was about 2 feet off the airplane centerline. The lower fins of the front missiles and the left aft missile were damaged. Scrapes were found on the bottom of the F-4C to the left of the right aft missile.

The fuel tank on the left wing separated during the collision, and the bottom of the missile launcher for heat seeking missiles on the left wing was also damaged. The bottom of the fuel tank was 37 inches below the bottom of the wing and the tank centerline was 10 feet 6 inches from the junction of the wing leading edge and fuselage. The wing-mounted launcher was 22 inches below the bottom of the wing. The centerline of the launcher was 4 feet from the junction of the wing leading edge and fuselage.

Four areas of the left wing of the F-4C had come in contact with occupants of the Beech Baron. Hair and smeared blood were found on the wingtip and at 17 inches, 54 inches, and 69 inches inboard from the wingtip.

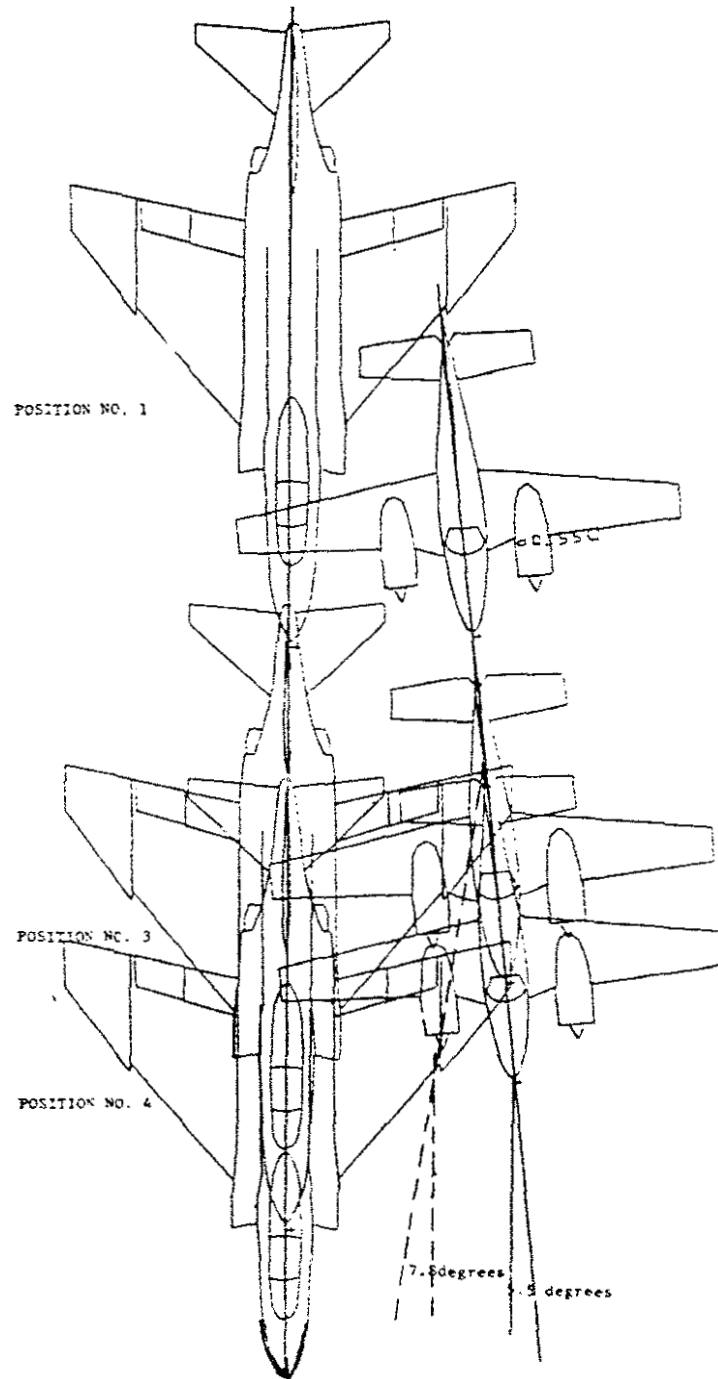
Propeller slash marks, which were 36.9 inches apart, also were used as a basis to compute the closure rate. The engine rpm was estimated at 2,100 rpm, or 35 revolutions per second, or one blade hit every .01428 second. Thus, closure velocity was 36.9 inches in .01428 second or 215 feet per second, which equals 127 knots. The true airspeed of the F-4C at impact would then have been 180 KTAS (Baron) + 127 KTAS (closure), or 307 KTAS, or 327 knots ground speed. Using the true airspeeds of the F-4C and Baron (307 KTAS and 180 KTAS), a closure rate of 127 KTAS, and the relative scratch mark angle on the F-4C of 7.8° in an aft and outboard direction, a vector diagram yielded a 5.5° heading difference with the Baron heading to the left of the F-4C.

Figure 4.--Reconstructed sequence of positions of each airplane (top view).

- (1) Aligning the rudder tab of the Baron to the position where the rudder tab hinge pin was embedded into the F-4C left wing leading edge.
- (2) Matching the propeller blade tip with the first slash mark in the wing leading edge.
- (3) Matching the original installation location of the manifold gauge in the Baron with the location where the manifold gauge installation nut was found along the F-4C leading edge.

The relative position of each airplane and its movements from positions 1, 3, and 4 as the collision progressed are illustrated in figure 2. When a straight line is drawn through the centerline of each airframe, the line from positions 1, 3, and 4 remained straight. This consistency was also illustrated as the F-4C left wing leading edge penetrated the Baron's tail. The line scribed by the Baron's tail across the F-4C left wing was  $7.8^\circ$  and was parallel to the scratch marks found on the left wing of the F-4C. The Baron right wing was in such a position that the only missile that could not be hit and was not hit during the collision was the right aft missile. The right Baron engine would have been aligned with the F-4C wing joint, and the Beech Baron occupants could have contacted the F-4C wing where the blood and hair were noted.

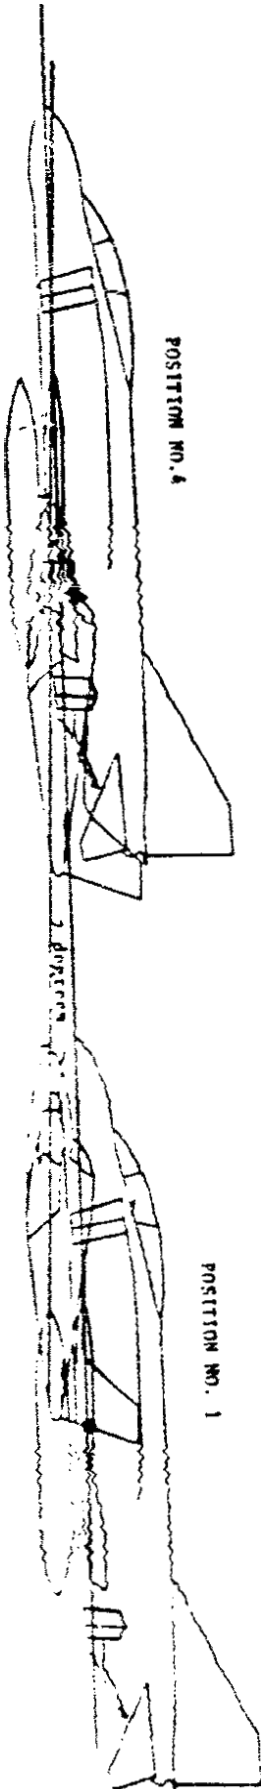
Figure 5. --- Reconstructed sequence of positions  
of each airplane (side view).

Impact time (reference to radar timing) was at 1644:36 and the altitude was about 9,300 feet. (Impact time based on Washington Center voice recording is 1644:46 and is considered more accurate.) Radar data indicated that the Beech Baron was flying reasonably straight and level for some time before it began the left turn just before the collision. The F-4C, however, was climbing at 2,000 feet per minute at an angle of  $3.8^\circ$  with respect to the horizon. A left turn by the F-4C was indicated for at least 8 seconds before the collision and the roll angle increased to more than  $20^\circ$  left wing down at or near the impact point. (See figure 6.) The horizontal separation distance at 8 seconds before the collision was about 1,830 feet and at 4 seconds was about 900 feet. The difference in roll angles of both airplanes explains how the F-4C could be climbing and still have a descending impact angle ( $2^\circ$ ) relative to the top of the Baron.

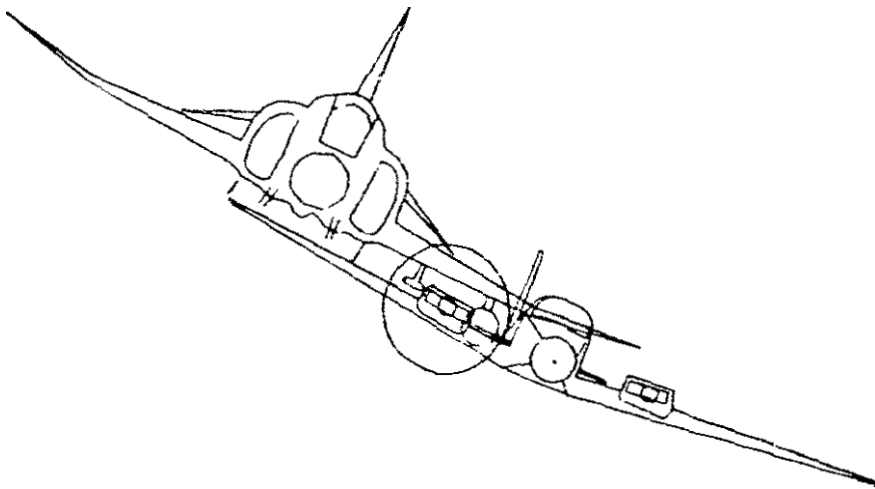
The pilot of the Baron was instructed to turn left ("direct New Bern") by Washington Center just before impact and collision impact marks confirm that the Baron was in a left turn. A standard rate turn at 180 KTAS would require a bank angle of  $26^\circ$ . The F-4C pilot stated that he rolled  $30^\circ$  left at "break X"; a bank angle of 4" more than that of the Baron. Since the radius of turn of the Beech Baron would have been smaller than that of the F-4C, the relative closure angle was such that the F-4C would have been closing onto the Baron. Based on the point of impact of the Baron tail, the impact on the bottom of the heat-seeking missile launcher, and the strikes on the Sparrow missile fins, the roll angle of the Baron relative to the F-4C was established at  $3.5^\circ$  left wing down.

Figure 6.--Probable bank angles at collision.
