NATIONAL  
**TRANSPORTATION**  
SAFETY  
BOARD

**AIRCRAFT ACCIDENT REPORT**

**SIMMONS AIRLINES, FLIGHT 1746**  
**EMBRAER BANDEIRANTE**  
**EMB-110P1, N1356P**  
**NEAR ALPENA, MICHIGAN**  
**MARCH 13, 1986**

NTSB/AAR-87/02

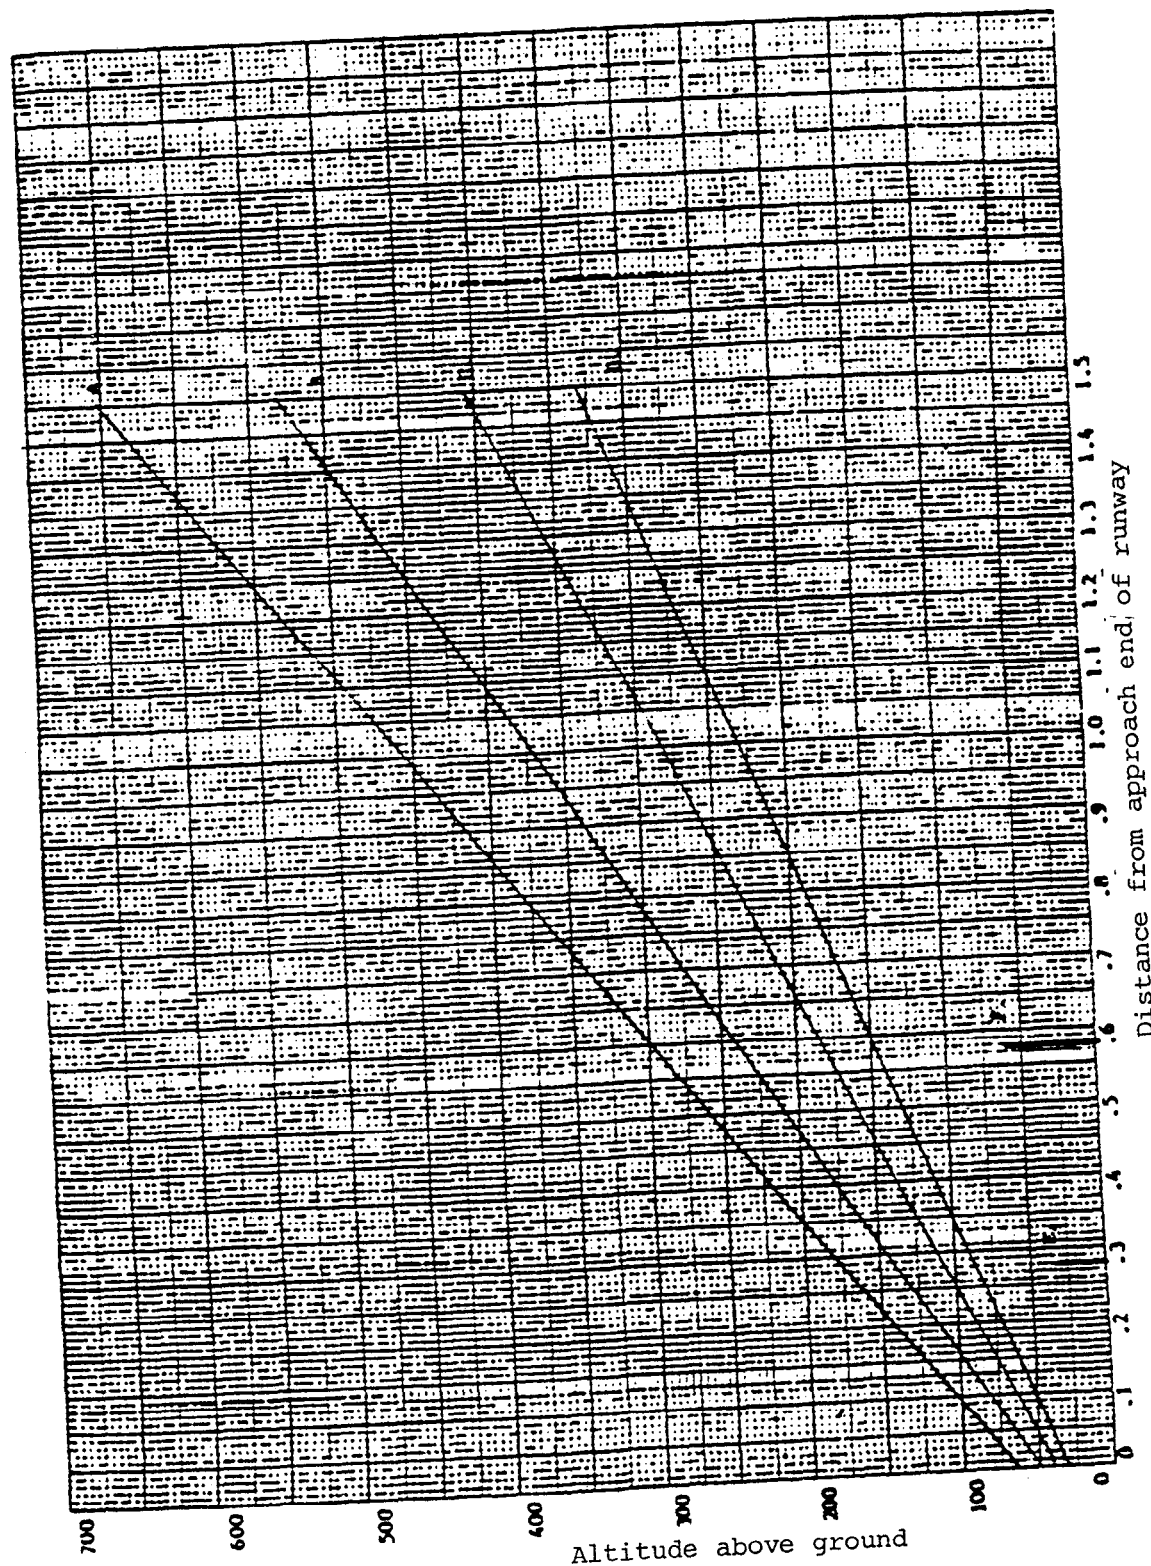
A. 3.70 degrees.  
Equivalent to 150  
microamp flydown on a  
3.0 degree  
glideslope

B. 3.00 degrees.  
Normal glideslope

D. 1.88 degrees. Worst  
case scenario. Glide-  
path at maximum  
tolerance width .9  
and lowest intolerance  
angle (2.78) and A/C  
at 150 microamp flyup  
(Note: after accident  
check of 3/14/86 found  
190 microamp flyup  
pt. at 2.12 degrees.

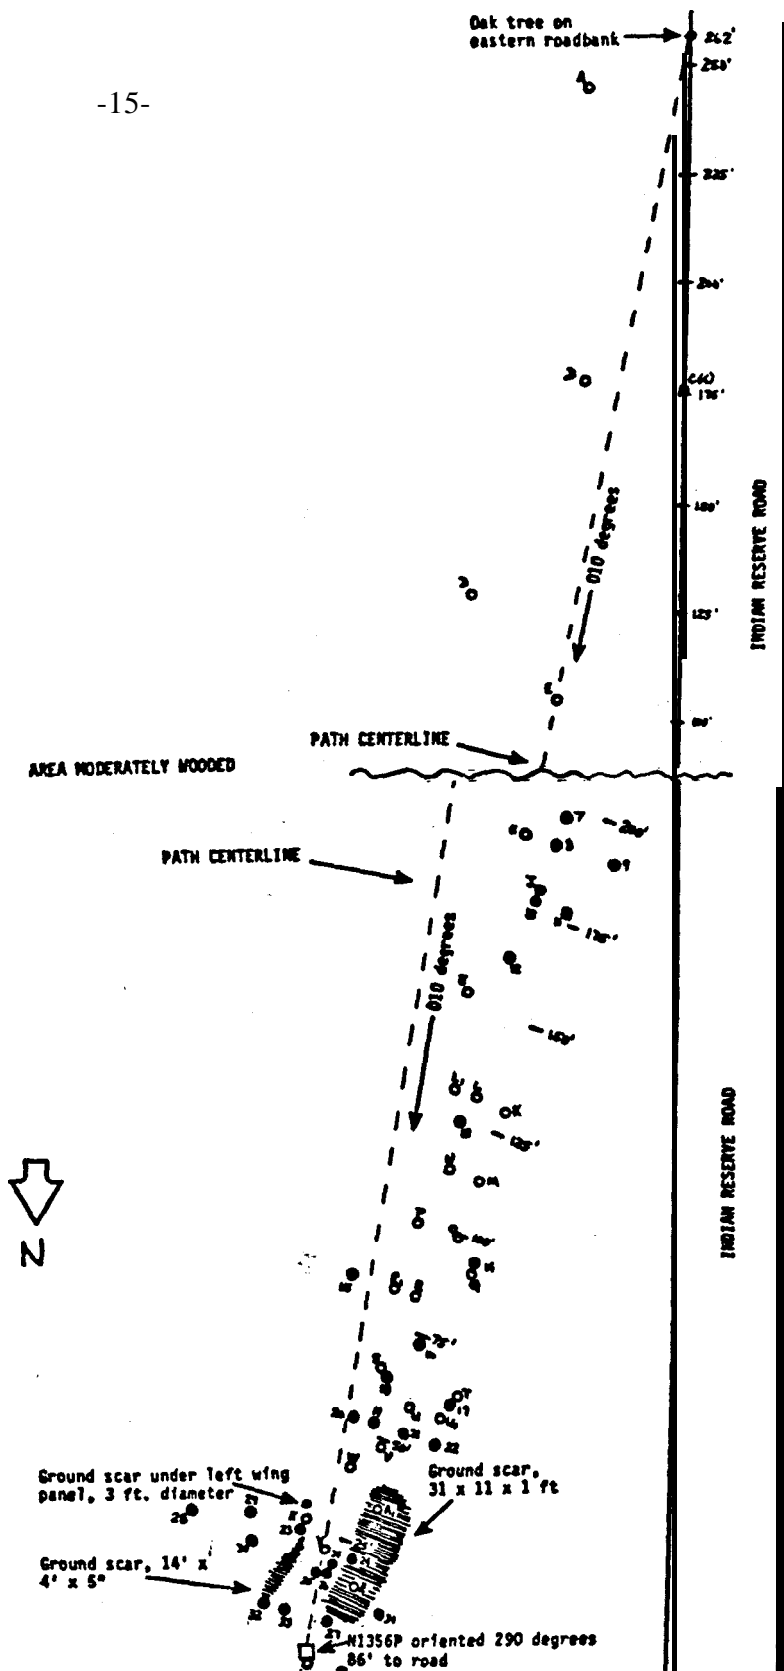
Figure 3.-Wreckage distribution of Simmons 1746.

The airplane came to rest in a wooded area 1 1/2 miles south of the runway 1 threshold. The wreckage path was confined to an area about 500 feet long, and about 80 to 90 feet to the east of Indian Reserve Road, which was parallel to the extended centerline of the runway. (See figure 3.) The initial flightpath of the airplane through the trees was 3.2° down, an angle which then steepened to 10.4° at the principal impact point. The first tree struck was located on the east side of the road, about 500 feet south of where the airplane came to rest. Damage was found at the treetop level, about 35 feet above ground level (AGL). A second tree, about 35 feet north of the initially damaged tree, also was damaged at 35 feet AGL. An S-inch tip section from a right propeller blade was embedded in another tree located 84 feet north of the first damaged tree at about 17 feet AGL. The elevation of the tree tops at the initial impact point was about 40 feet (AGL), and the elevation of the terrain at the main wreckage was about 680 feet.

The right wing structure from the area outboard of the engine nacelle was fragmented and found distributed along the wreckage path. The remainder of the wing was attached to the fuselage. The left wing was found separated about 2 feet outboard of the engine nacelle and 18 inches outboard of the main wing spar attachment.

The ventral fin was bent by impact 90° to the right, and the left horizontal stabilizer by about 50° upward. The right stabilizer was found intact but had been crushed about mid-span.

- Z1. Eighteen inch dia. oak tree penetrating right side of cabin
- Al. Treebase
