# **NATIONAL TRANSPORTATION SAFETY BOARD**

## **AIRCRAFT ACCIDENT REPORT**

**COLLISION OF  
AERONAVES DE MEXICO, S.A.  
McDONNELL DOUGLAS DC-9-32, XA-JED  
AND PIPER PA-28-181, N4891F  
CERRITOS, CALIFORNIA  
AUGUST 31, 1986**

**NTSB/AAR-87/07**

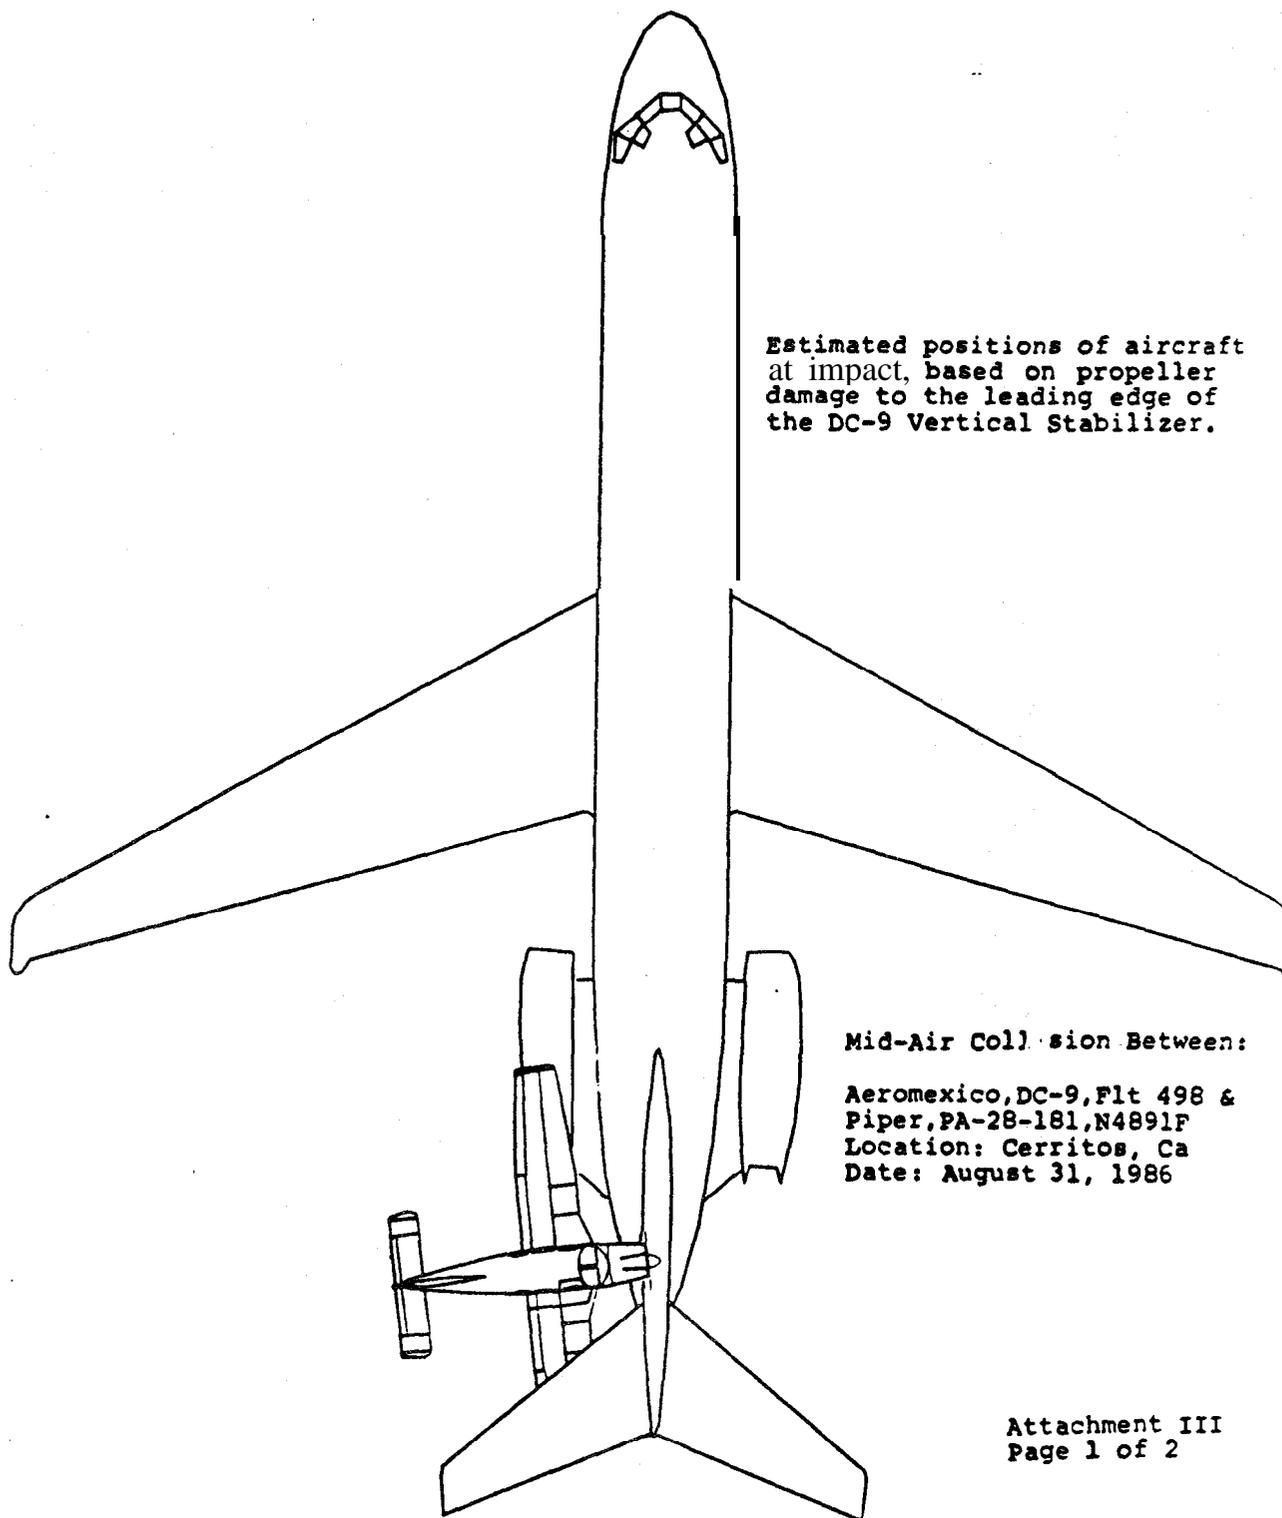
Figure 6.--Collision geometry as viewed from above the DC-9.

**The** damaged areas on the DC-9 vertical and horizontal stabilizers contained propeller slice marks, paint transfer marks Rom the nose wheel area and vertical stabilizer of the Piper, and embedded pieces from the cabin roof area of the Piper. **The** location and angles of these marks and damage on the **DC-9**, when matched to their respective locations on an intact Piper PA-28, showed that the front of the Piper had struck the left side of the DC-9 vertical stabilizer and that the impact angle was perpendicular to the longitudinal axis of each airplane. (See figure 6.) The impact angle was generally consistent with the flight tracks of the airplanes shown on the radar data plots.

Estimated positions of aircraft at impact, based on the propeller damage and scratch marks on the DC-9 Vertical and Horizontal Stabilizers.
