NATIONAL TRANSPORTATION SAFETY BOARD

AIRCRAFT ACCIDENT REPORT

PIEDMONT AIRLINES FLIGHT 467

BOEING 737-222, N752N

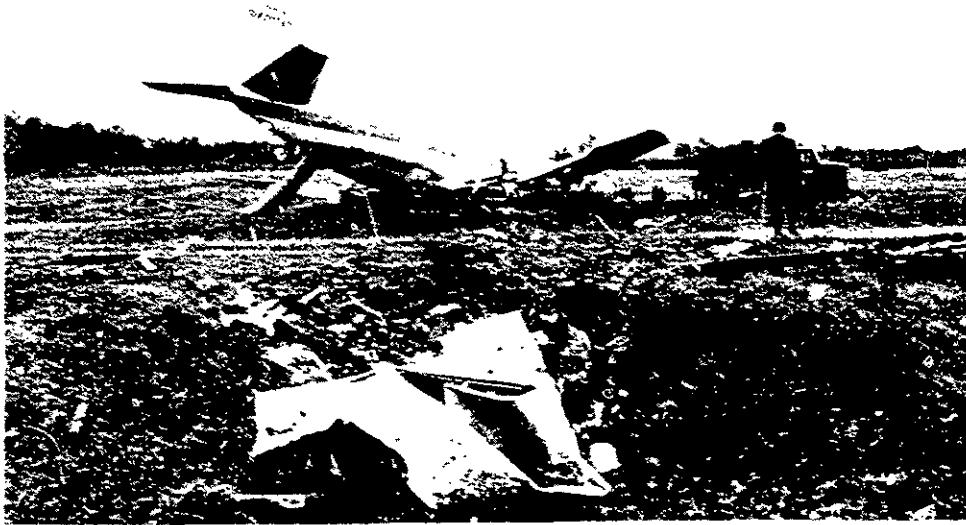
Figure 2.—Concrete culvert area and rear view of airplane.

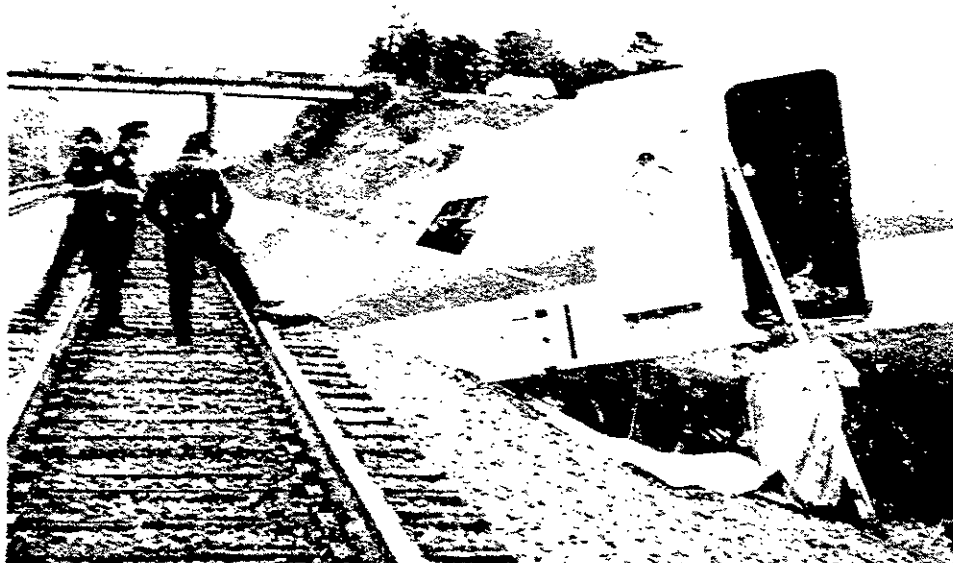
Figure 3.—Left side of airplane nose against railroad track.

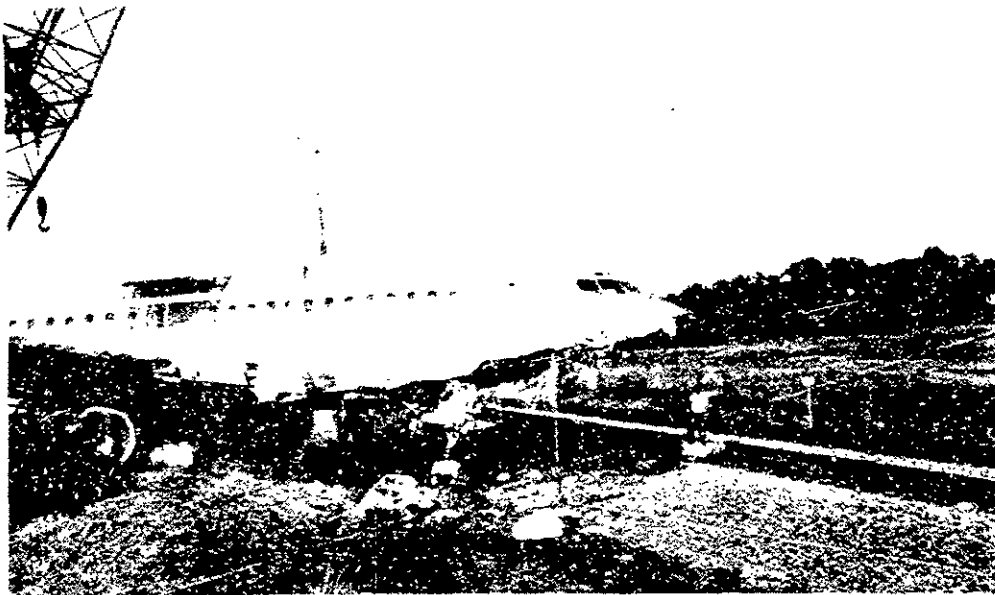
The airplane wreckage was confined to the area between the localizer antenna array, located north of the departure end of runway 36R, and the railroad tracks. Most of the damage to the airplane occurred to its underside, resulting mostly from contact with the concrete culvert located beyond the runway. (See figures 5 and 6.)

Figure 6.—Right side of forward fuselage

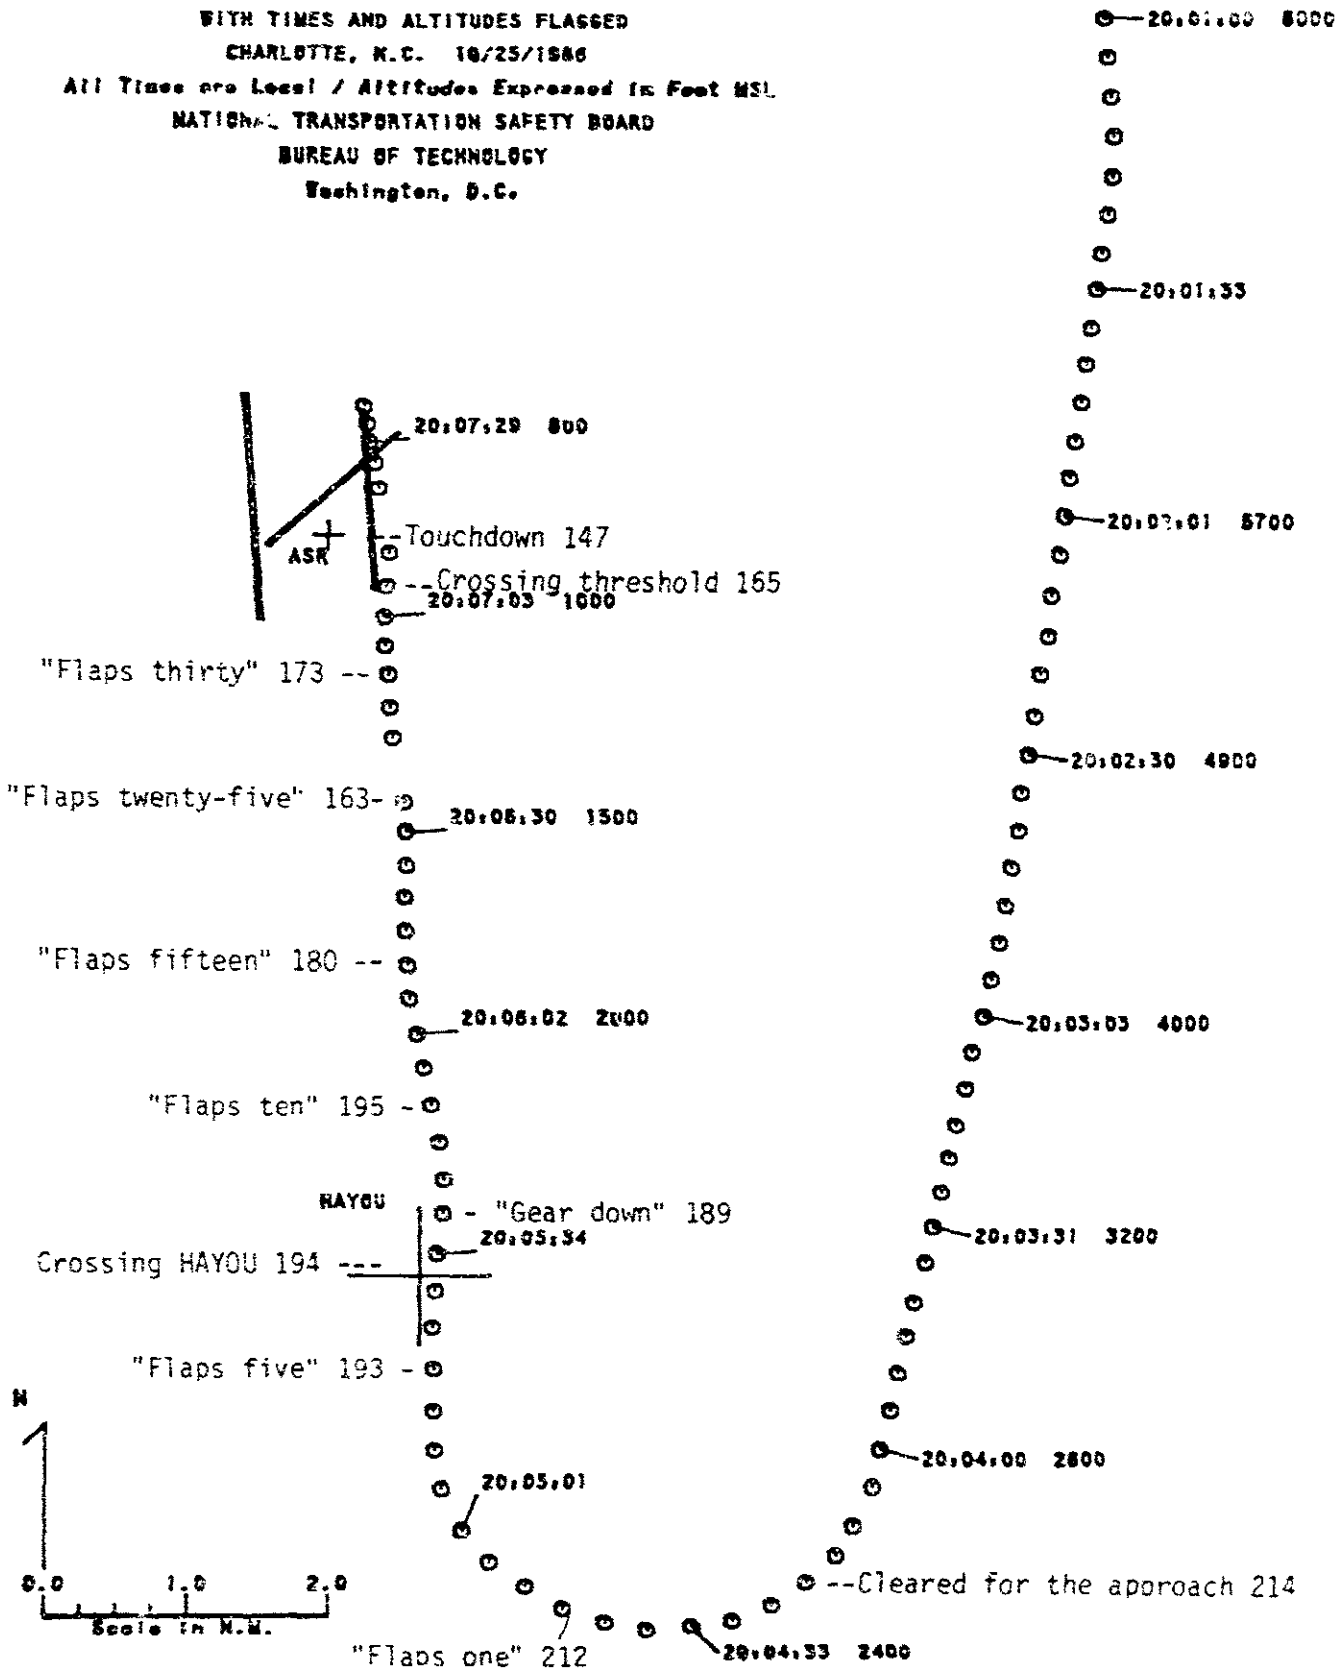
Figure 7.—Airspeeds and airplane configuration at selected points in the approach of P1 467.

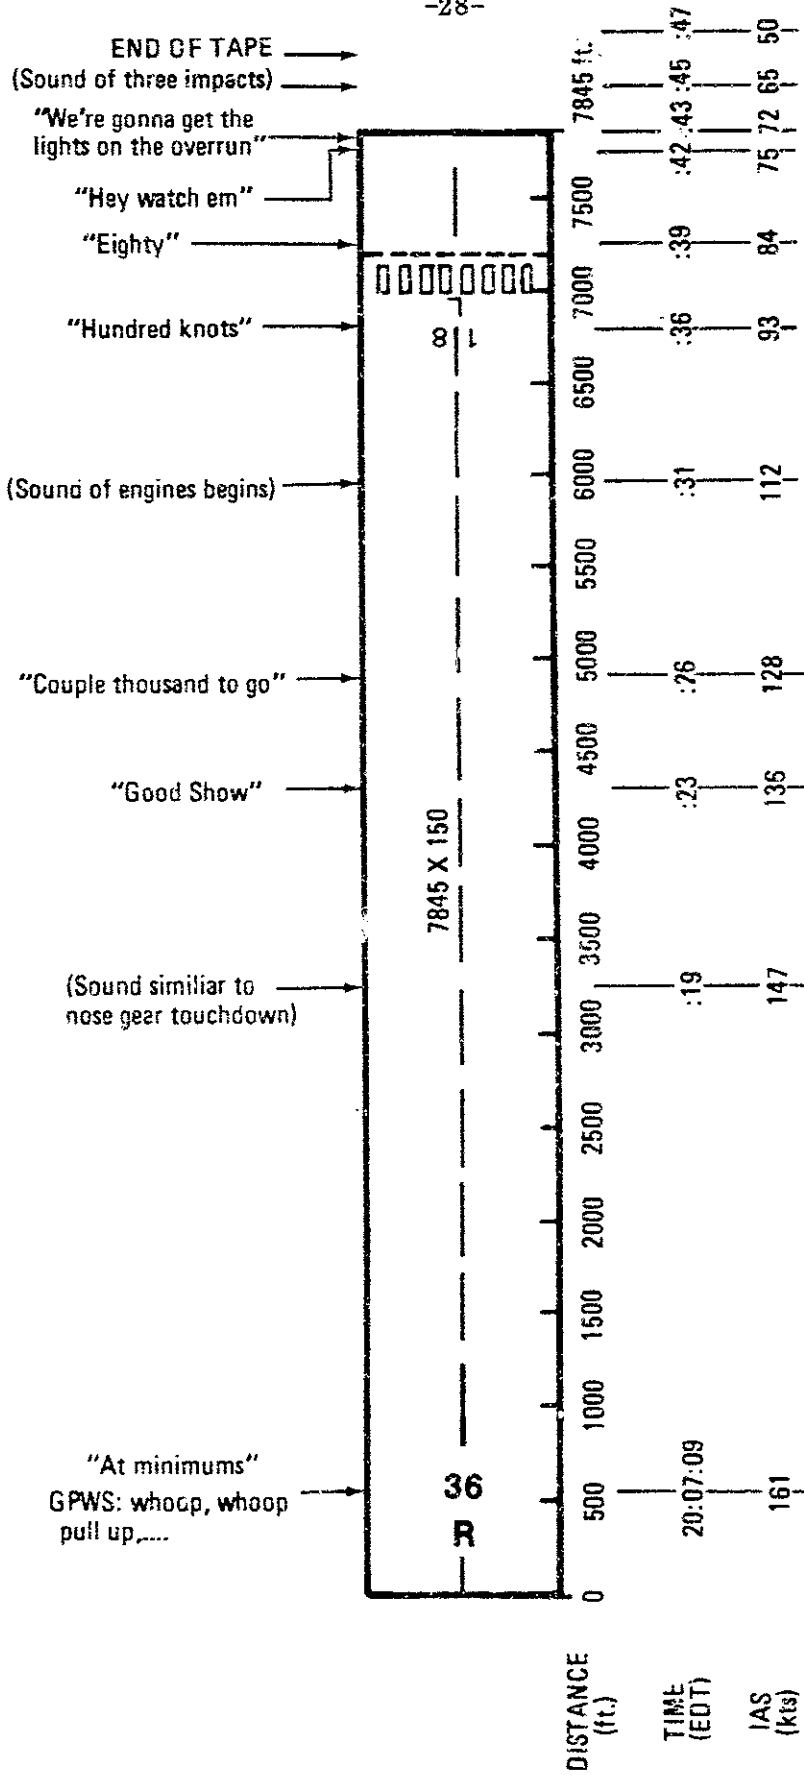
Figure 8.—Speeds of PI 467 at selected points on the runway.

runway 36R were substandard, the lack of any spoiler extension could account for the delay in obtaining reverse thrust, the airplane poor stopping performance with the last 1,900 feet of runway, and its departure from the runway at a speed in excess of 70 KIAS.

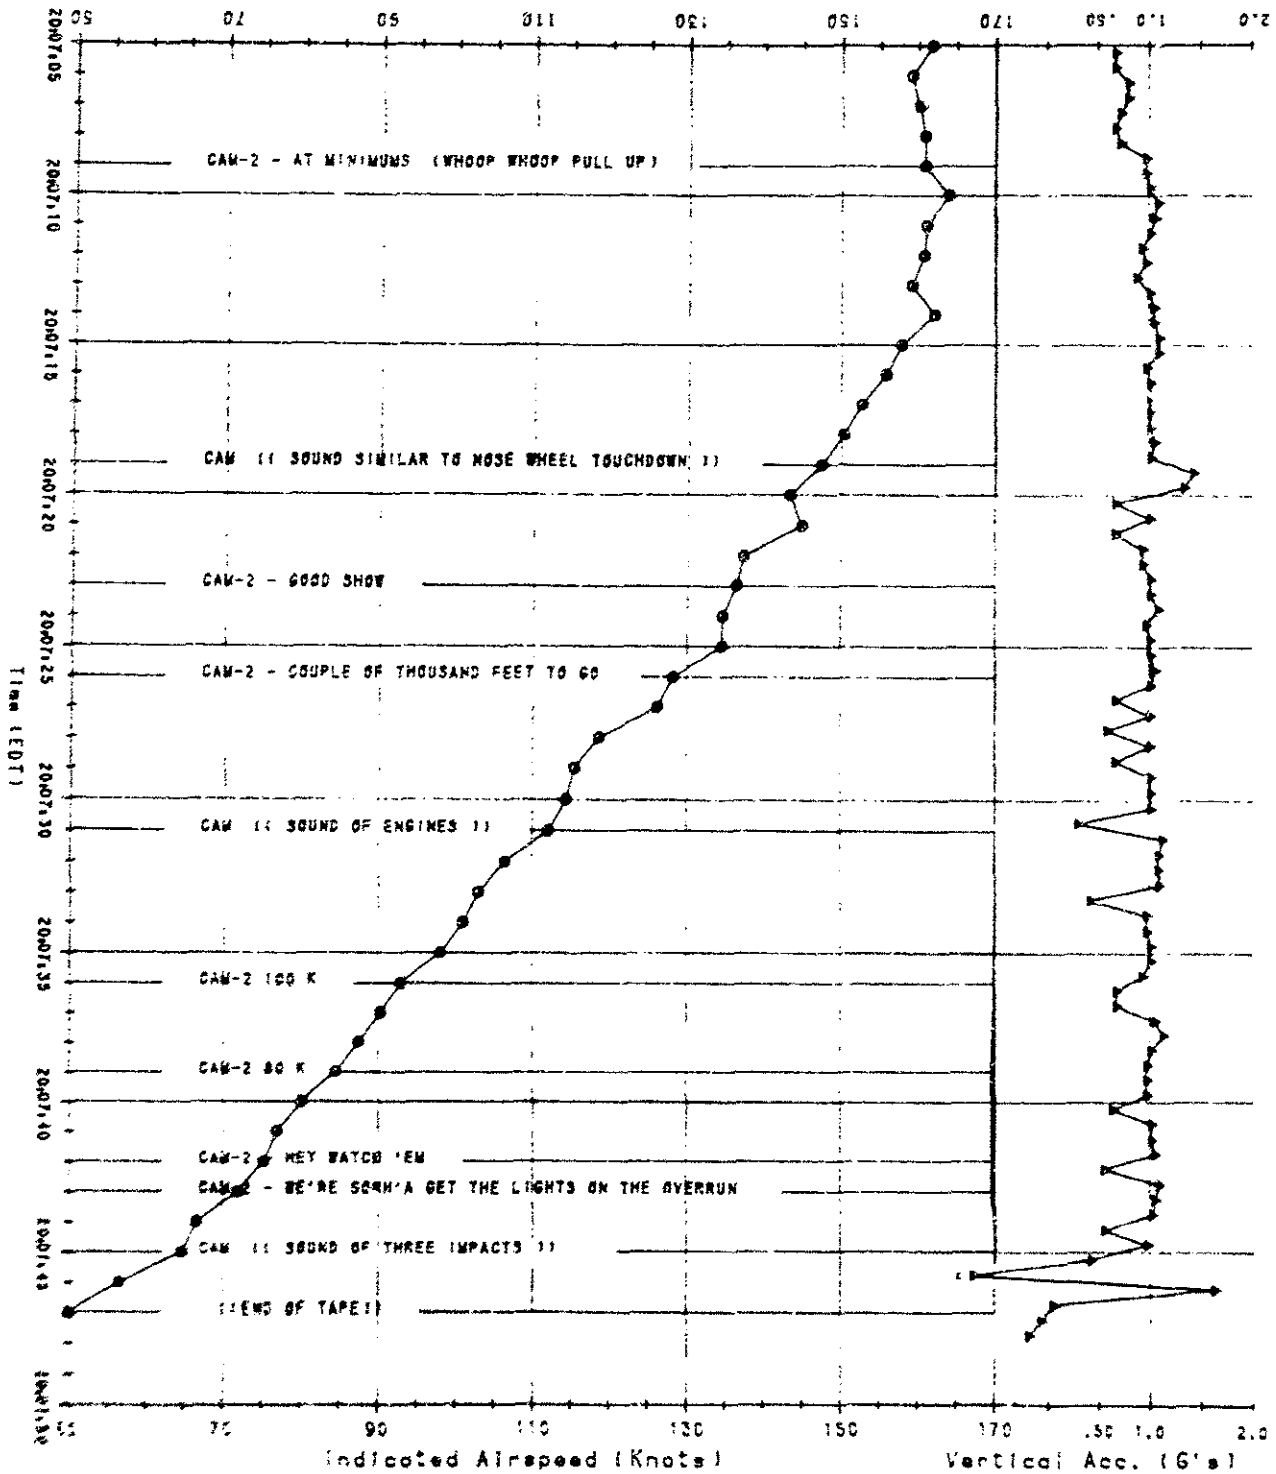
During the 6 seconds after touchdown, the airplane slowed from about 147 knots to about 135 knots, a deceleration of about 2 ft/sec². Since the brakes on the inboard wheels would not have been available immediately due to locked wheel protection, the performance of PI 467 in the first 6 seconds after touchdown suggests that the outboard wheels may have locked up within 3 to 4 seconds after touchdown, most likely due to the captain's application of wheel brakes before synchronous speed was achieved.

Figure 9.—Vertical acceleration and speeds of PI 467 following touchdown.
