NTSB-AAR 90/03

NATIONAL TRANSPORTATION SAFETY BOARD

AIRCRAFT ACCIDENT REPORT

USAIR, INC., BOEING 737-400
LAGUARDIA AIRPORT
FLUSHING, NEW YORK
SEPTEMBER 20, 1989

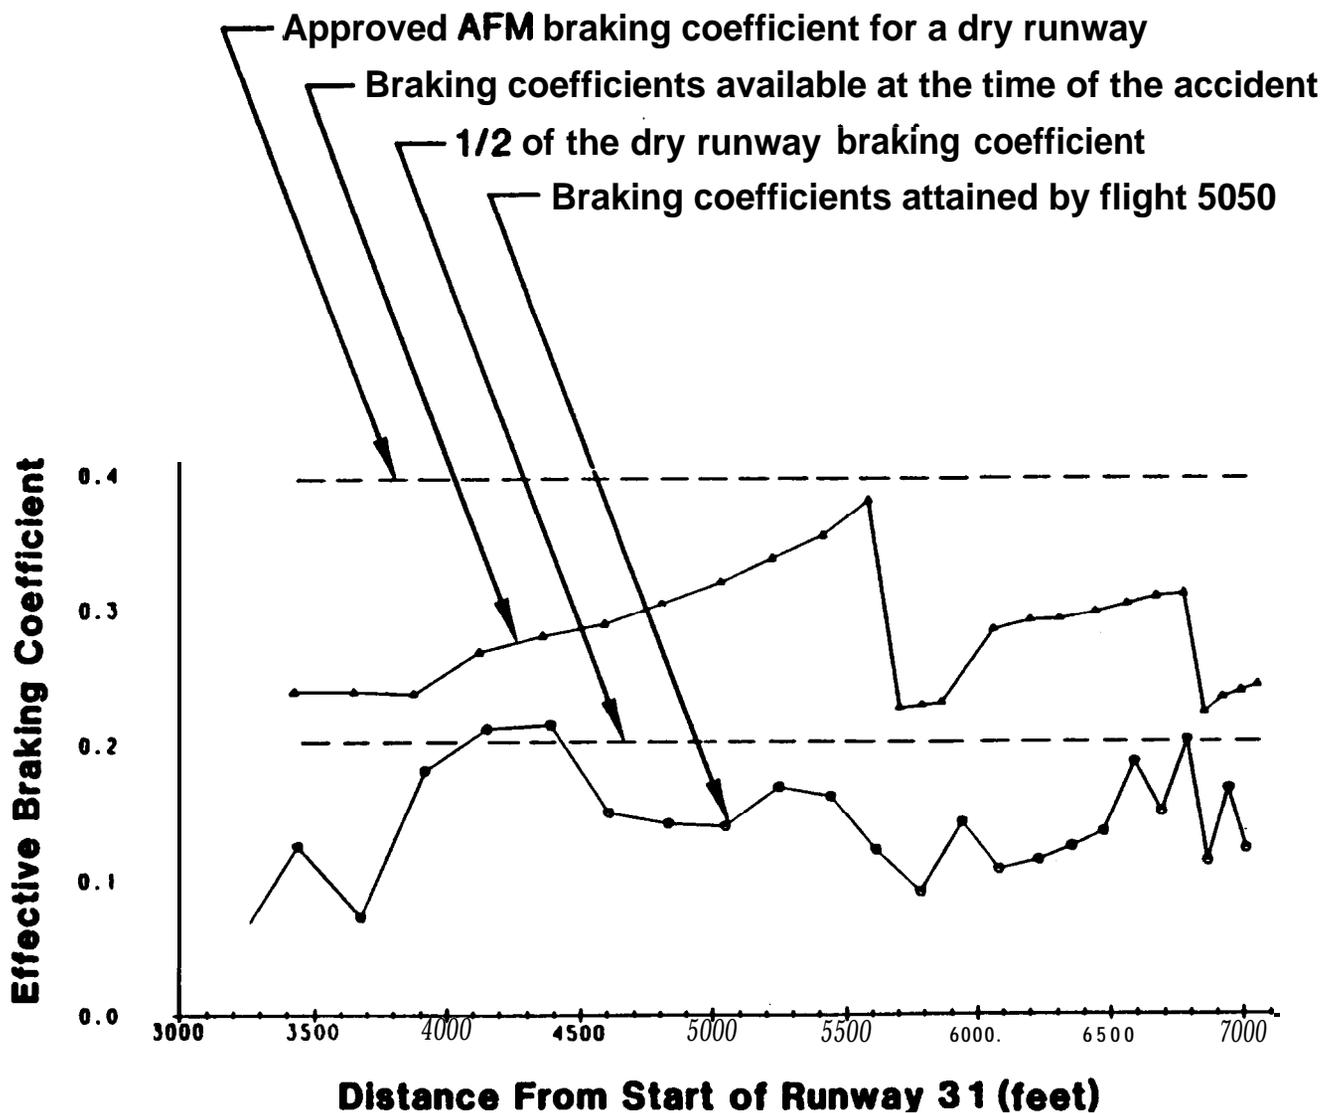
Figure 2. -- NASA Evaluation of B-737-400 aircraft rejected takeoff on runway 31 at LaGuardia Airport on September 20, 1989.

runway threshold. About 5,000 feet from the threshold, the two nose gear scrub marks merged into one wider mark for a short distance before they disappeared. The scrub marks on the overrun reappeared at the end of the runway near the centerline and extended onto the overrun. The location of the tire marks is depicted in figure 2.
