**PB90-910405  
NTSB/AAR-90/05**

## **AIRCRAFT ACCIDENT REPORT**

**ALOHA ISLANDAIR, INC., FLIGHT 1712  
DE HAVILLAND TWIN OTTER, DHC-6-300, N707PV  
HALAWA POINT, MOLOKAI, HAWAII  
OCTOBER 28, 1989**

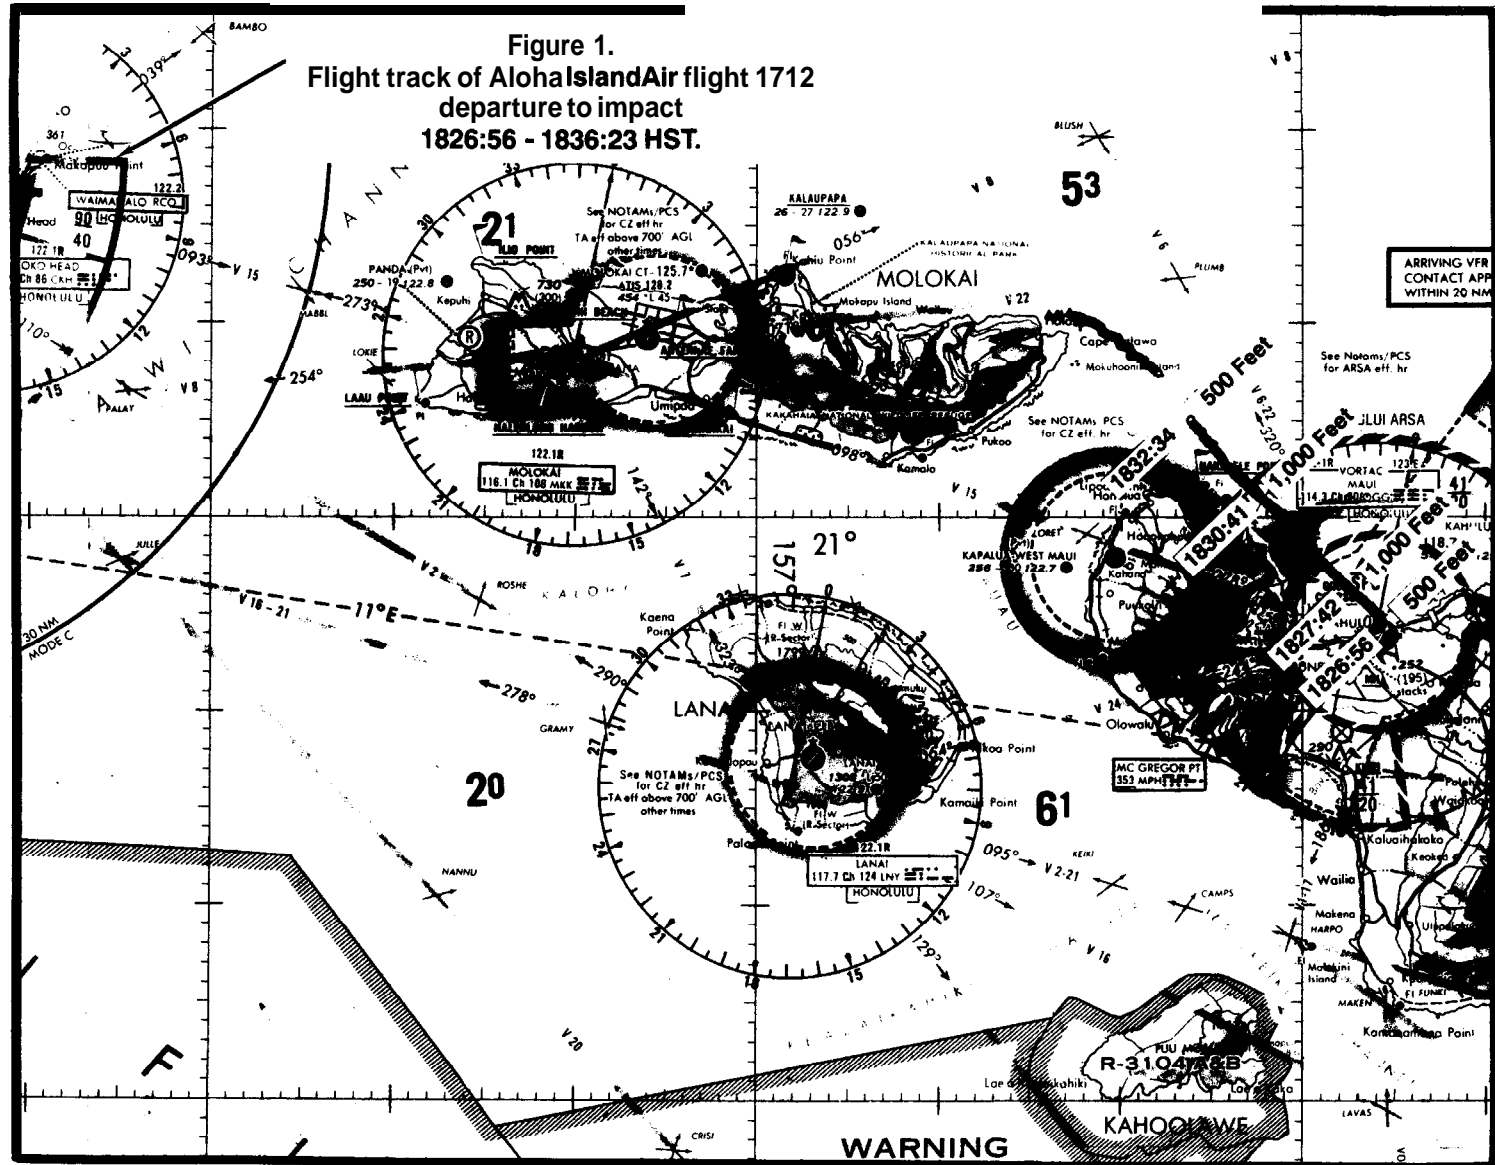
Figure 1.  
Flight track of Aloha Island Air flight 1712  
departure to impact  
1826:56 - 1836:23 HST.

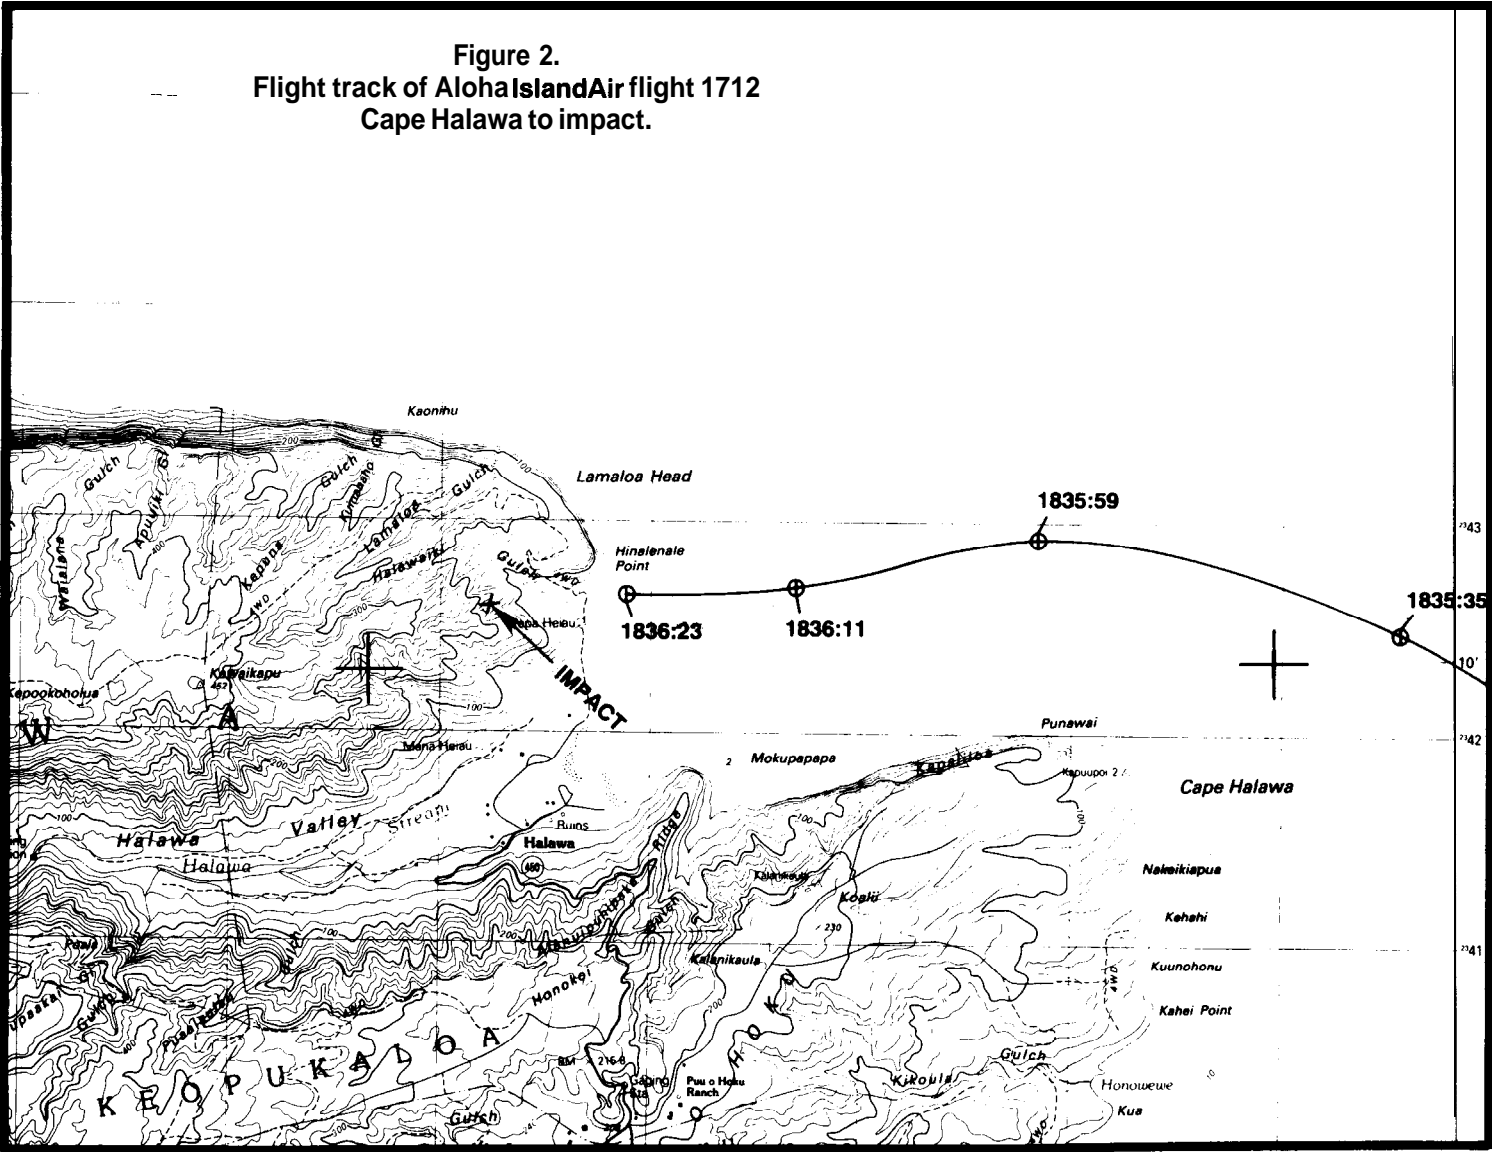
Figure 2.  
Flight track of Aloha Island Air flight 1712  
Cape Halawa to impact.
