AIRCRAFT ACCIDENT REPORT

**RUNWAY COLLISION
OF EASTERN AIRLINES BOEING 727, FLIGHT 111
AND EPPS AIR SERVICE BEECHCRAFT KING AIR A100
ATLANTA HARTSFIELD INTERNATIONAL AIRPORT
ATLANTA, GEORGIA
JANUARY 18, 1990**

**ADOPTED: May 29, 1991
NOTATION 5458**

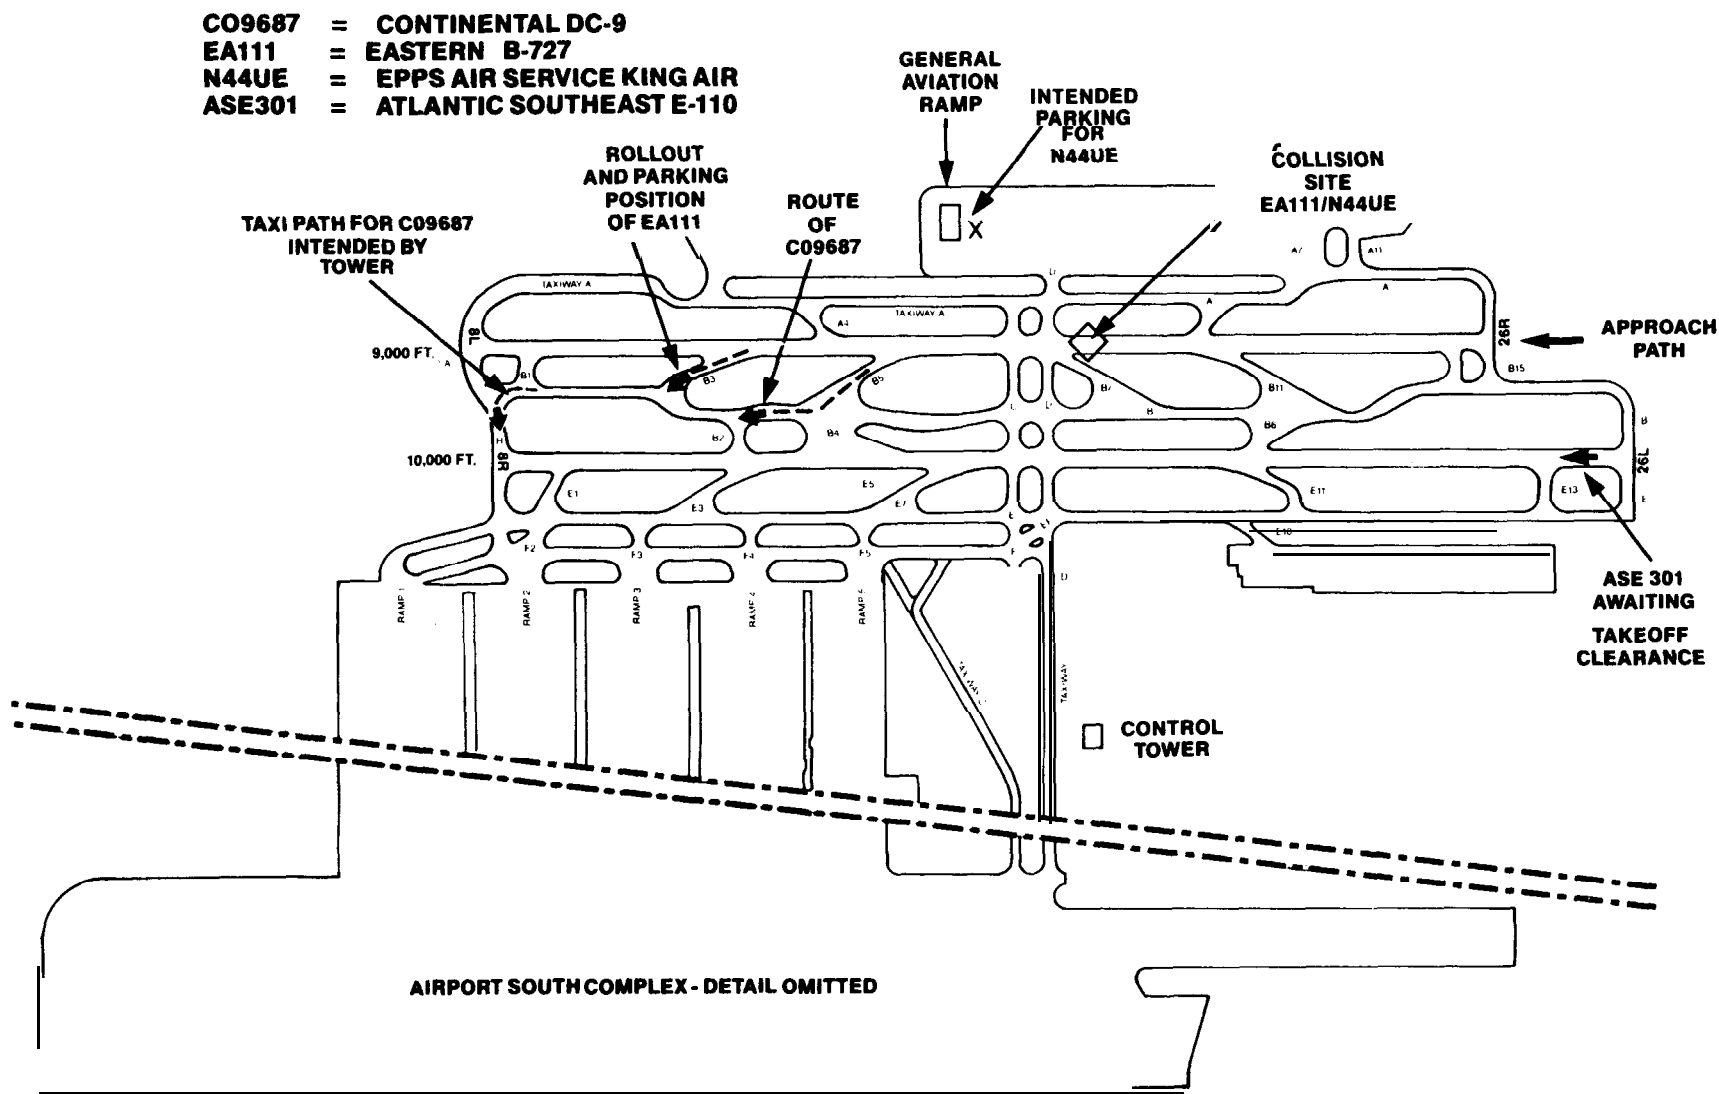
Figure 2. --Airport diagram with overlay of activity related to collision.

Ground scars from the collision indicated that the King Air had moved to the right side of runway 26 at the time of the collision and was near **taxiway "D,"** the primary **taxiway** for general aviation airplanes. The turnoff for **taxiway "D"** was about 3,800 feet from the approach end of the runway. The right wing of the B-727 struck the tail cone and structure of the King Air, separating the horizontal and vertical stabilizers from the fuselage and shearing the top of the fuselage/cockpit from the airplane. The King Air was destroyed. It came to rest at the turnoff for **taxiway "D"** with the engines still running. There was no postimpact fire. Airport Rescue and Fire Fighting (ARFF) personnel shut down the engines and secured the electrical system.

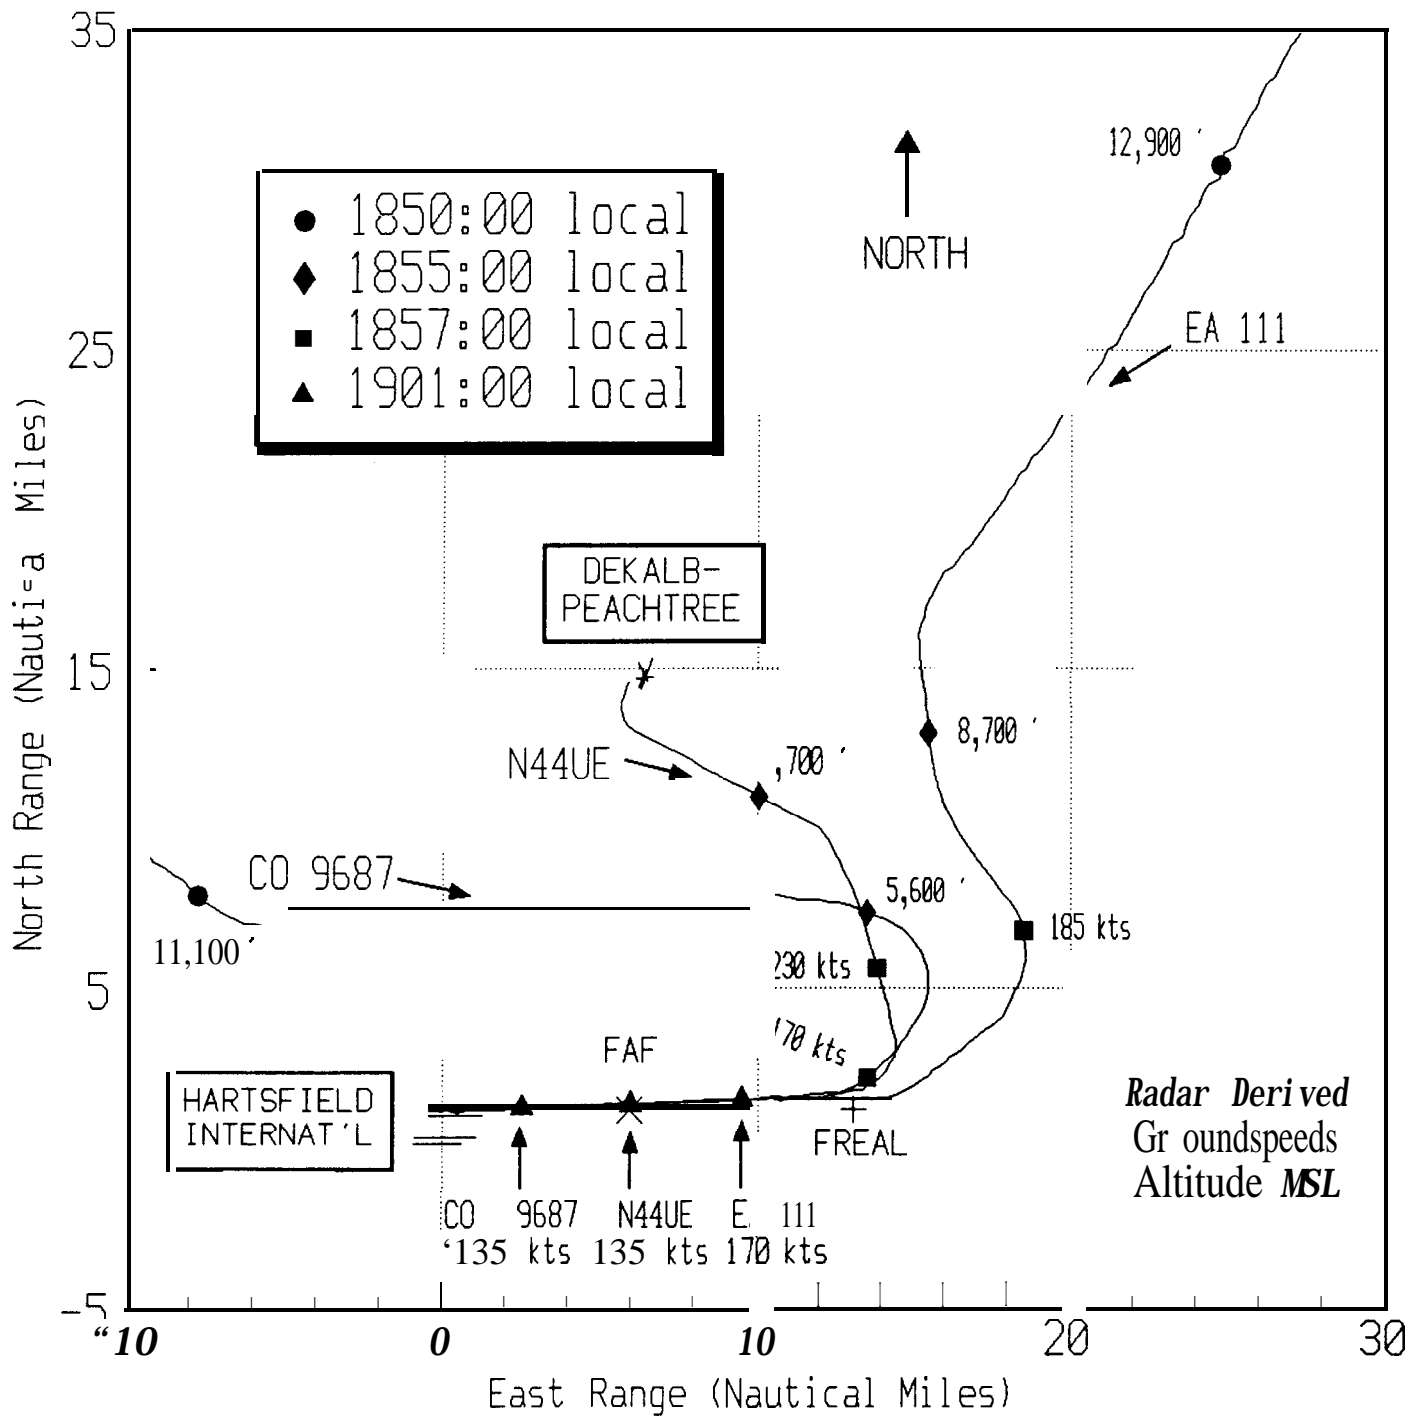
Figure 3. --Data showing landing sequence for runway 26 right.

ATC radar and communications data reveal that vectors were issued to three inbound airplanes to establish the landing sequence for runway 26 right immediately before the accident. (See figure 3). The three airplanes were CO 9687, a Continental Airlines **DC-9; N44UE**, the Beech King Air; and EA 111. A complete description of the air traffic actions is contained in paragraph 1.17.2, Air Traffic Handling.
