AIRCRAFT ACCIDENT REPORT

ATLANTIC SOUTHEAST AIRLINES, INC., FLIGHT 2311
UNCONTROLLED COLLISION WITH TERRAIN
AN EMBRAER EMB-120, **N270AS**
BRUNSWICK, GEORGIA
APRIL 5, 1991

**Adopted: April 28, 1992
Notation 5511A**

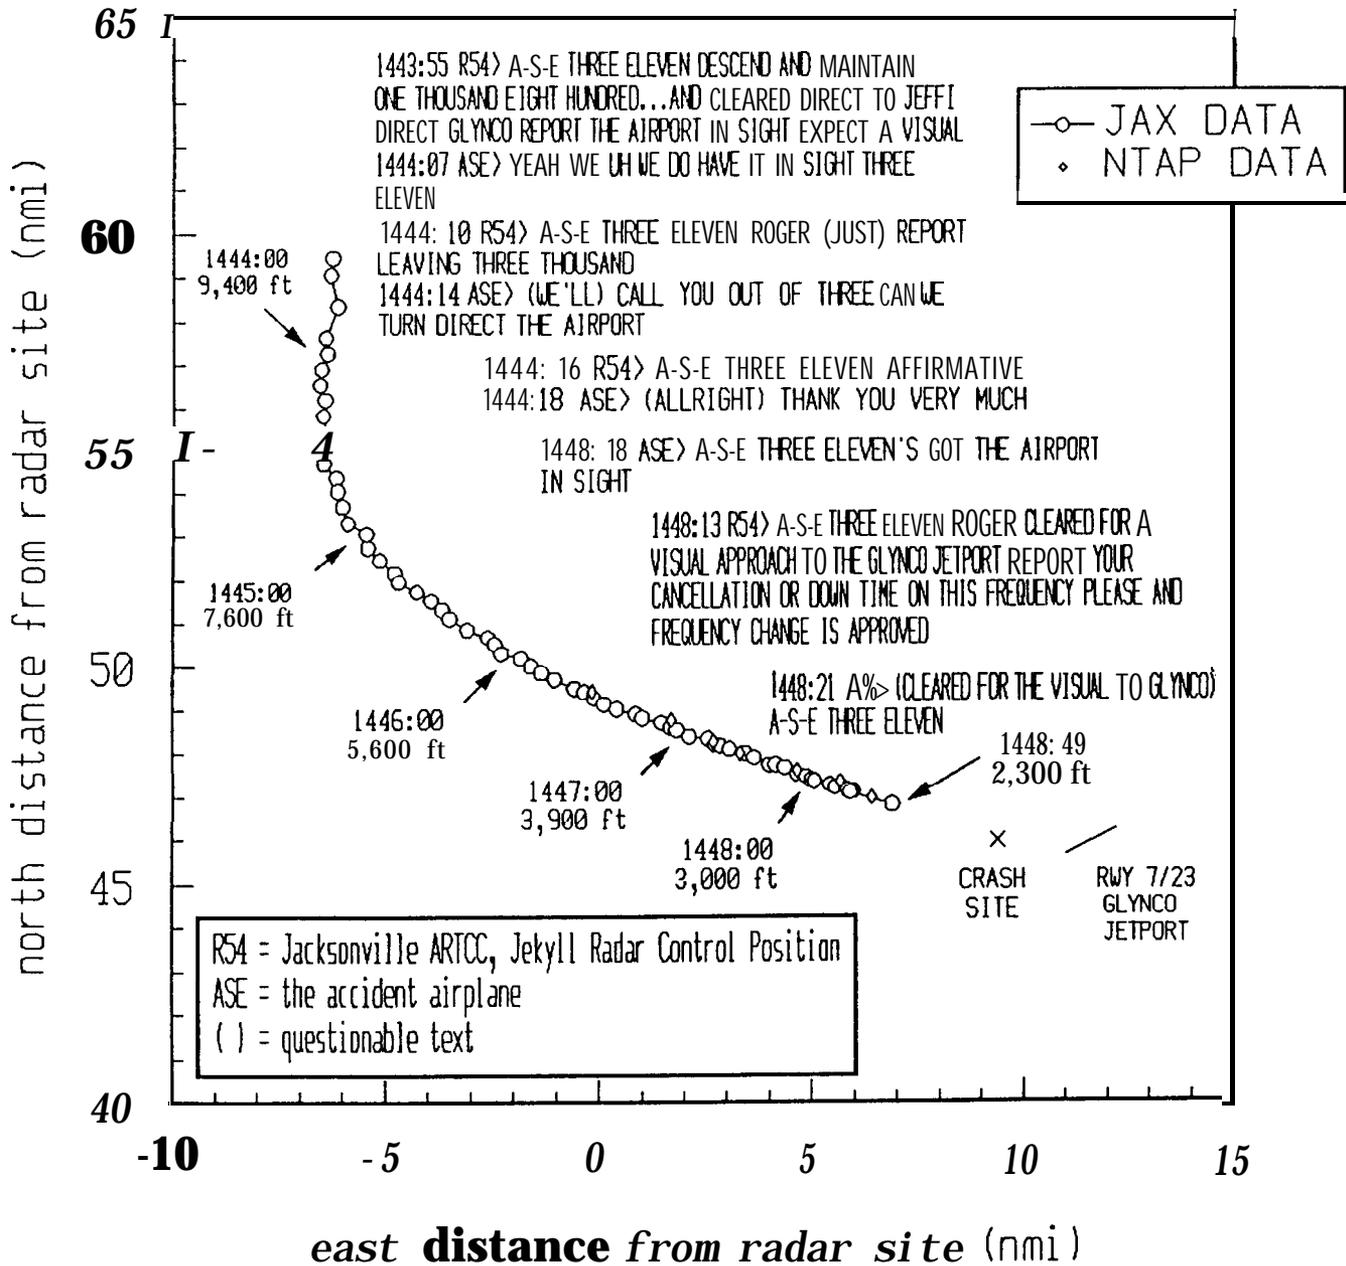
Figure 1.--EMB-120 Accident, Brunswick, Georgia, Raw Radar Data

The starting point for the majority of simulator flights was the point of last radar contact with the accident flight: 2,300 feet above msl, 2.6 nautical miles (nmi) from the crash site, and 4.1 nmi from runway 07. The initial configurations assumed applicable to the accident flight were: landing gear extended, flaps 25 degrees, condition levers to 100 percent N_p , power levers to 30 percent torque, and airspeed between 125 and 150 KIAS. The initial descent rate was approximately 1,000 feet per minute, on a heading of 117 degrees.

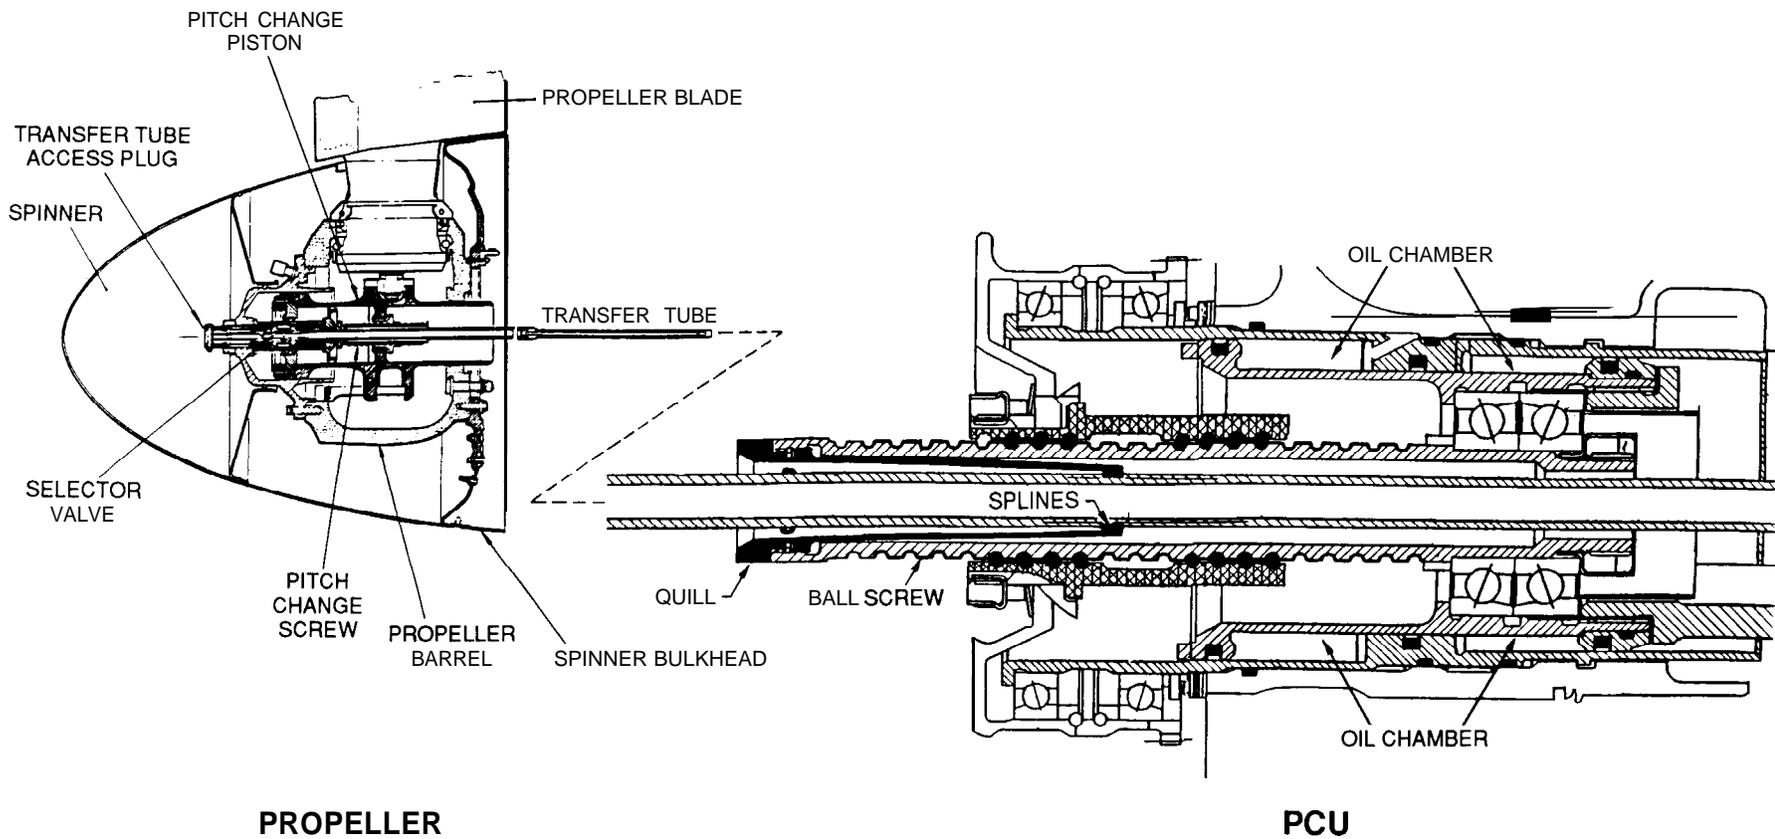
Figure 2.--Hamilton Standard propeller system Model 14RF.

The Hamilton Standard 14RF-9 propeller is a flange mounted, controllable pitch, dual acting, full feathering, reversible, four blade propeller with composite blades. The propeller and PCU are mounted on a common centerline and connected through the propeller shaft by the oil transfer tube. The transfer tube provides high pressure oil from the gearbox-mounted main oil pump to the propeller hub. The PCU governor provides metered oil pressure to operate a ballscrew drive which imparts rotary motion to the transfer tube by means of a splined quill. The transfer tube turns an acme screw in the pitch change assembly. The acme screw positions the pitch change selector valve, which directs oil to the "increase pitch" or "decrease pitch" side of the piston. (See figure 2).

Both PCU oil transfer tubes had the newer titanium-nitrided surface coating on the splines that engage the quill rather than the originally certificated nitrided surface finish. The spline surfaces on both tubes had a "matted" or dull finish appearance. The manufacturer's engineers stated that the matted appearance was the result of a relatively rough surface and that a smoother surface would have

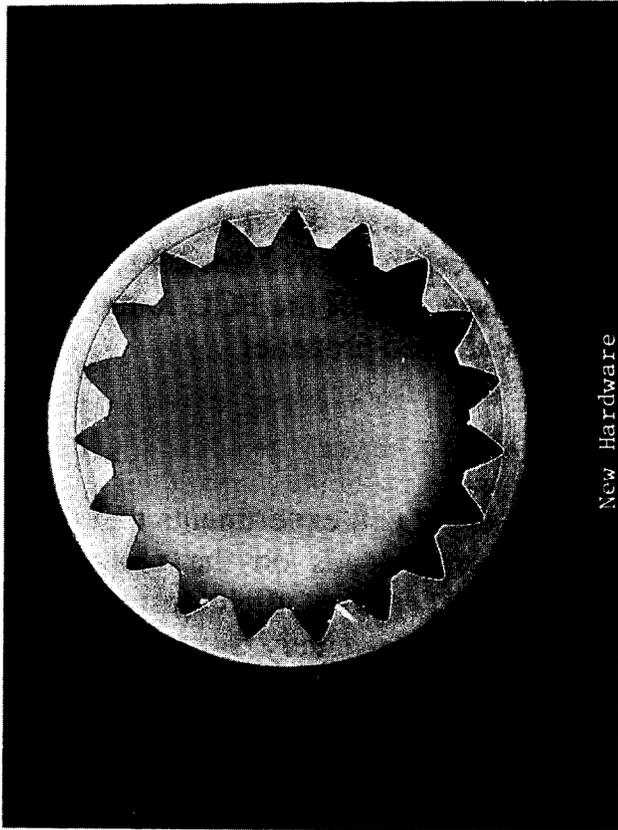
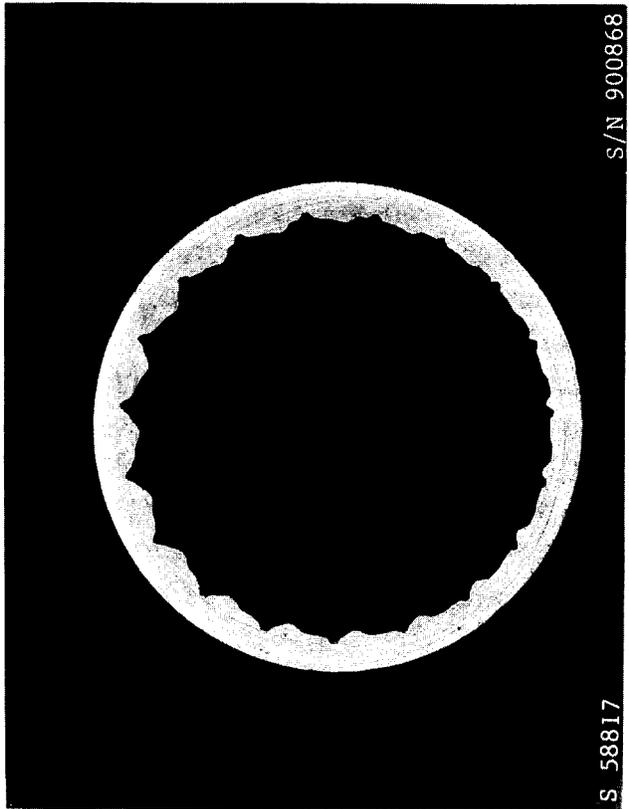
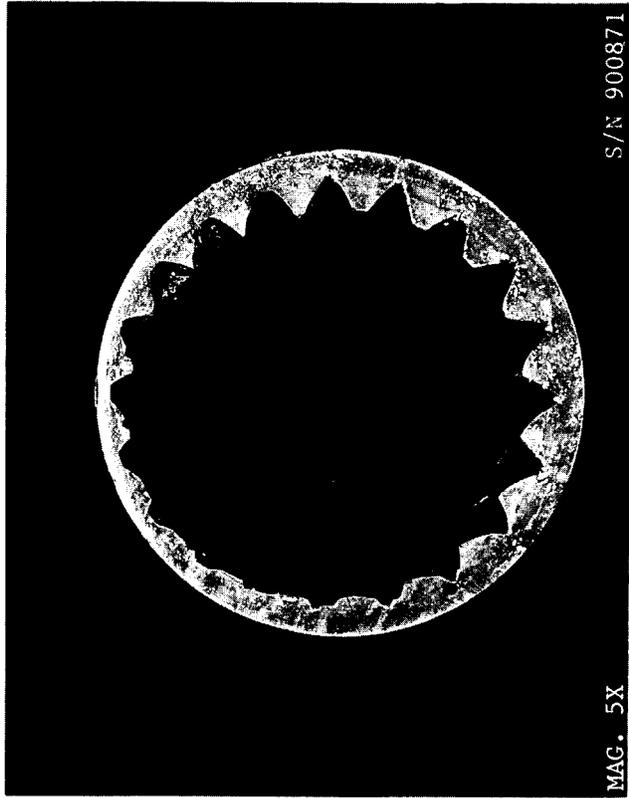
Figure 3.--PCU quill.

The discrepancy in the propeller control unit was found to have been extreme wear on the propeller control unit quill spline teeth which normally engaged the titanium-nitrided splines of the propeller transfer tube. It was found that the titanium-nitrided surface was much harder and rougher than the nitrided surface of the quill. Therefore, the transfer tube splines acted like a file and caused abnormal wear of the gear teeth on the quill. The investigation found that wear of the quill was not considered during the certification of the propeller system.

The ballscrew quills were removed from the PCUs for examination. The quills from both PCUs had severely worn internal splines. (See figure 3). The spline teeth on the left quill were almost entirely worn away, and the wear pattern was slightly off the axial centerline. The right quill spline wear was more eccentric with a heavy wear pattern on one side and relatively little wear on the opposite teeth. The left quill was assembled on the left oil transfer tube for measuring radial displacement of the quill when engaged on the spline teeth of the transfer tube. While thus assembled, the quill would rotate freely about the tube, and the quill teeth were worn to the extent that they did not engage the grooves or teeth on the tube. A similar test accomplished with the right quill indicated that the quill would engage the spline teeth of the transfer tube.

In several years of service, with some PCUs accumulating several thousand hours in service, the manufacturer stated that quill spline tooth wear had not been a problem. Thus, it was determined that the accelerated wear was a result of the introduction of a transfer tube having titanium nitride-coated spline teeth. The titanium nitride-coated surface is significantly harder than the case-hardened nitrided surface of the quill spline teeth. The history of the introduction of the titanium nitride-coated transfer tubes is further discussed in 1.17.2.

However, based upon the number of worn quills found, including those from the accident airplane, the manufacturer issued Alert Service Bulletin 14RF-9-61-A49 on May 7, 1991, that advised all operators to inspect PCUs for worn quills and began a fleet campaign to remove from service the titanium nitrided transfer tubes and to replace them with the original nitrided tubes. The Alert Service Bulletin defined the manufacturer's recommended inspection intervals and wear limits for the quill.
