NATIONAL TRANSPORTATION SAFETY BOARD

AIRCRAFT ACCIDENT REPORT

CONTROLLED COLLISION WITH TERRAIN
GP EXPRESS AIRLINES, INC., FLIGHT 861
A BEECHCRAFT 699, N118GP
ANNISTON, ALABAMA
JUNE 8, 1992

**Adopted: March 2, 1993
Notation 5806A**

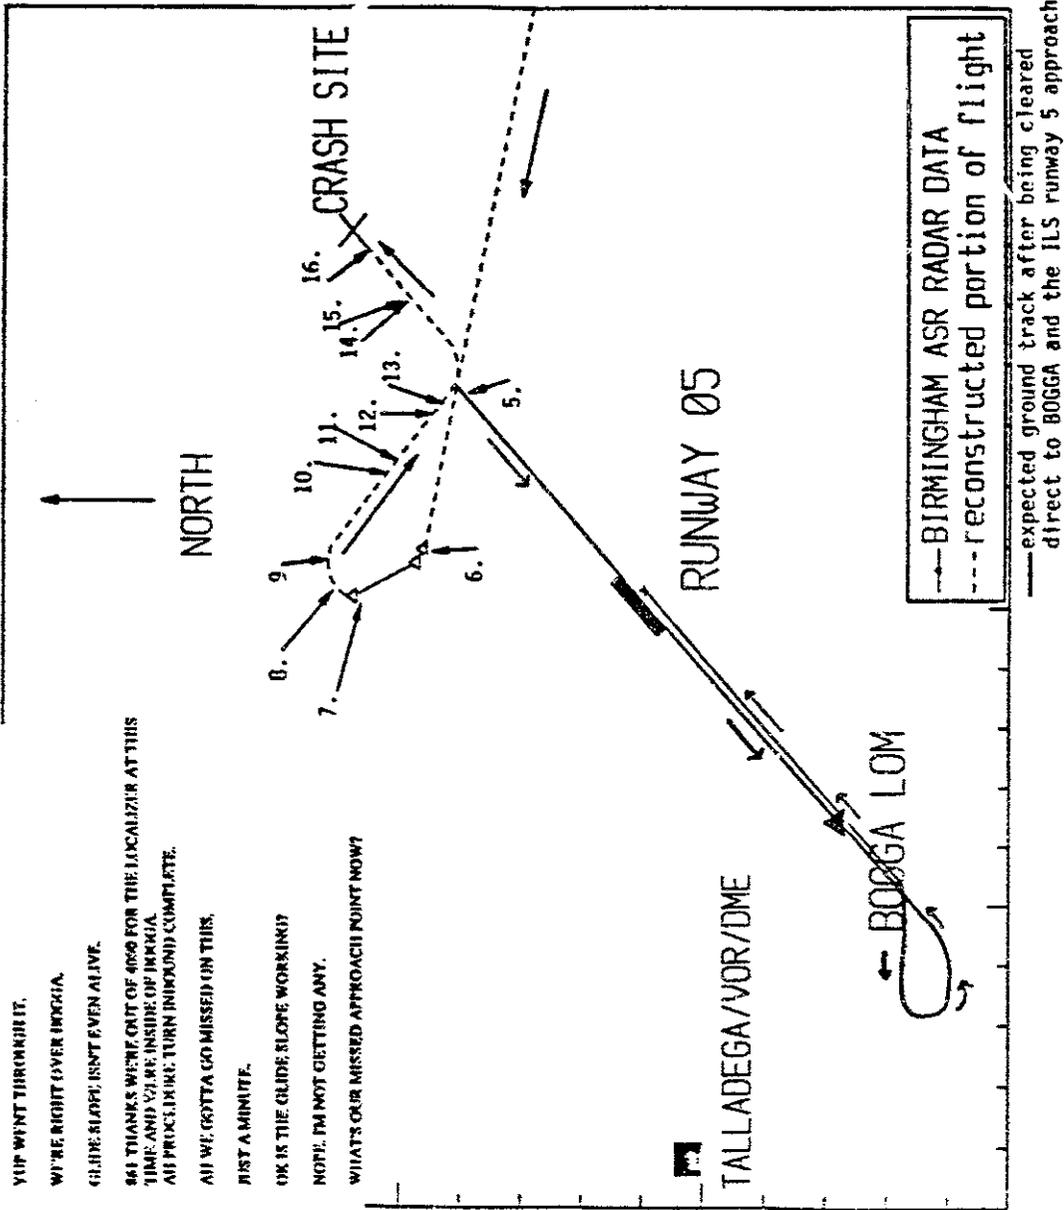
Figure 3.--Expected ground track of flight 861 for the ILS approach.

failed to acknowledge their situation and request help from ATC. The flightcrew should have abandoned the approach at *this* time. The failure to do so was causal to the accident.
