# NATIONAL TRANSPORTATION SAFETY BOARD

## AIRCRAFT ACCIDENT REPORT

MIDAIR COLLISION  
MITSUBISHI MU-2B-60, N74FB, AND PIPER PA-32-301, N82419  
GREENWOOD MUNICIPAL AIRPORT  
GREENWOOD, INDIANA  
SEPTEMBER 11, 1992

Abstract: This report explains the midair collision of an MU-2 aircraft with a PA-32 aircraft about 2 miles northeast of the Greenwood Municipal Airport, Greenwood, Indiana, on September 11, 1992. Safety issues in the report focused on the deficiencies in the see-and-avoid concept as a primary means of collision avoidance, and the failure **of pilots to fully** utilize the air traffic control system by obtaining instrument flight **rules** clearances before takeoff. Recommendations concerning these issues were made to the federal Aviation Administration, the National Business Aircraft Association, the National Association of Flight instructors, the Experimental Aircraft Association, and the Aircraft Owners and Pilots Association.

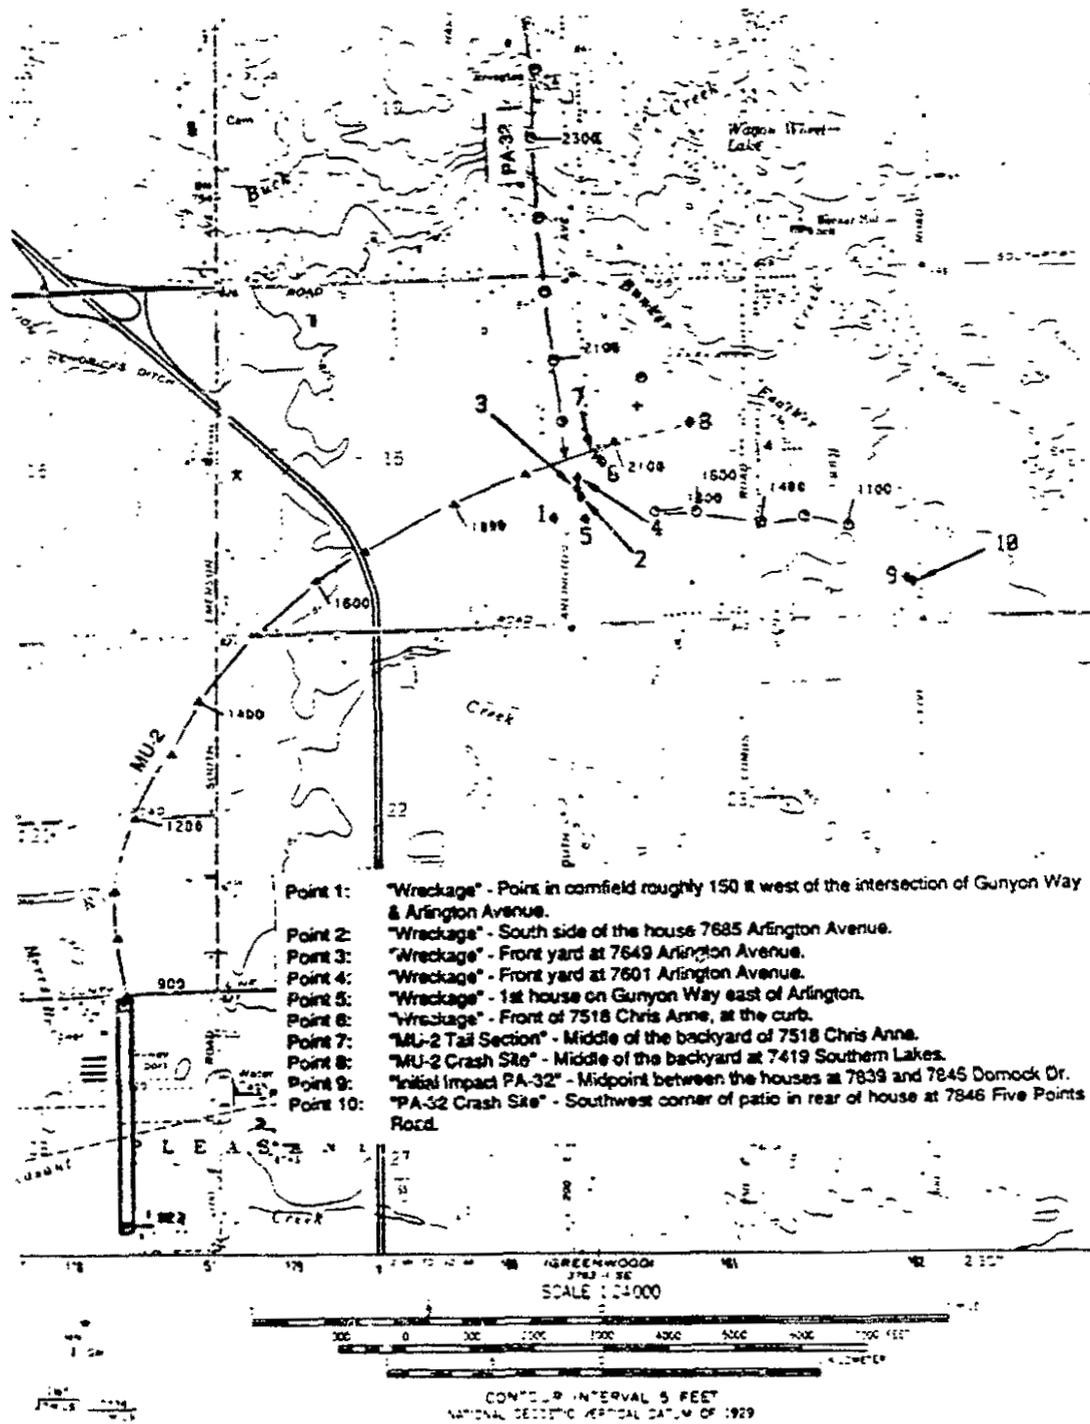
Figure 1.--Wreckage plot.

Debris from the two airplanes was scattered over a rectangular residential area approximately 1/2 by 1 mile in Southern Marion County, Indiana. Three houses located on Southern Lakes Drive were damaged when the fuselage of the MU-2 came to rest in their back yards and caught fire. The PA-32 struck the roofs of two houses on Dornock Drive causing minor damage. The airplane touched down in the back yard of one of those houses, and its left wing struck and destroyed a children's playhouse. The impact separated the outboard 4 feet of the left wing

from ~~the~~ airplane. ~~The~~ airplane ~~then~~ slid through the fence at the rear of the yard and into the back yard of another house, coming to rest next to the rear of the house. A postcrash ~~fire~~ consumed the airplane and a major portion of the house. The fire caused minor damage to ~~an~~ adjoining house.

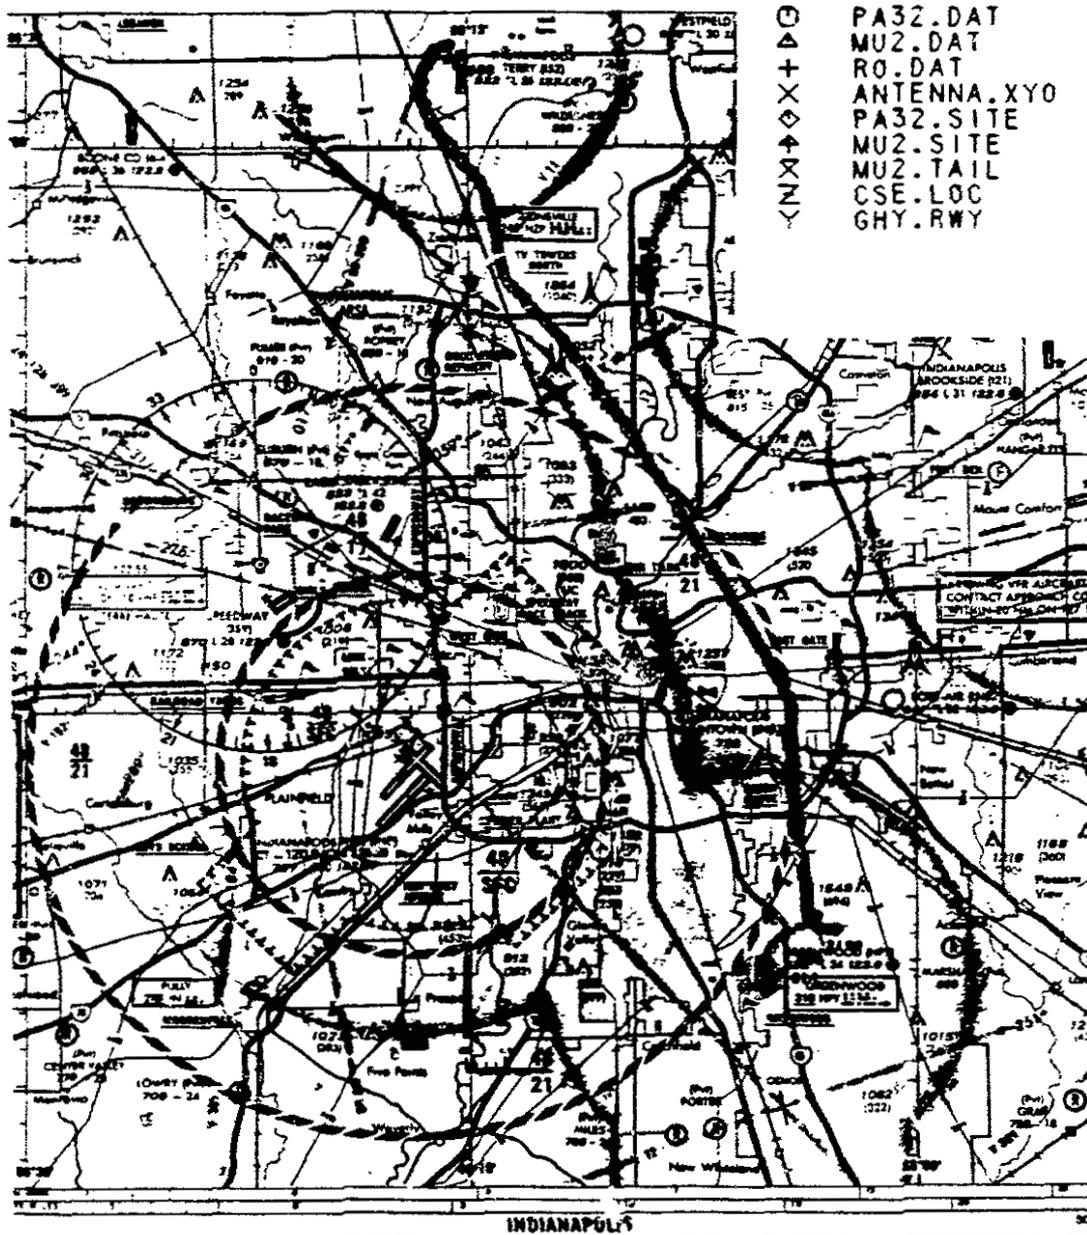
Figure 3.--Recorded radar ground track plots,

Recorded radar data indicated that at 1444:51 an airplane associated with a "1200" beacon code, assumed to be the PA-32, was directly north of Terry Airport at an altitude of **1600** feet. At 1445:33, the radar target, assumed to be the PA-32, switched to a beacon code of "0301" and continued to track to the south. At **1456:04**, a "1200" beacon code target, assumed to be the MU-2, was observed approximately over Greenwood Municipal Airport at 900 feet heading northeast. At **1456:08**, the radar data indicated that the PA-32 switched beacon codes to "1200" and continued to track to the south at an altitude of **2,500** feet. At **1456:51**, recorded radar data indicated a beacon target report of "**4564**," assumed to be the MU-2, at **1,900** feet northeast of the airport. At **145655.47**, one "**4564**" (last recorded radar return) and one "1200" beacon target report were recorded in close proximity to each other at an altitude of 2,100 feet, **11.4** nautical miles southeast of Indianapolis International Airport, and 2 miles northeast of the Greenwood Airport.

The **Airport** Surveillance Radar (ASR) magnetic tape data from the Indianapolis **sensor** were processed at the Safety Boards facilities. The beacon target reports **for** transponder codes 0301, ~~4564~~, and 1200, assumed to be associated with the PA-32 and N74FB between 1431:00 and 1458:00, were identified. Also obtained were the positions **of** the MU-2s fuselage and tail **section**, the PA-32, and the Control **Systems** Engineering building. The coordinates **for** runway 18/36 at Greenwood were supplied by the FAA. Indianapolis Terminal Control Area (TCA) location and dimensions were obtained **from** the St. Louis Aeronautical Sectional Chart. These data, along with the recorded radar data between 1431:00 and 1458:00, were scaled in nautical miles and plotted **using** the location of the Indianapolis sensor as the origin.

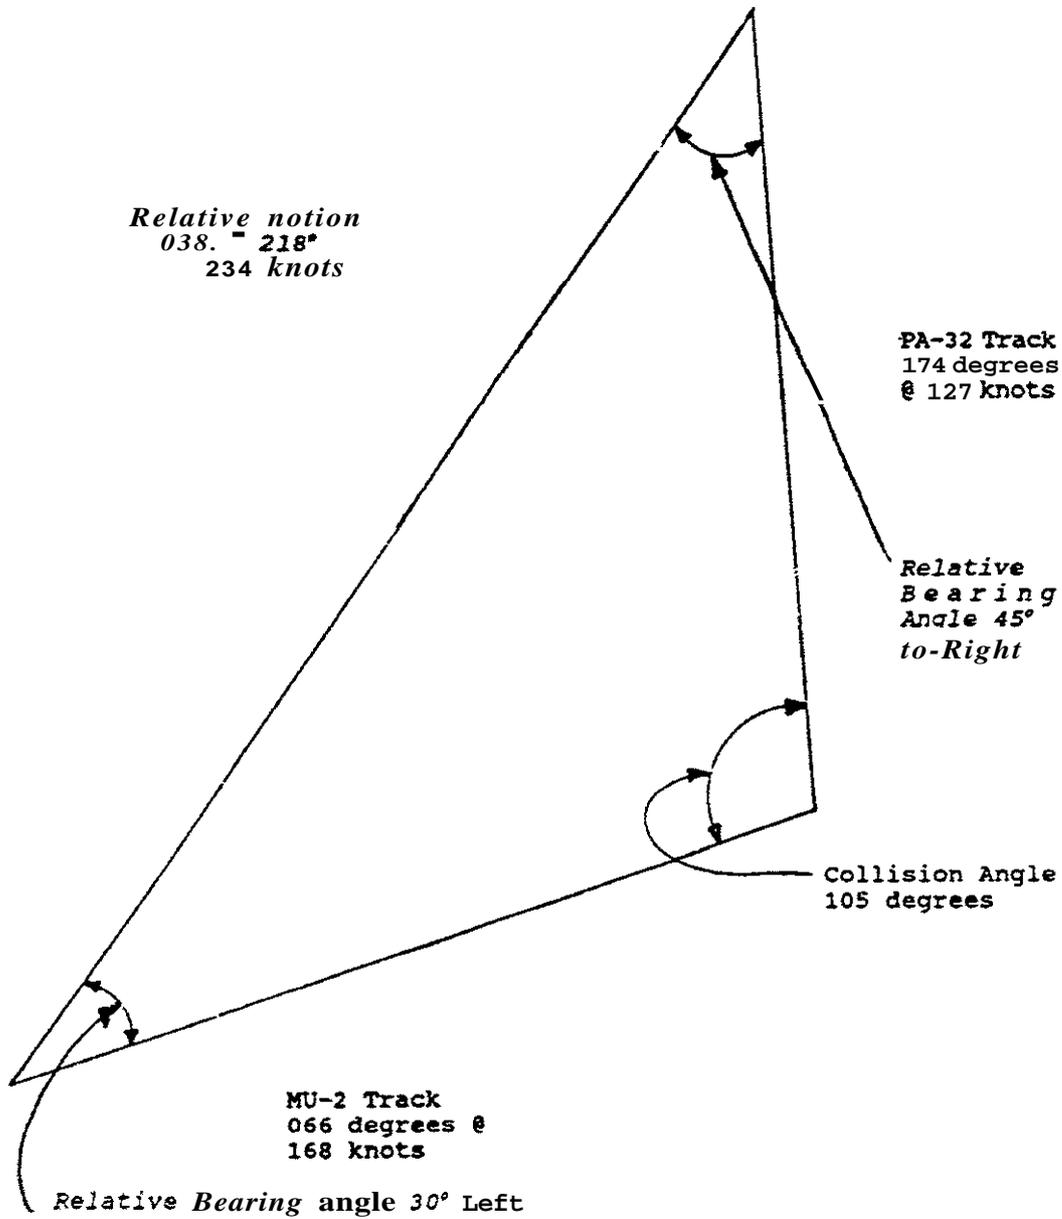
Figure 5.--Triangular relationship of the airplanes at impact.

The collision occurred as the **MU-2** climbed through **2,100** feet on a course of **070** degrees at a ground speed of **168** knots, climbing at approximately **1,200** feet per minute (fpm). The vertical component of this rate of climb was **12** knots, and the climb path was **4** degrees relative to the horizontal plane. The collision damage on the **MU-2** was confined to the empennage. Most of the **MU-2's** structure forward of the empennage was consumed by a postimpact fire. However, on those pieces of structure that were not destroyed, there was no evidence of collision damage.

The radar data showed the **PA-32** to be on a track of **174** degrees, at a ground speed of **127** knots, with a rate of descent of **390 fpm**. The vertical component of this rate of descent is **3.9 knots**, and the descent path is **-2.1** degrees relative to the horizontal plane. The collision damage to the **PA-32** involved the propeller, propeller spinner, engine cowling, and belly skin. The **PA-32** structure was destroyed by the fire.

Since the plane of motion of the two airplanes was within **15** degrees of the horizontal, an accepted practice was used in solving this 3-dimensional relative motion problem. This practice dictates that if the plane of motion of the two aircraft is within **15** degrees of the horizontal or vertical planes, the problem is resolved by using either the horizontal or the vertical motion alone, as appropriate. This will introduce errors of less than 5 percent at a maximum value of 15 degrees. Since the motion of both airplanes was within **4** degrees and **1.5** degrees of the horizontal, the relative motion geometry was solved in the horizontal plane, and the resulting errors were considered negligible.

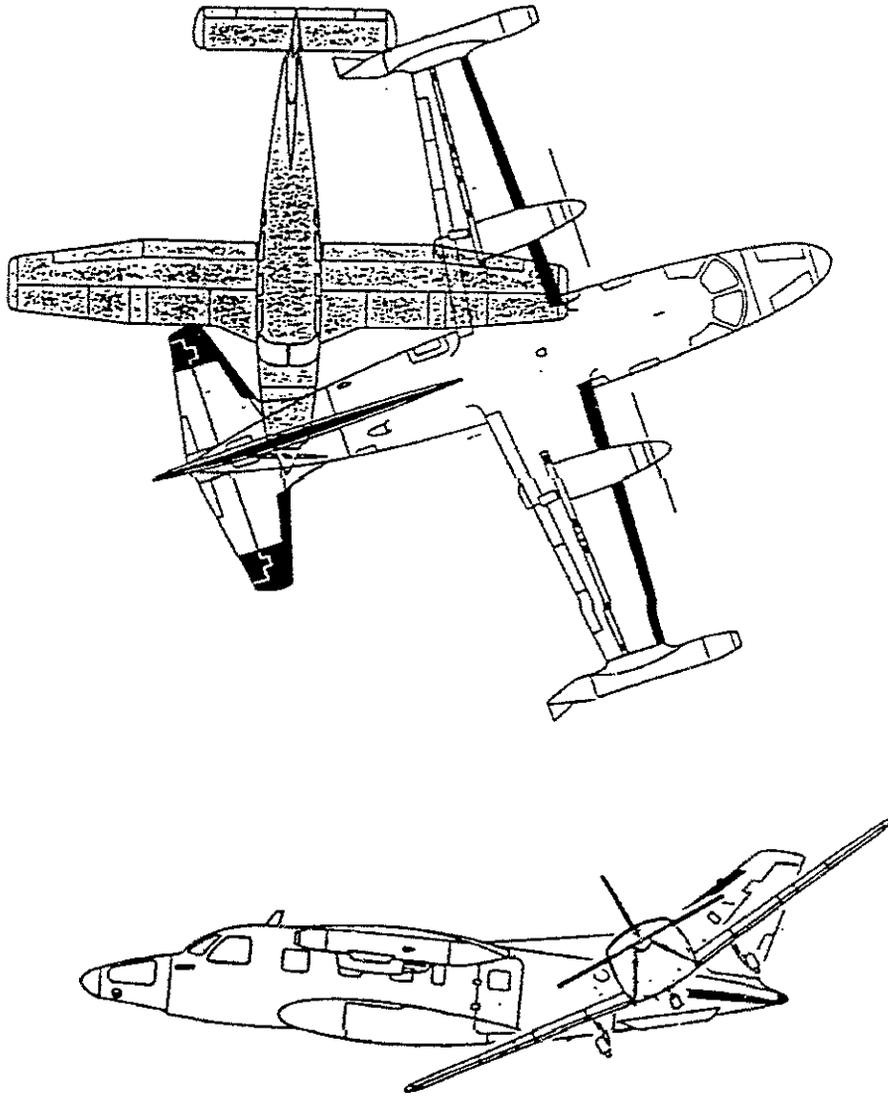
Figure 6.--Horizontal view and pfanview of the airplanes at impact.

It is probable that the MU-2 appeared suddenly and that the PA-32 pilot made a reactive turn to the left just before impact. The absence of impact marks or damage on those portions of the MU-2 forward of the empennage indicate that the PA-32 passed behind the left wing of the MU-2 as it climbed and that it contacted the MU-2's empennage. The impact damage and the engine oil spray pattern on the PA-32 also indicated that the attitude of the PA-32 was nose high at the time of impact. The first contact between the two airplanes was one propeller blade of the PA-32 contacting the tip of the left horizontal stabilizer and elevator of the MU-2 and separating the balance weight from the elevator. The balance weight was of sufficient mass to separate that blade in the propeller, resulting in the weight being sprayed with oil from the hub of the PA-32's propeller assembly. There were two additional propeller strikes on the horizontal stabilizer before the stabilizer was crushed rearward during contact with the belly of the PA-32. There were black rubber transfer marks on the PA-32's belly stiffener, which had separated and was found near the probable area of the collision. There was also a gray paint transfer on the deice boot of the MU-2.

The propeller spinner of the PA-32 was driven into the vertical stabilizer of the MU-2 where the vertical spar joined the empennage. There was at least one propeller revolution before the empennage separated from the MU-2's aft fuselage joint, as evidenced by circular scrapes and cuts on the left side of the empennage. Blue paint transfer was found on all PA-32 propeller blades and the propeller spinner. The PA-32's oil-filled propeller dome was crushed when it contacted the MU-2, releasing a large amount of oil in the damaged area of the vertical stabilizer of the MU-2. The cowl of the PA-32 was also damaged in this sequence, and it separated from the airplane.

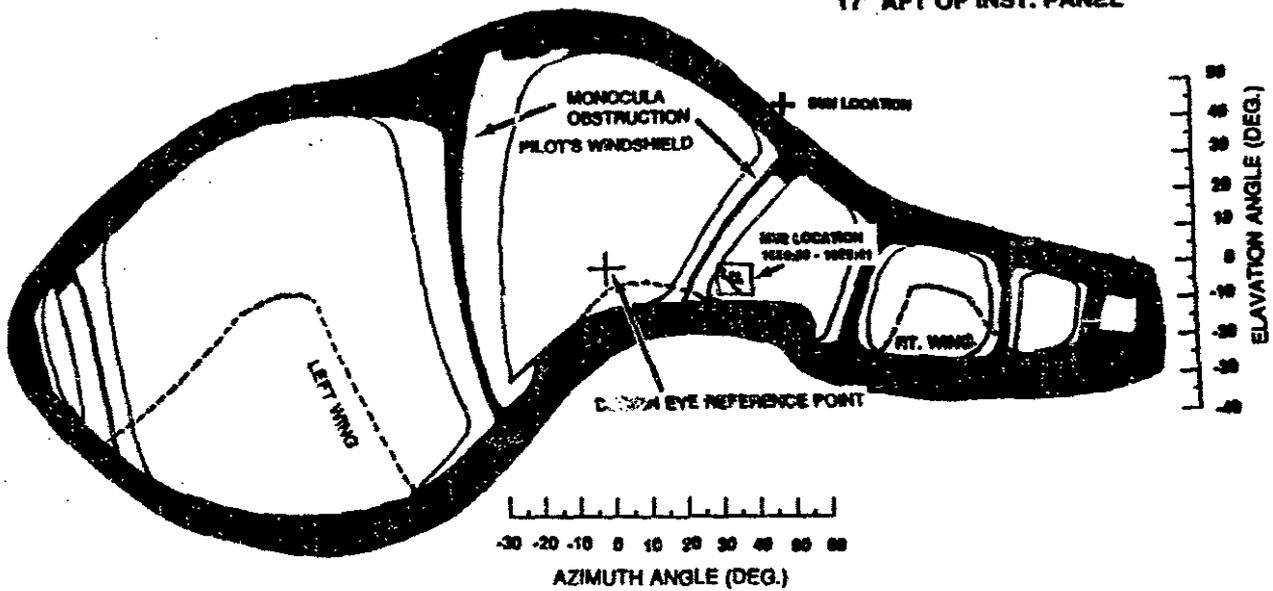
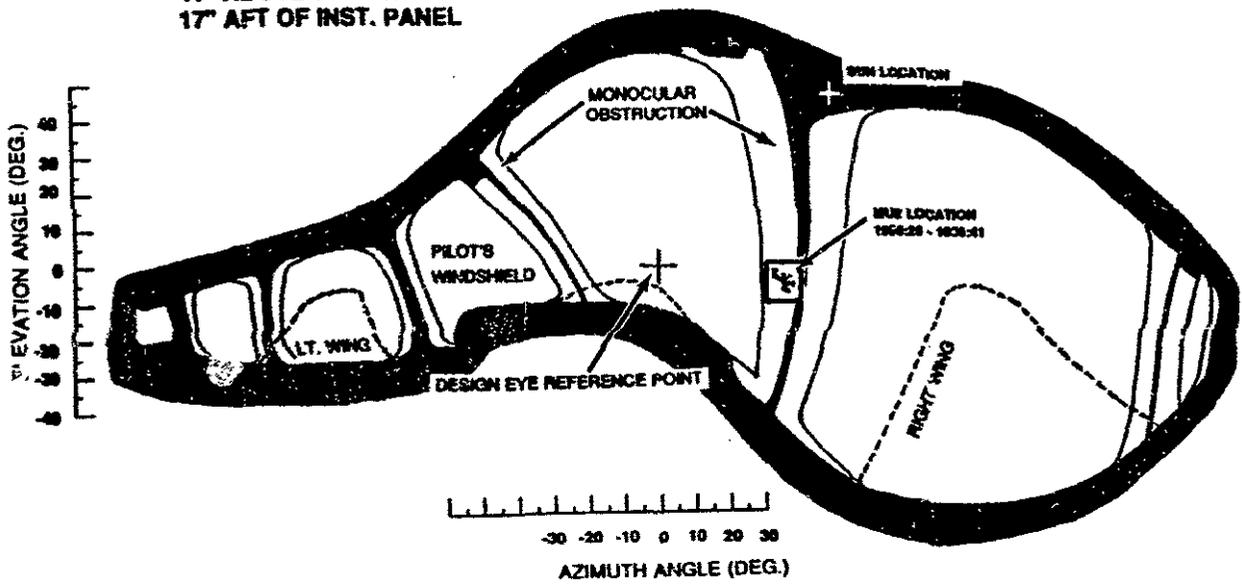
PIPER CHEROKEE PA32-206  
 ATTITUDE - LEVEL  
 CAMERA - NORMAL  
 PILOT'S EYE POSITION  
 41" ABOVE SEAT RAILS  
 17" AFT OF INST. PANEL

The MU-2, as viewed by the pilot of the PA-32, was in the right windshield, immediately right of the center windshield post from 1456:28 (25 seconds before the collision) to 1456:41 (12 seconds before the collision). The MU-2's position in the windshield would have moved from just below the horizontal zero eye reference plane to just above the instrument panel during this time. The apparent downward movement of the Mu-2 in the PA-32's field of vision would have been caused by the airplanes' converging flightpaths. (See PA-32 cockpit in appendix C).
