# NATIONAL TRANSPORTATION SAFETY BOARD

## AIRCRAFT ACCIDENT REPORT

CONTROLLED FLIGHT INTO TERRAIN  
FEDERAL AVIATION ADMINISTRATION  
BEECH SUPER KING AIR 300/F, N82  
FRONT ROYAL, VIRGINIA  
OCTOBER 26, 1993

**Adopted: April 12, 1994  
Notation 62188**

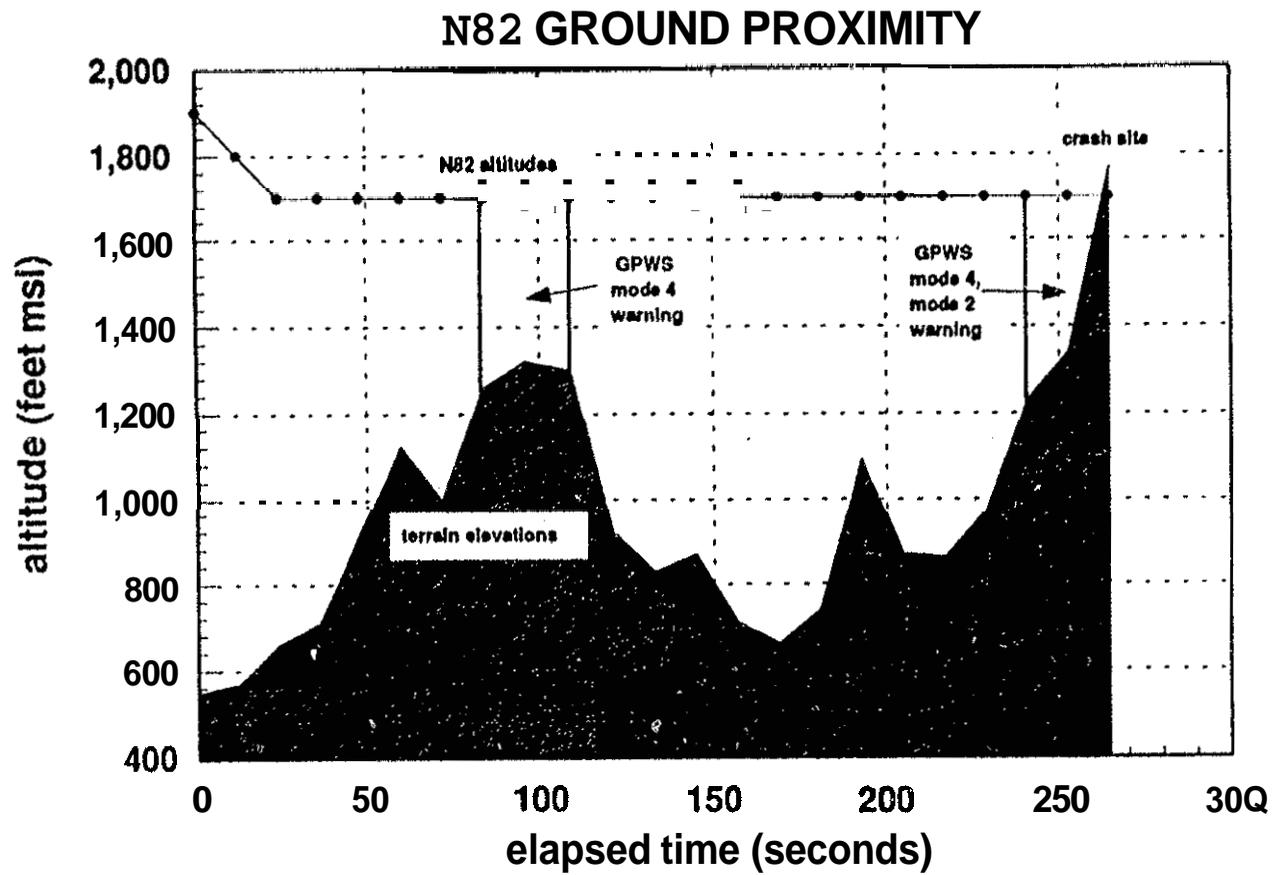
Figure 5.--GPWS warnings from ground track reconstruction.

<sup>11</sup>Modern **GPWS** equipment provides a variety of situational warnings. In the context of this accident, Technical Standard Order-C92b specifies that the mode four warning becomes active at an *altitude* below **500** feet agl and that *the* mode two warning becomes active at varying terrain closure rates related to height above the terrain.
