**OVERSPEED AND LOSS OF POWER
ON BOTH ENGINES DURING DESCENT AND
POWER-OFF EMERGENCY LANDING
SIMMONS AIRLINES, INC., d/b/a
AMERICAN EAGLE FLIGHT 3641, N349SB
FALSE RIVER AIR PARK, NEW ROADS, LOUISIANA
FEBRUARY 1, 1994**

**Adopted: September 27, 1994
Notation 6293A**

Abstract: This report explains the emergency landing of American Eagle flight 3641, a Saab 340B airplane, at False River Air Park, New Roads, Louisiana, on February 1, 1994. The safety issues in the report focused on the safety hazards involved with the in-flight operation of propellers in the beta mode in airplanes for which such operation is prohibited. The Safety Board reiterated Safety Recommendation A-94-62, which is intended to prevent the in-flight beta operation unless the airplane is certificated for such use.

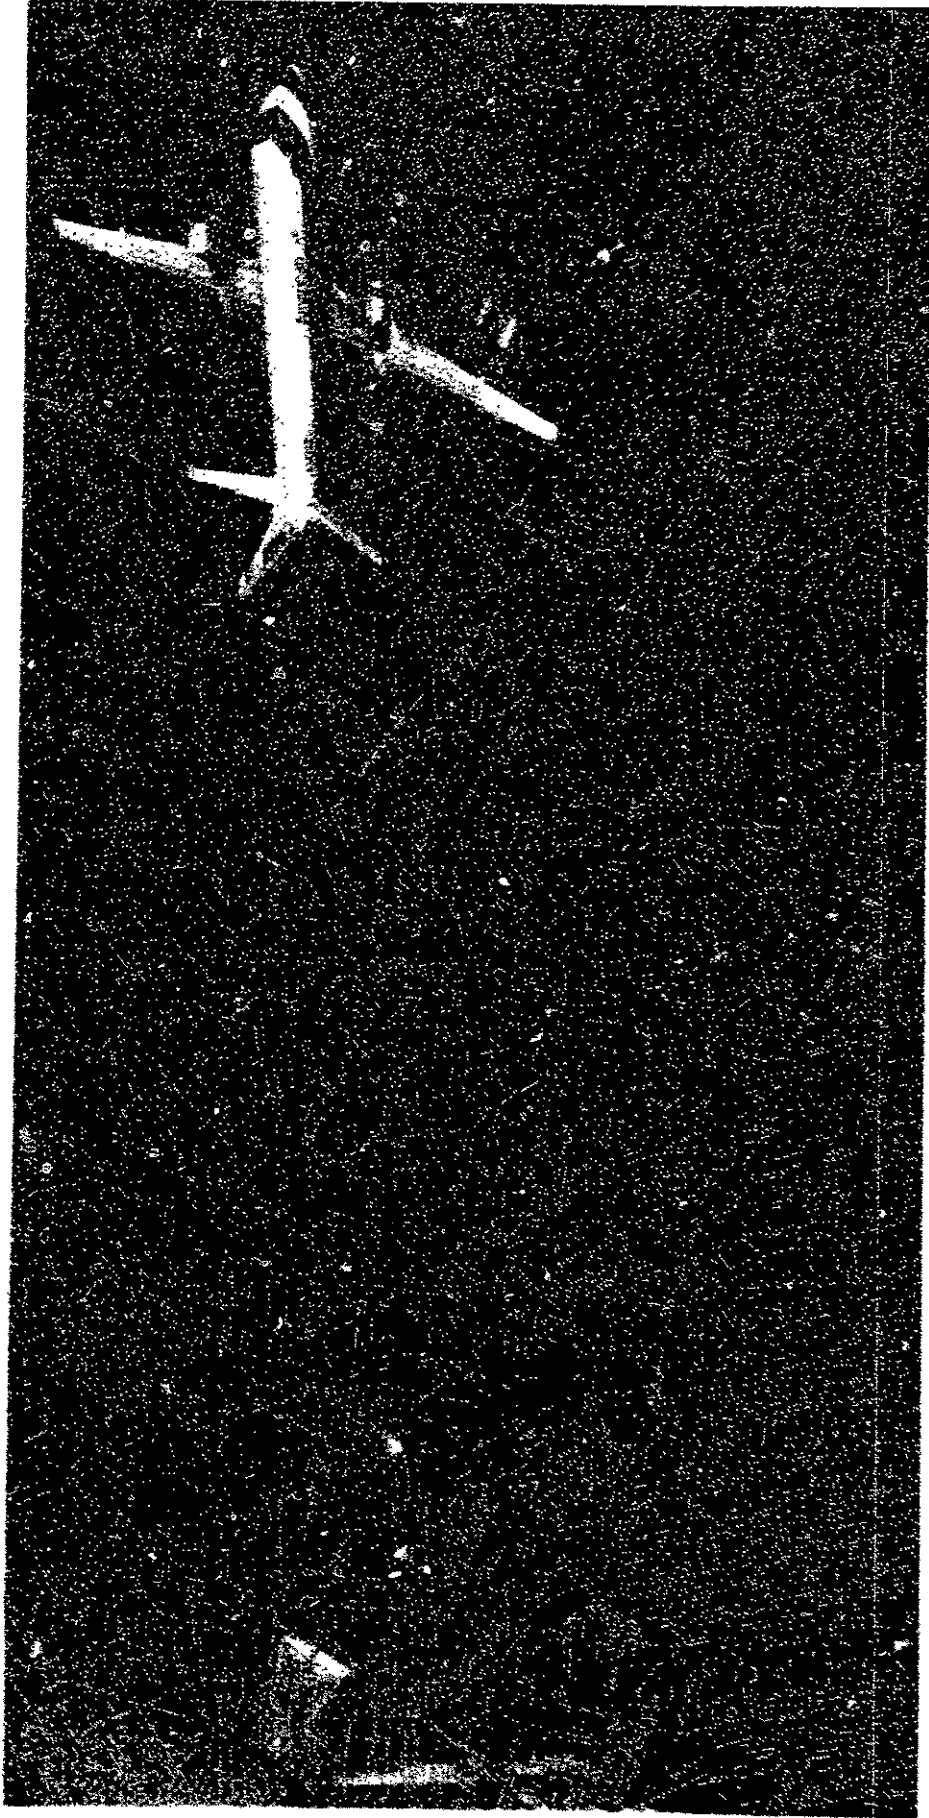
Figure 1.--Resting position of airplane.

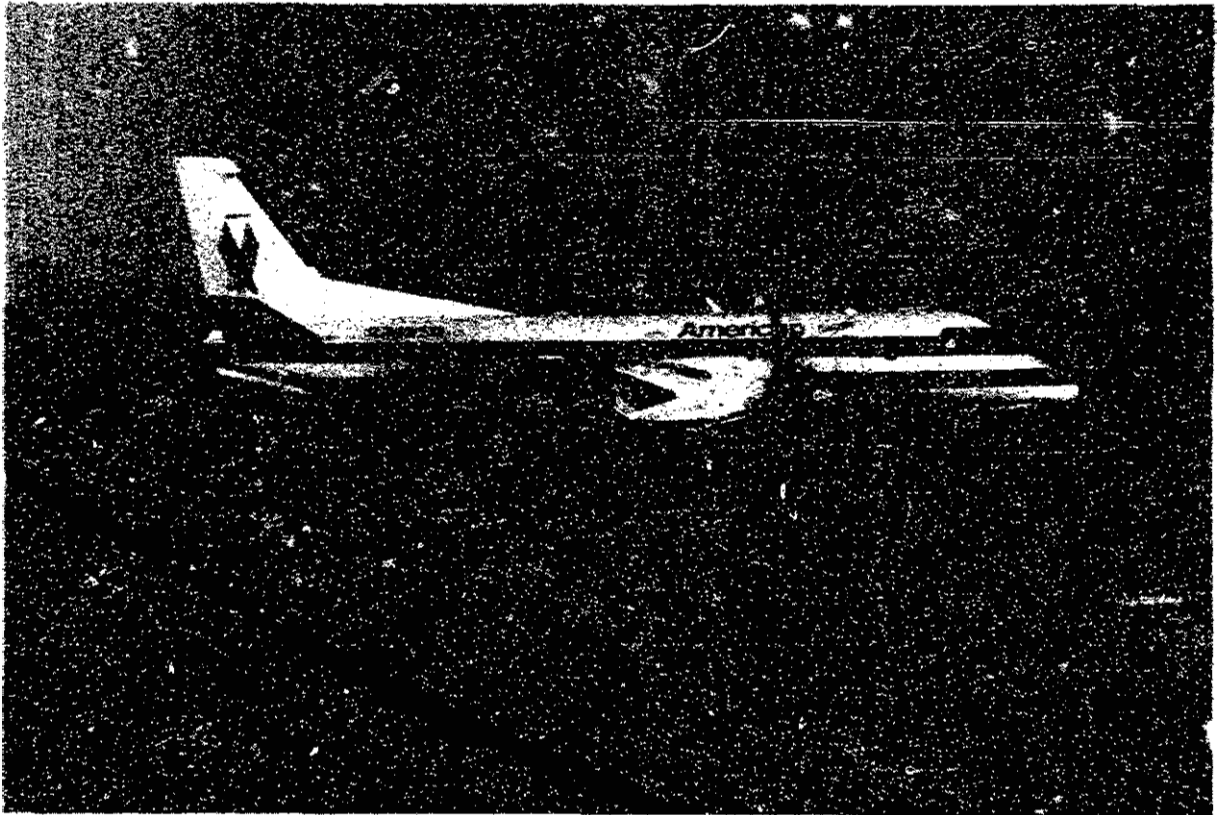
Figure 2a.--Airplane in sugar cane field with fence visible on landing gear.

After the airplane came to a stop, the first officer exited the cockpit. After he observed fencing materials wrapped around the landing gear, he lowered the airstair door to assist passengers exiting the cabin so that they would not jump

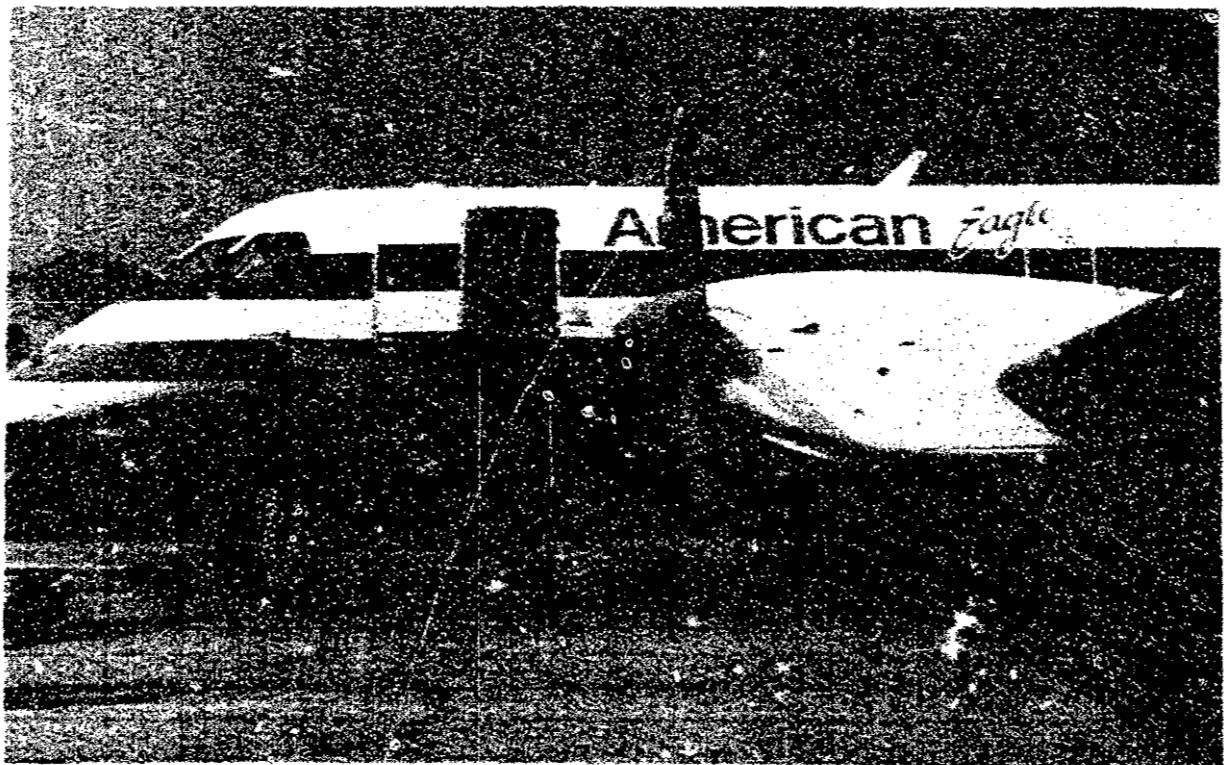
Figure 2b.--Airplane after recovery showing radome, puncture (in front of logo), and dented leading edge of wing.

Structural damage to the airplane included dents and puncture.. in wing leading edge panels and flap panels, a horizontal crease in the left nose structure at the radome, and crushing of the composite radome. There was a 2- by 3-inch hole surrounded by a 6- by 12-inch dent in the fuselage aft of the main cabin door upper edge. **Also**, there was a 3-inch tear near the forward hinge point for the right nose landing gear door, a buckled skin and former section on the left side of the left nacelle, and **a bend** in the lower forward spar cap at the root of the left wing. Figures 4a and 4b illustrate the wreckage site and damage to the airplane.

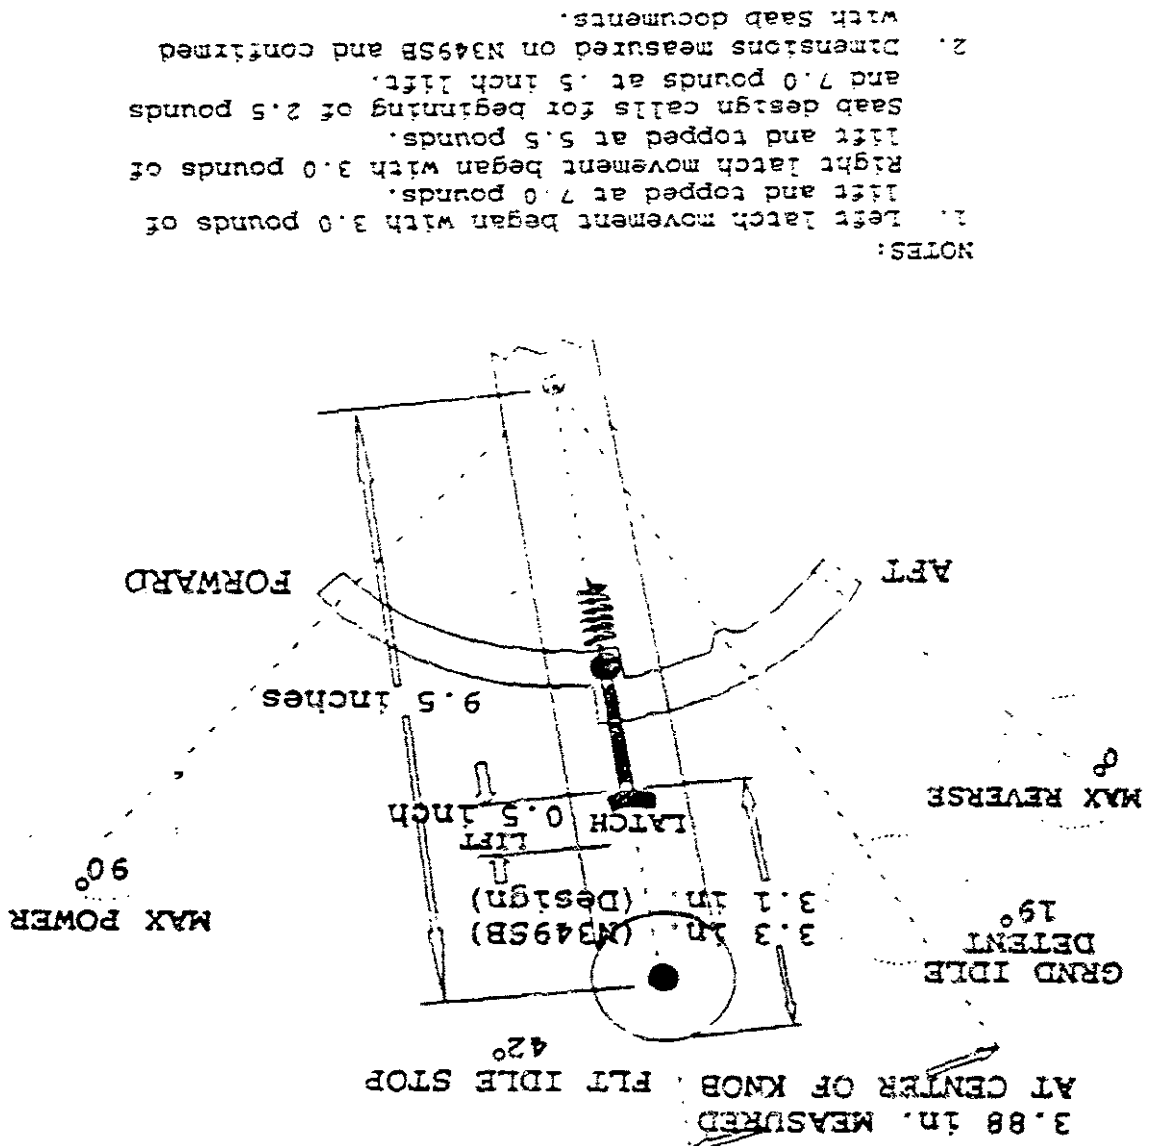
Figure 3.--Power lever.

The power lever schedules fuel over the entire power range from reverse to maximum, as selected by the pilot. From reverse to just below the flight idle stop, the power lever also directly controls propeller blade angle (beta). (See figure 3). This range is commonly called the beta range. Operation in this range is prohibited in flight. From flight idle to maximum power, the power lever schedules fuel flow at the HMU, and propeller blade angle is controlled by the constant speed governor in the propeller control unit (PCU). The condition lever, at its lowest end of travel below the "MIN SPEED" position, operates the fuel shutoff in the HMU and operates the feathering valve in the PCU. In the upper range of travel between the MIN SPEED and MAX SPEED positions, the condition lever adjusts the constant speed governor to maintain propeller speed as selected by the pilot. This range is from 75 percent (1,038 rpm) to 100 percent (1,384 rpm).

thrust, and blade angle is controlled only by power lever position. When the same condition occurs in flight, the governors have **no control** of blade angle, and **high airspeeds** can windmill the propeller to high rotational overspeeds. **In this** condition, because the propeller is driving the power turbine, the fuel shutoff function of the DEC is ineffective in preventing power turbine overspeed.

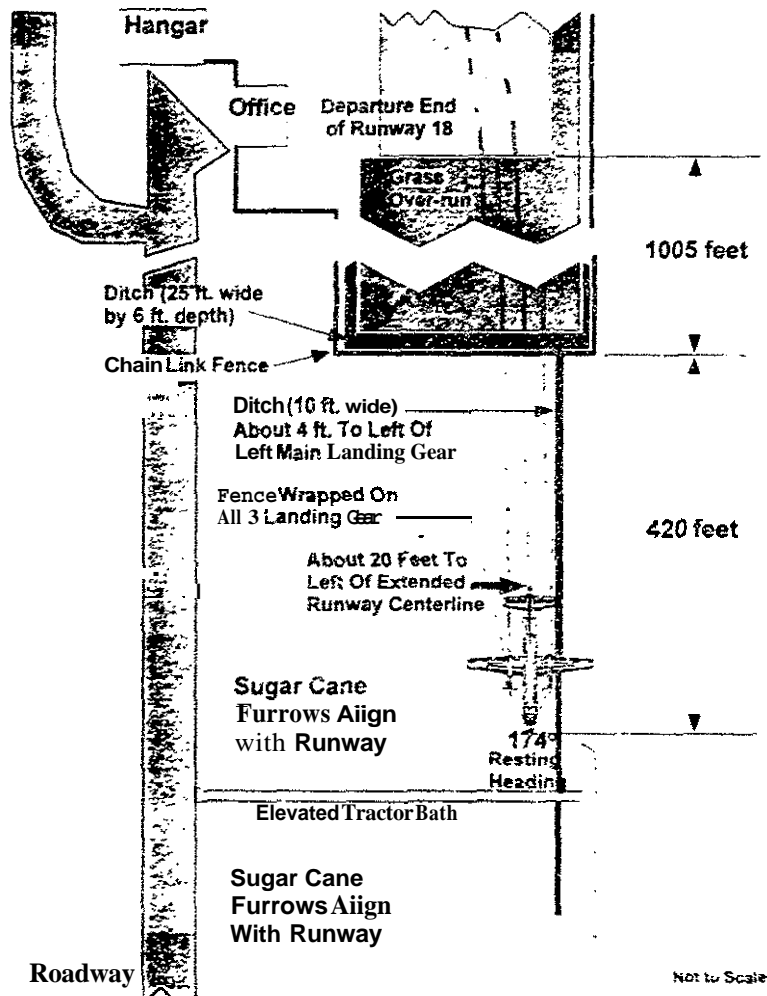
Figure 4a.--Wreckage site and airplane damage.

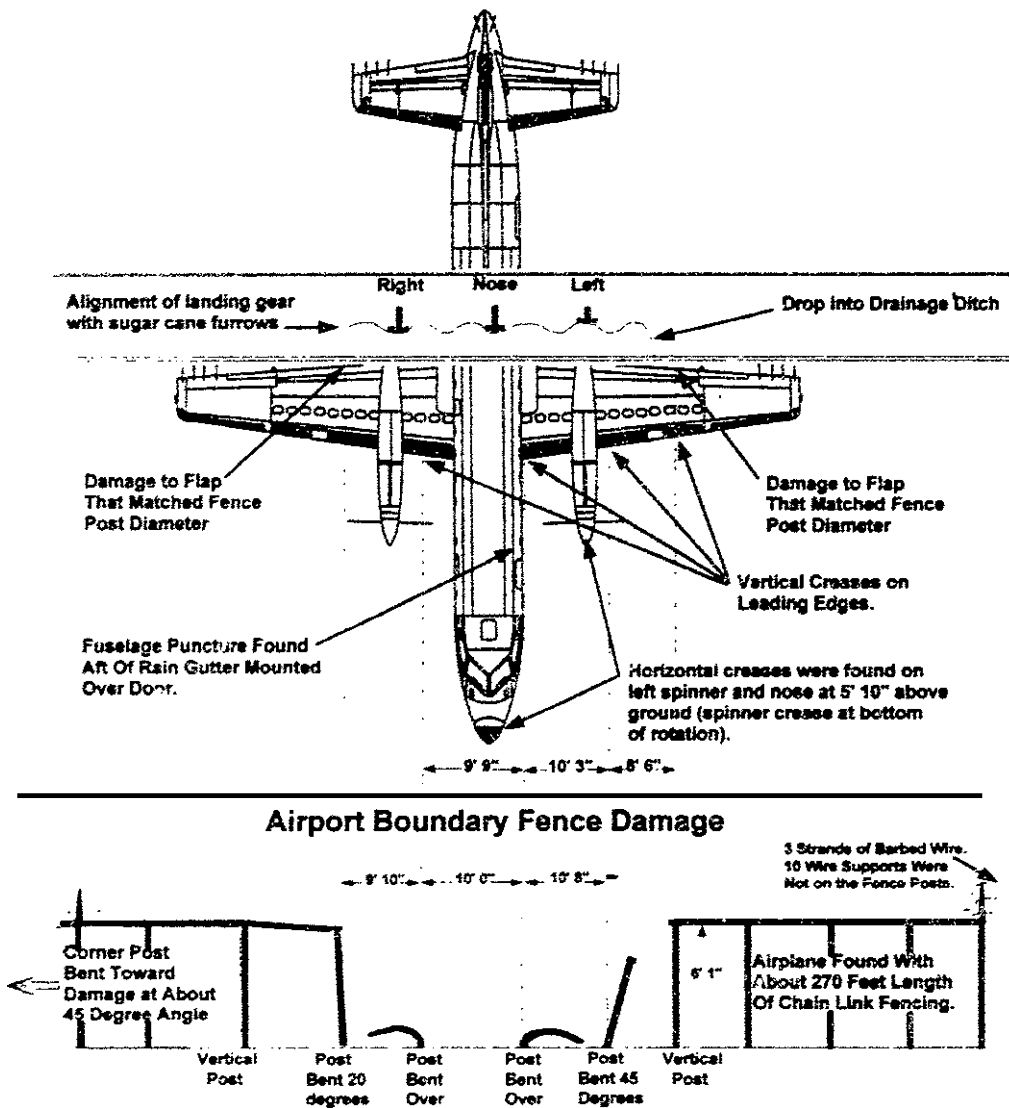
Figure 4b.--Wreckage site and airplane damage.
