AIRCRAFT ACCIDENT REPORT

STALL AND LOSS OF CONTROL ON FINAL APPROACH
ATLANTIC COAST AIRLINES, INC./
UNITED EXPRESS FLIGHT 6291
JETSTREAM 4101, N304UE
COLUMBUS, OHIO
JANUARY 7;1994

Adopted: October 6, 1994

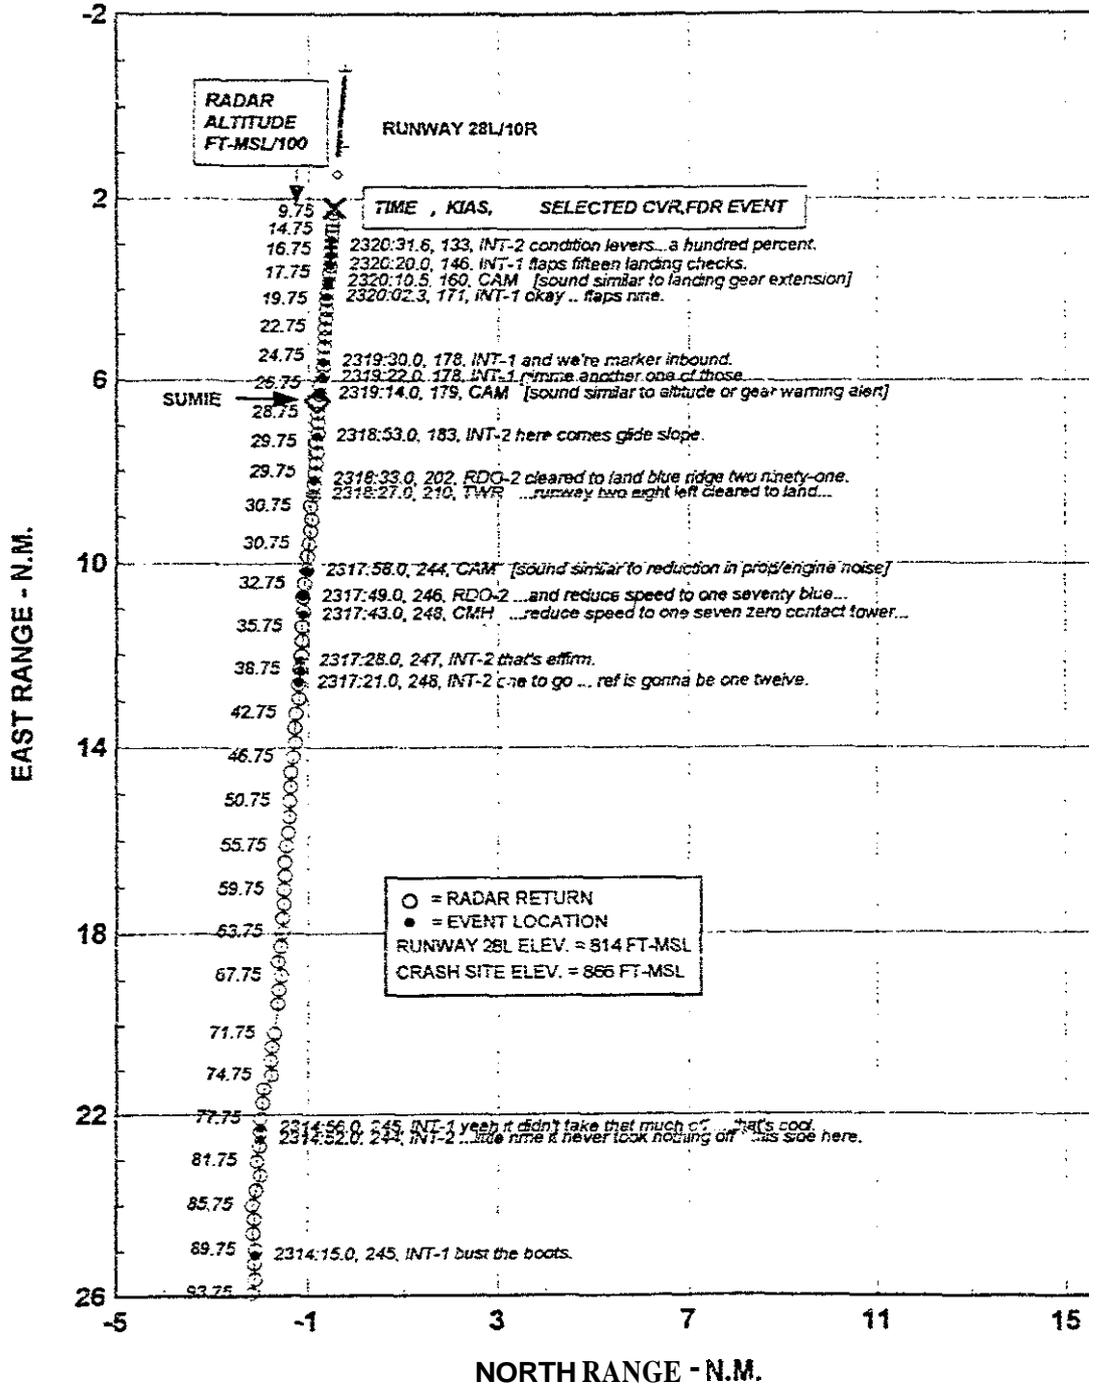
Figure 2.--Selected events from the CVR and FDR.

At 2318:56, the "approach capture mode" indicated a transition to "capture" as the ILS glideslope (G/S) value indicated less than 1/2 dot low. The altitude was 2,988 feet and the airspeed was 180 knots. The autopilot was "on." The data indicate passing the center of the outer marker 14 seconds late: at an airspeed of 178 knots as the altitude decreased through 2,784 feet, and the

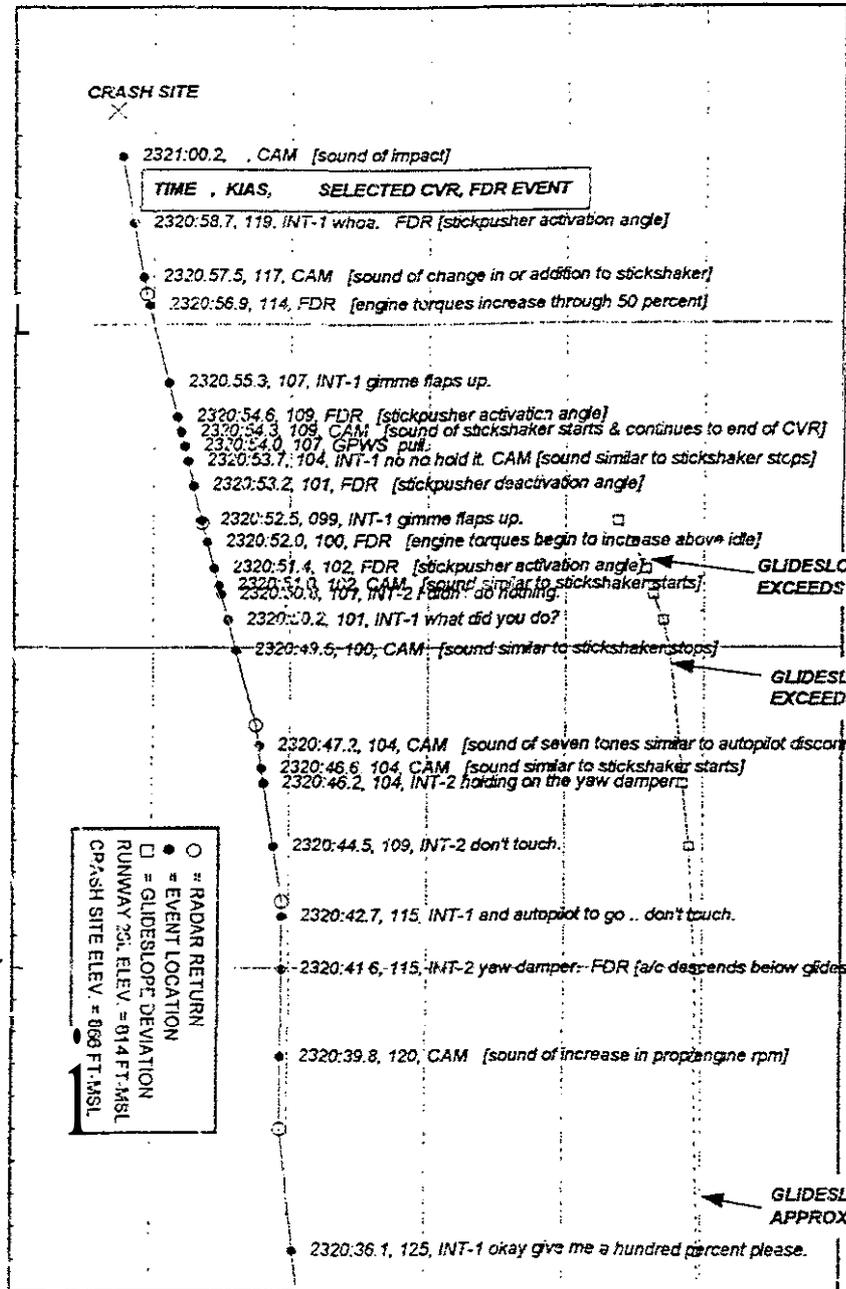
Figure 6.--Profile view of approach.

airplane remained on the localizer and G/S with the gear and flaps in the up position.

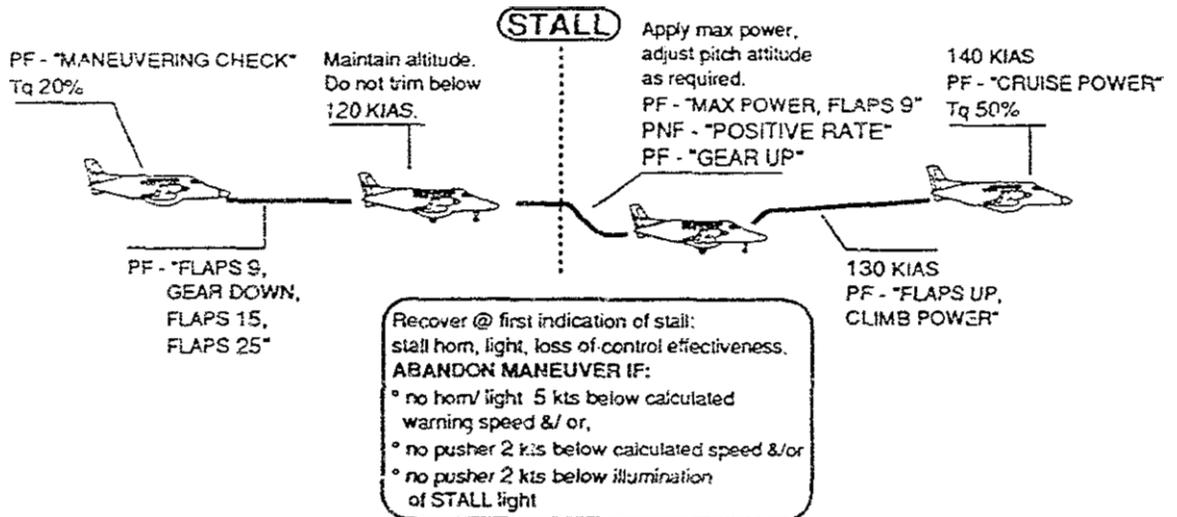
Figure 7.- J-4101 approach to stall -- landing configuration

Figure 7 contains a graphic depiction of a J-4101 in landing configuration encountering a stall condition. It contains the procedure used to recover from such a situation.

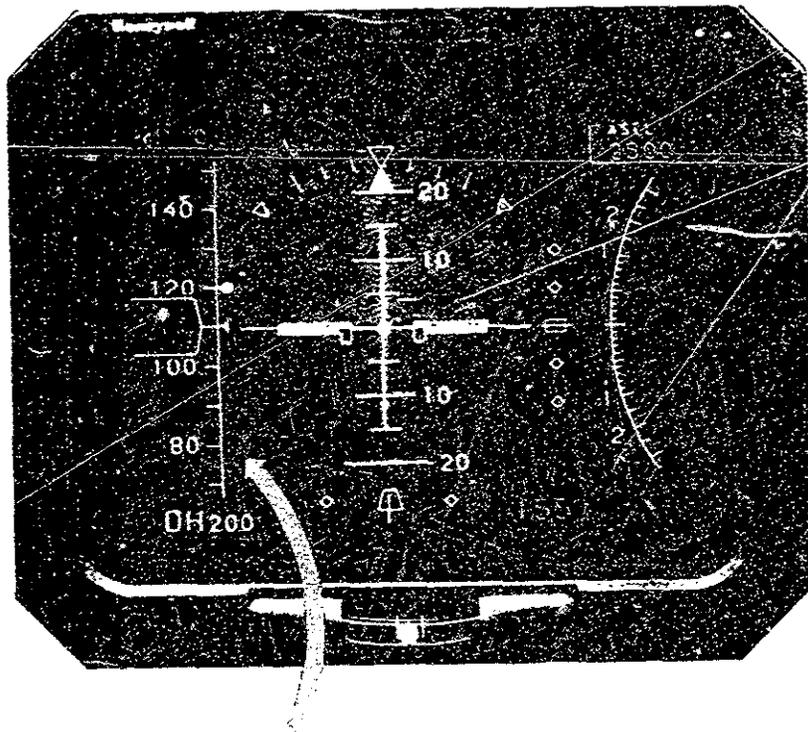
Figure 9.--Electronic attitude director indicator.

low airspeed
awareness indicator [red color]
