AIRCRAFT ACCIDENT REPORT

IMPACT WITH BLAST FENCE UPON LANDING ROLLOUT

ACTION AIR CHARTERS FLIGHT 990

PIPER PA-31-350, N990RA

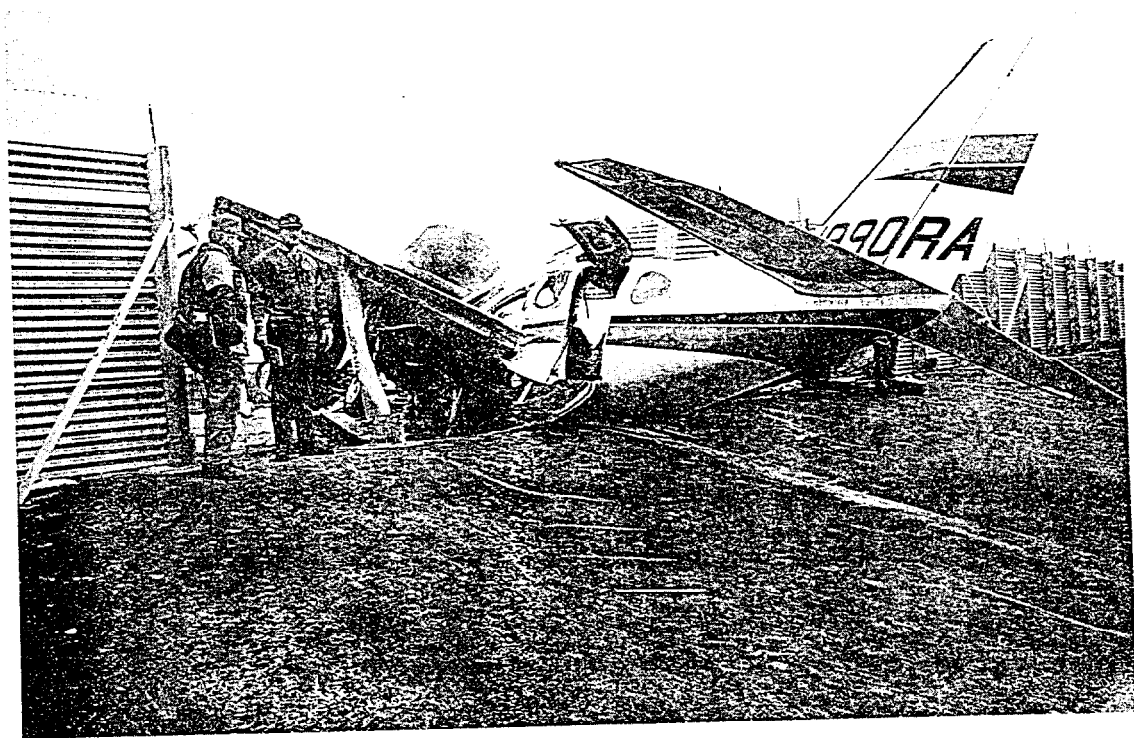
Figure 1 a.-Rear view of wreckage.

The fuselage remained in one piece at the main wreckage. The nose section of the fuselage was found about 10 feet past the blast fence in the direction of the flight. There was no evidence of bird feathers or any foreign objects in or near the cockpit.

The fuselage section from the nose of the airplane to the wing rear spar and above the cabin floor line was consumed by fire. The belly of the fuselage remained intact but was heavily damaged by fire. The fuselage belly structure near the pilot's seat was bent aft and suffered heavy fire damage. A "C" channel of the blast fence had dislodged from its base and was near the left side of the forward fuselage structure. Another "C" channel of the blast fence was near the right wing rear spar root area. This "C" channel remained attached to its base and was bent in the direction of flight. The distance between the "C" channel sections of the blast fence before impact was 6 feet. The nose gear trunnion was separated from the fuselage and was broken in numerous sections. The tire remained attached to the rim and was found under the right wing aileron and had no fire damage.

The fuselage section from the wing rear spar to the passenger door had no impact damage. The left side windows were heat damaged. Heavy soot accumulation and fire damage was observed on the upper forward portion of the passenger door. The split-type passenger door was open, and fire damage to the interior of the door was evident. The fuselage section aft of the passenger door to the tail cone did not have fire or impact damage. There was no evidence of scrape marks on the aft tail cone belly section.

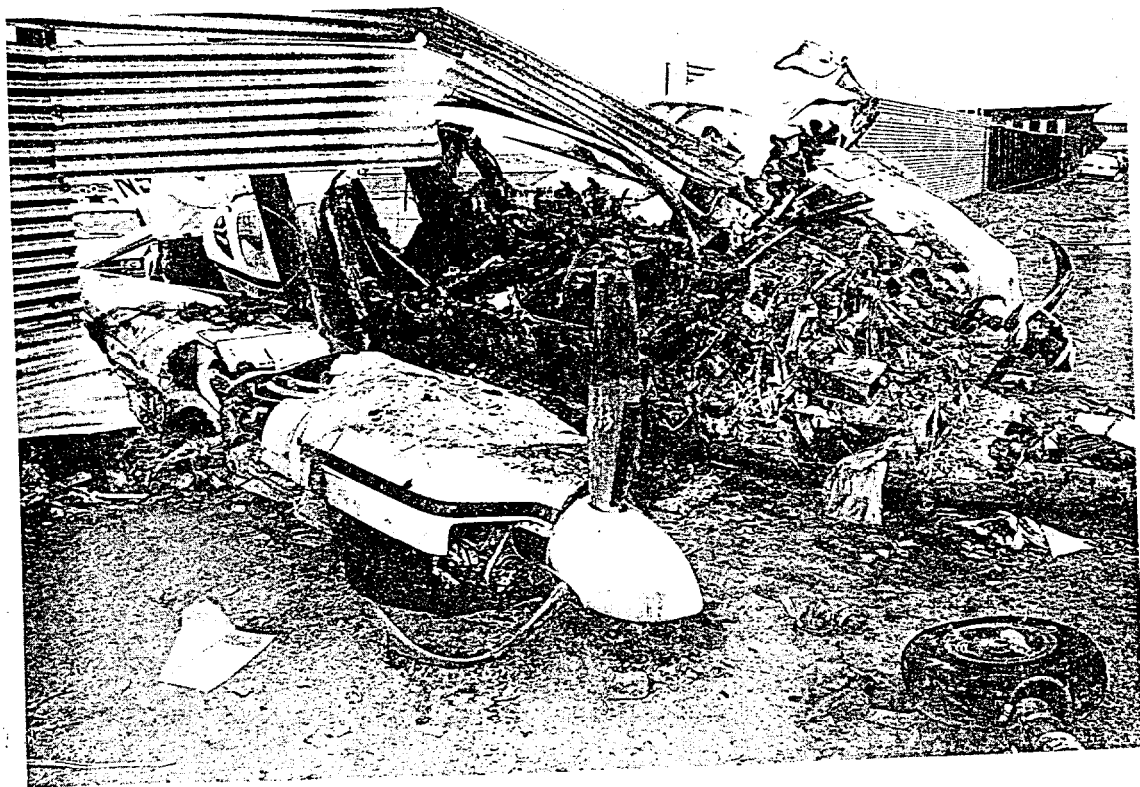
Figure 1b.-Front view of wreckage.

The right wing, which was heavily fire damaged, sheared from the fuselage at the root and remained with the main wreckage. The leading edge section between the fuselage and the right engine was consumed by fire. The mid and aft spars were bent aft at the wing root and had fire damage. There was no buckling or twisting observed in the web or the angles of the right wing spars. The fracture

The left wing remained attached to the fuselage and had heavy fire and impact damage. Evidence of tire damage to the upper and lower skin surfaces of the leading edge was observed. A "C" channel section of the blast fence was aft of the crush and was embedded in the flap structure section.

The left wing sheared outboard of the left engine. The leading edge skin was crushed aft, and the front spar was bent in the aft direction. No evidence of bird feathers or foreign objects was found on or near the wing leading edge. The flap remained attached to the wing with slight fire damage and bending at various locations. The aileron remained attached to the broken section of the outboard wing and suffered impact damage but no fire damage.
