AIRCRAFT ACCIDENT REPORT

CONTROLLED COLLISION WITH TERRAIN
TRANSPORTES AEREOS EJECUTIVOS, S.A. (TAESA)
LEARJET 25D, XA-BBA
DULLES INTERNATIONAL AIRPORT
CHANTILLY, VIRGINIA
JUNE 18, 1994

**Adopted: March 7, 1995
Notation 6527**

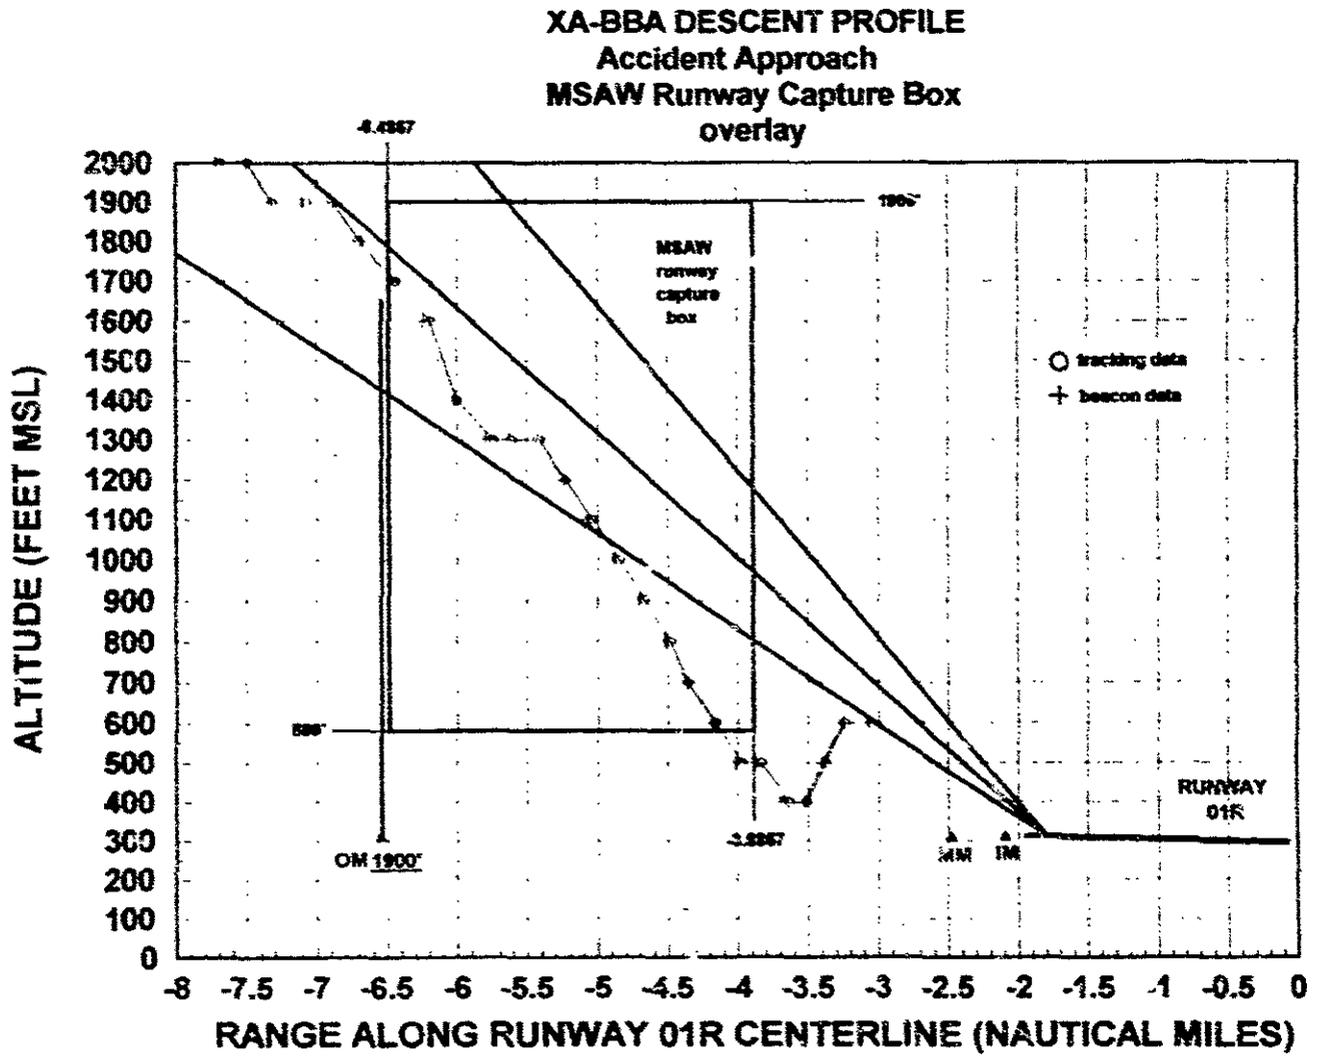
Figure 1.--Airplane descent profile.

There were no **primary radar** targets **found** in the vicinity of XA-BBA, and there were no minimum safe altitude warning (MSAW)⁷ alerts during the **period** of the approaches. A **plot** of the MSAW site variable parameters and the XA-BBA radar track indicated that XA-BBA had one return **below** the alarm altitude **of the** runway 1R **capture** box in both tracking and beacon **data** (see figure 1). However, the **FAA** states in their MSAW system functional specifications, **two** "current position" hits, or three "predicted position" hits must be received **on radar** before **an** alert will activate the aural and visual warnings.

Inspection of the MSAW site variable parameter that defined the runway threshold indicated a discrepancy between the MSAW-defined **runway** location **and** the actual threshold location. The prescribed magnetic variation of 10 degrees west was applied to the MSAW-defined threshold coordinates which created **a** position offset of 700 feet **to the** northeast from the actual runway 1R threshold. However, when a 7-degree west variation was applied, a match between the MSAW-defined threshold and the **actual** runway threshold was established. Furthermore, inspection of the other site variables revealed that a localizer-only minimum descent altitude (MDA) was used **to** establish the base of the **runway** capture **box** (680 feet).
