AIRCRAFT ACCIDENT REPORT

UNCONTAINED ENGINE FAILURE
DELTA AIR LINES FLIGHT 1288
MCDONNELL DOUGLAS MD-88, N927DA
PENSACOLA, FLORIDA
JULY 6, 1996

**Adopted: January 13, 1998
Notation 6725C**

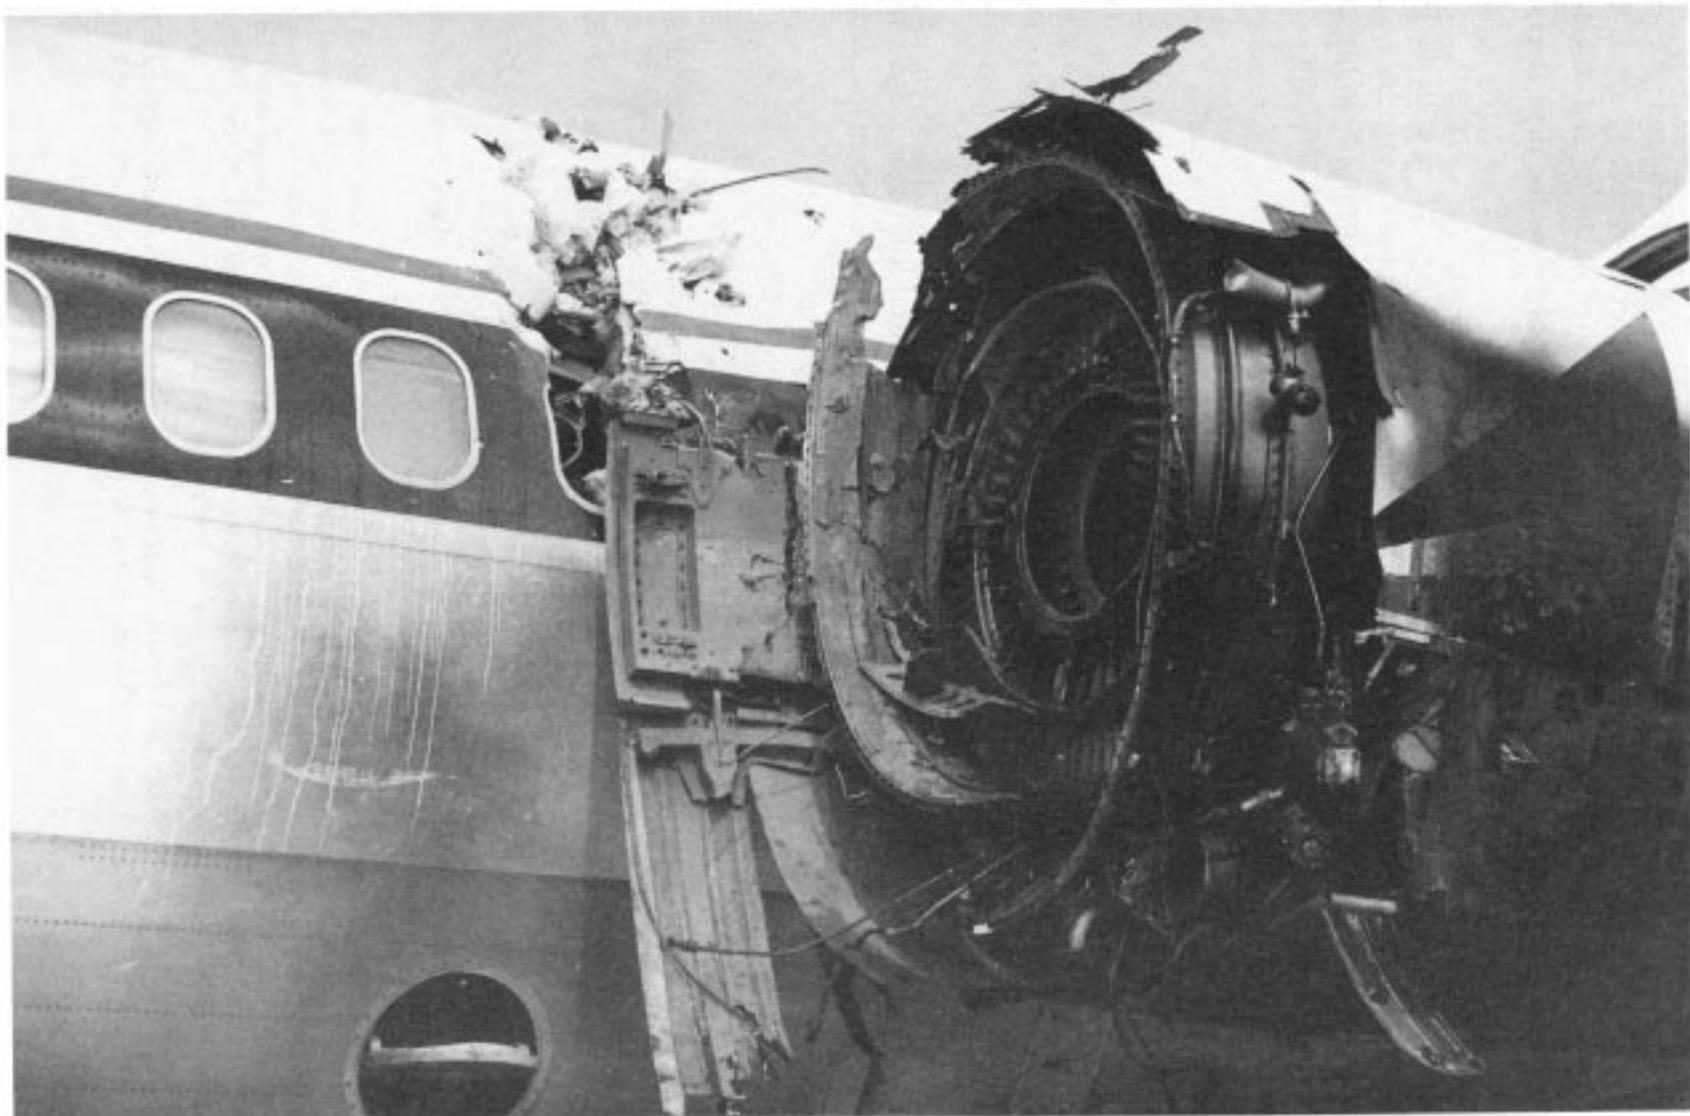
The aft left fuselage and interior of the airplane in the vicinity of the No. 1 engine were substantially damaged by debris from the engine (see figure 1). A total of 16 holes, punctures, or tears were documented on the left fuselage skin. Several large holes and tears were

Figure 1.—Damaged area of airplane near No. 1 engine.

The cabin interior was substantially damaged near seat row 37, next to the left engine. Debris from the left engine's fan hub and fan blades had penetrated the left cabin wall and overhead bin vertically from the lower left passenger window through the overhead bin and ceiling panel. Engine fan components had also pierced the side and ceiling of the right cabin wall.

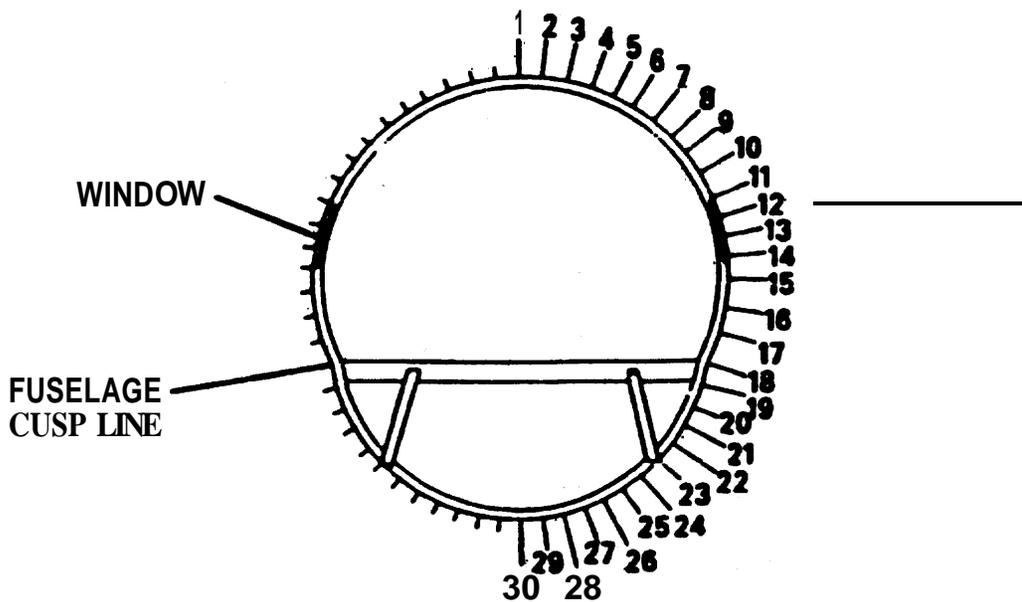
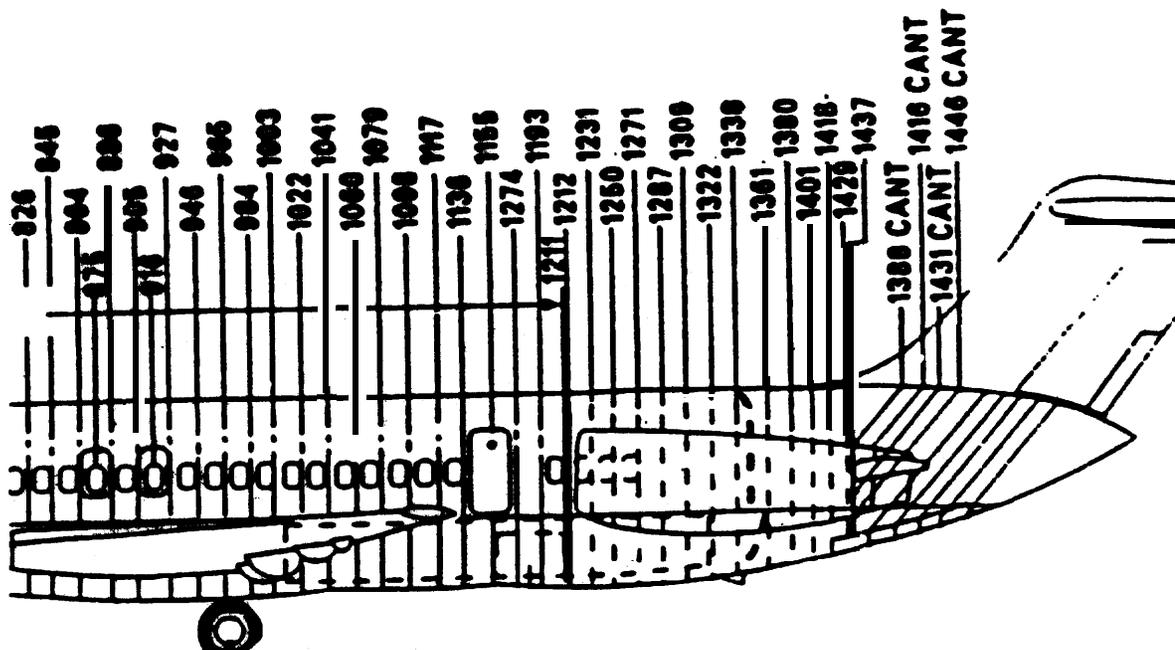
Figure 2.—Fuselage station and longeron identifications.

found between fuselage stations (FS) 1250 and FS 1282 (adjacent to row 37) and from the top of the window to longeron 2 (see figure 2).¹² Seven exit holes, punctures, and tears were documented on the right fuselage skin between FS 1228 and 1271 (just forward of row 37). Most of the wires in the wire bundle located along longeron 4 (on the right side of the fuselage) were severed near FS 1250. Of the 154 wires in the bundle, 146 had been severed. Four of the severed wires were channel differential protection wires that compared incoming and outgoing current for the right generator.¹³ No evidence of penetrations existed below the floor level on either side of the fuselage.

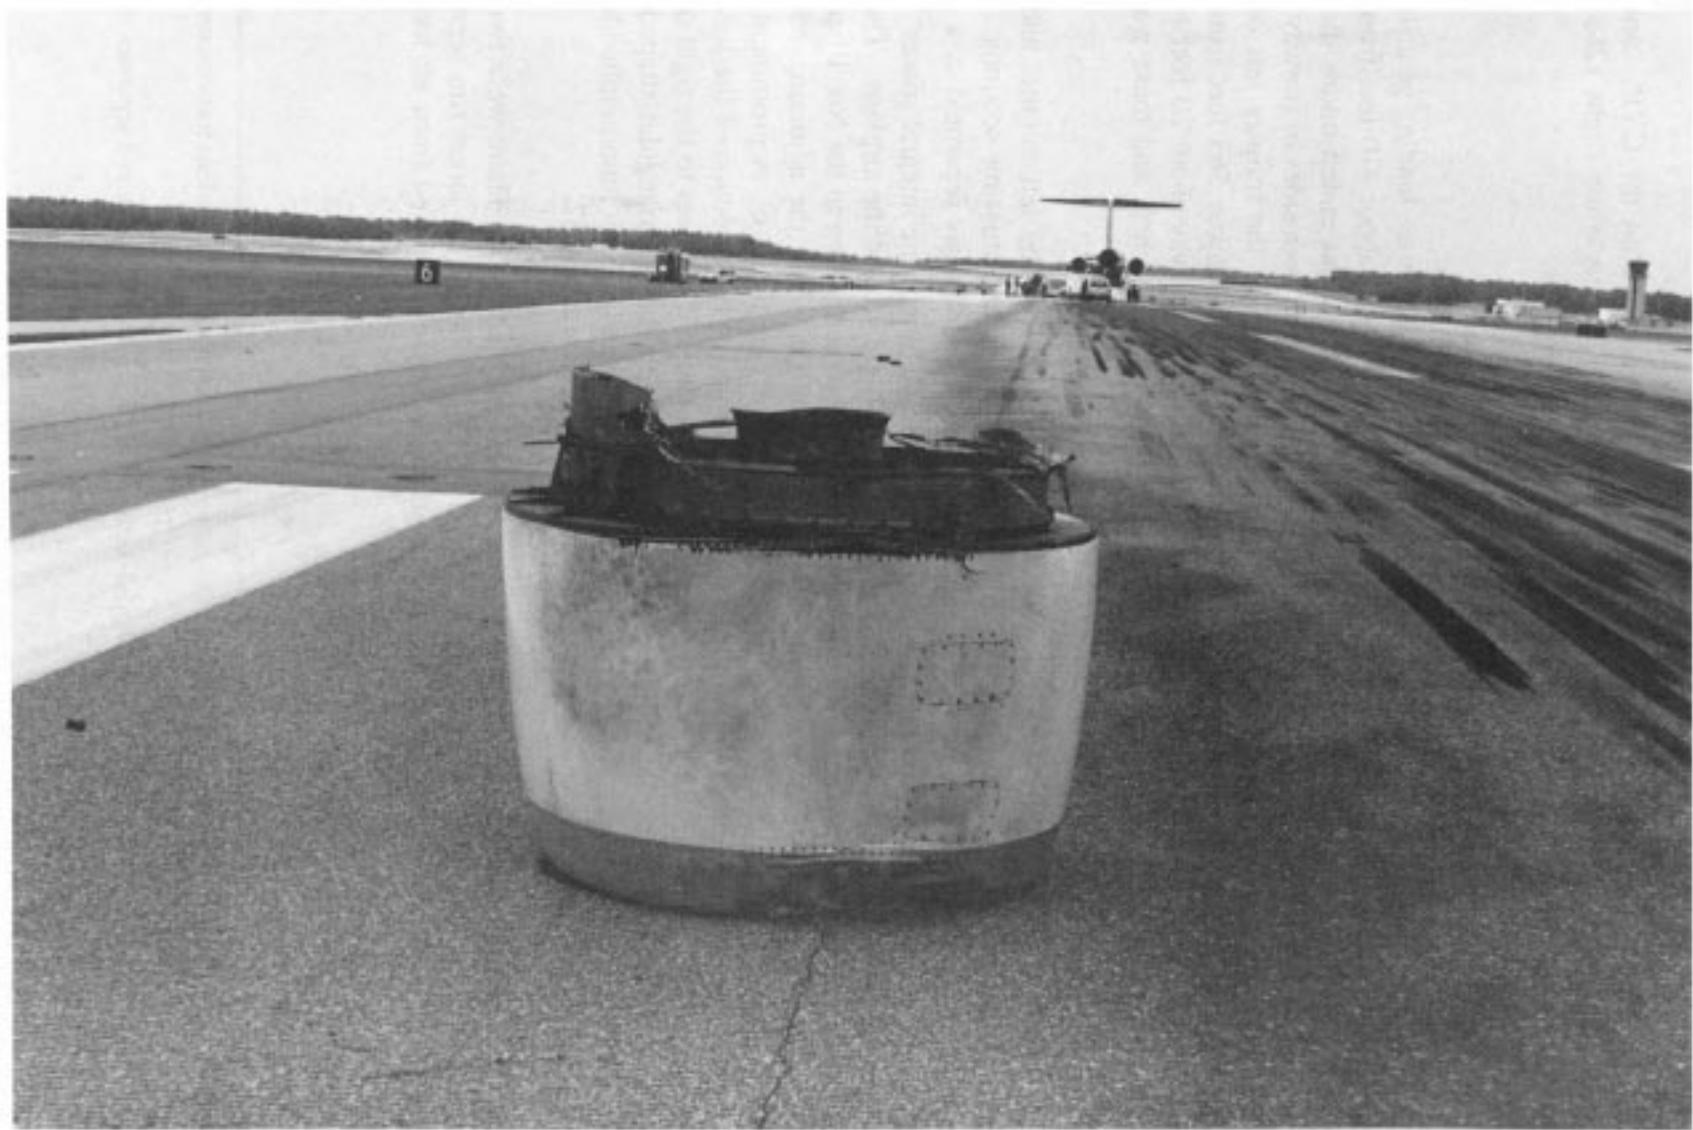
Figure 5.—Left engine nose inlet cowl.

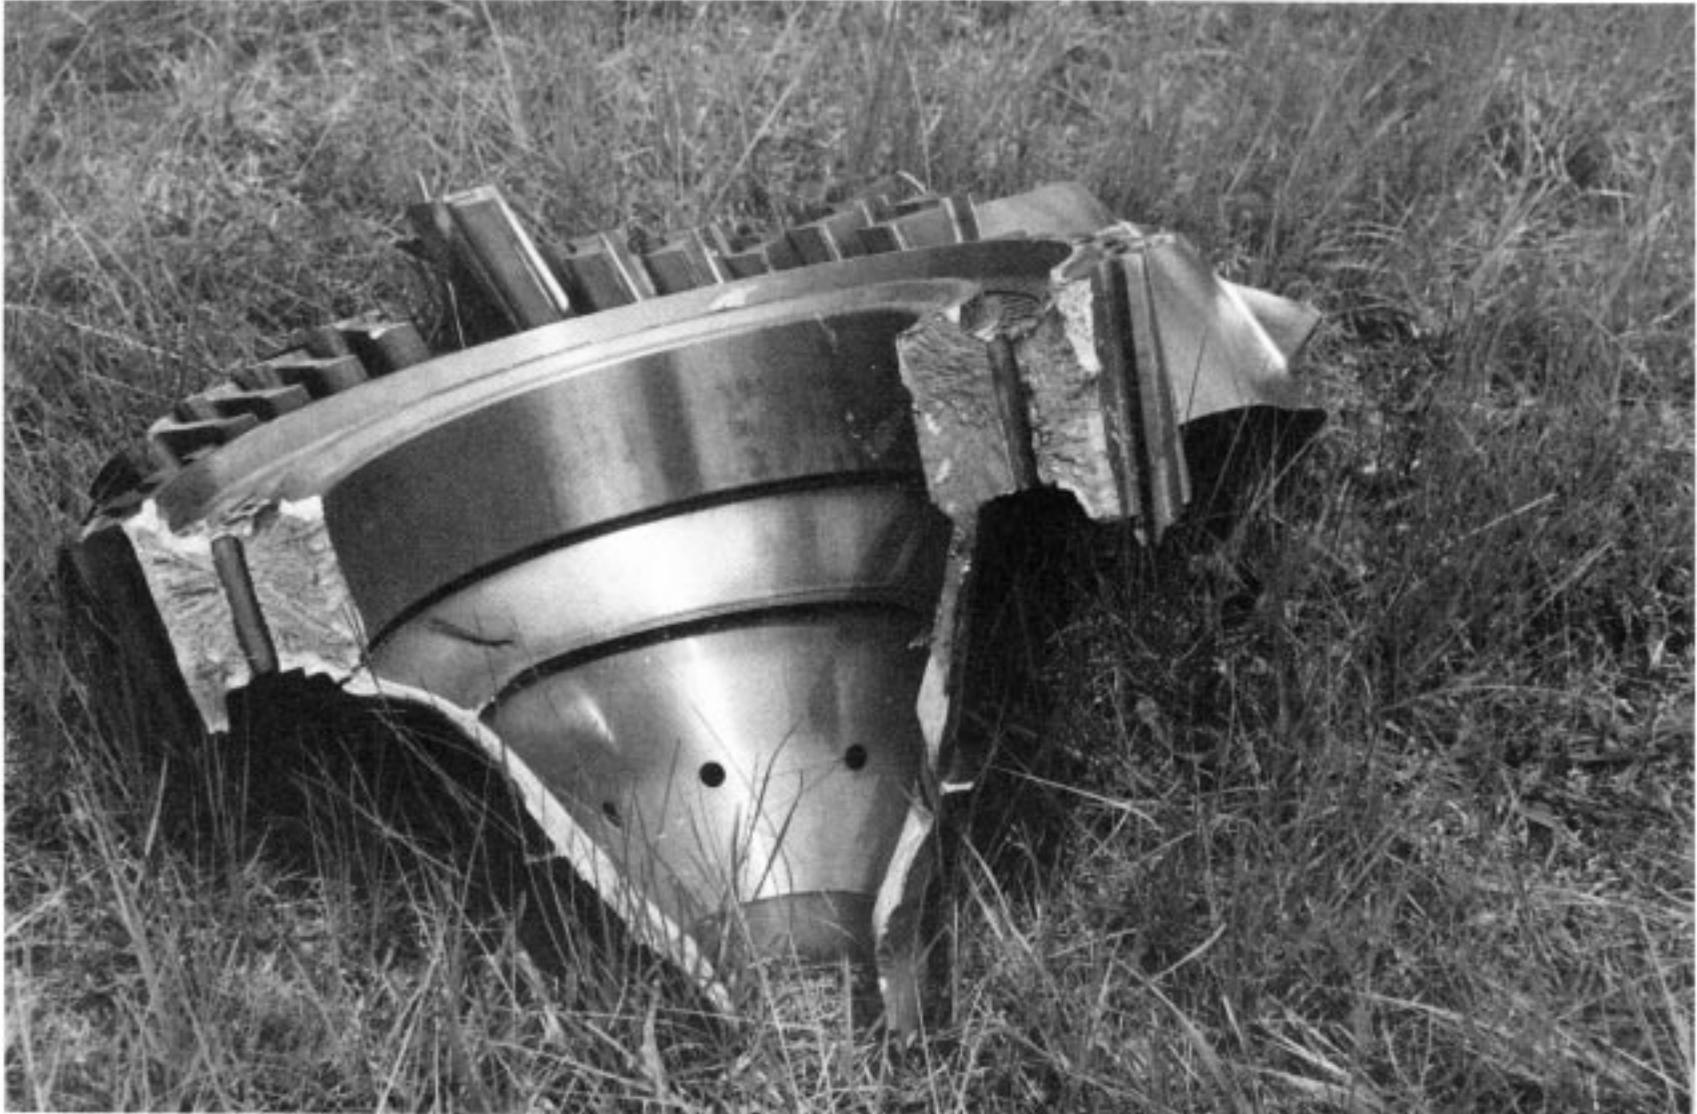
The fan hub fractured through a tierod hole and blade slot. There were two fan blade roots still in place on the small rim segment and 13 blade roots on the larger rim segment. Three of the 13 blades were full length and bent counterclockwise as viewed from aft looking

Figure 6.—Two-thirds of hub rim and adjoining conical section.

forward (ALF).³⁰ A smaller fracture surface was found at the forward section of the conical hub oriented at right angles to the hub axis and extending 360° around the part circumference. The hub rim's fracture surfaces were examined at the accident site by a Safety Board metallurgist and were found to have evidence of fatigue cracking.

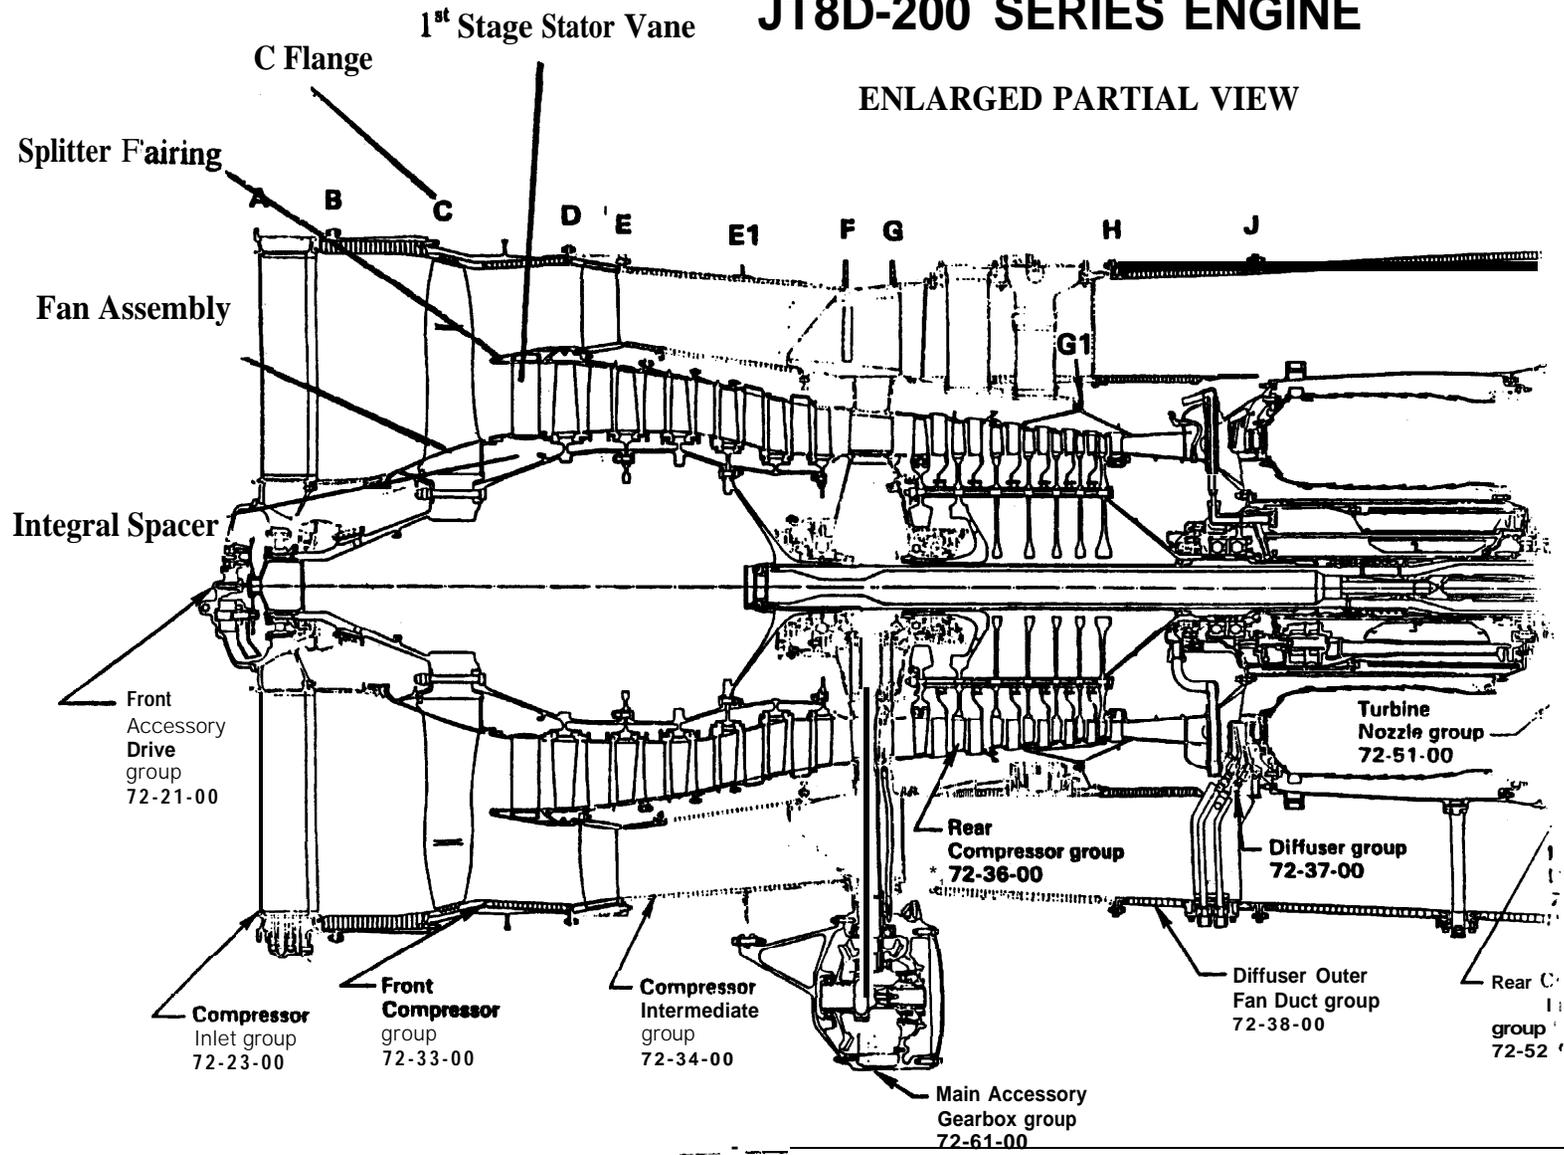
The outer engine case separated at the C flange (see figure 7).³¹ Forward of the C flange, the case remained attached to the cowl. The case was torn and fragmented in two areas (centered at the 1 o'clock and 7 o'clock positions) between the C and D flanges. The 1 o'clock position was missing a segment from the 12:30 to 2 o'clock positions. The case was intact but had been torn loose from the D flange between the 2 o'clock and 3 o'clock positions. A 14-inch circumferential part of the fan rear case was found on the runway 61 feet to the right of the centerline and 441 feet from the runway threshold. Acoustic honeycomb in the fan case area was ripped, torn, or missing in many places. The splitter fairing³² (see figure 7) was missing from the 1 o'clock to the 7 o'clock position. A torn piece of the splitter remained attached at the 5 o'clock position. Twelve first-stage stator vanes³³ were present on the remaining splitter fairing. The inner diameter ends of the vanes were separated from the inner shroud and bent in the direction of rotation.

Figure 7.—Enlarged, partial view of outer engine case of JT8D-200 series engine.

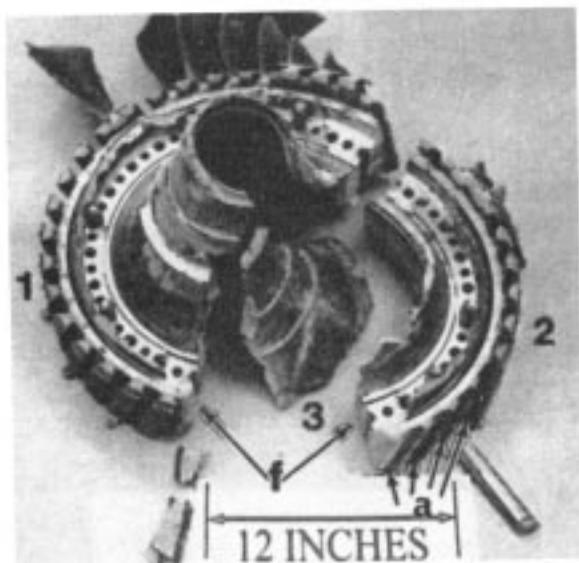
Figure 9a.—Fractured fan hub.

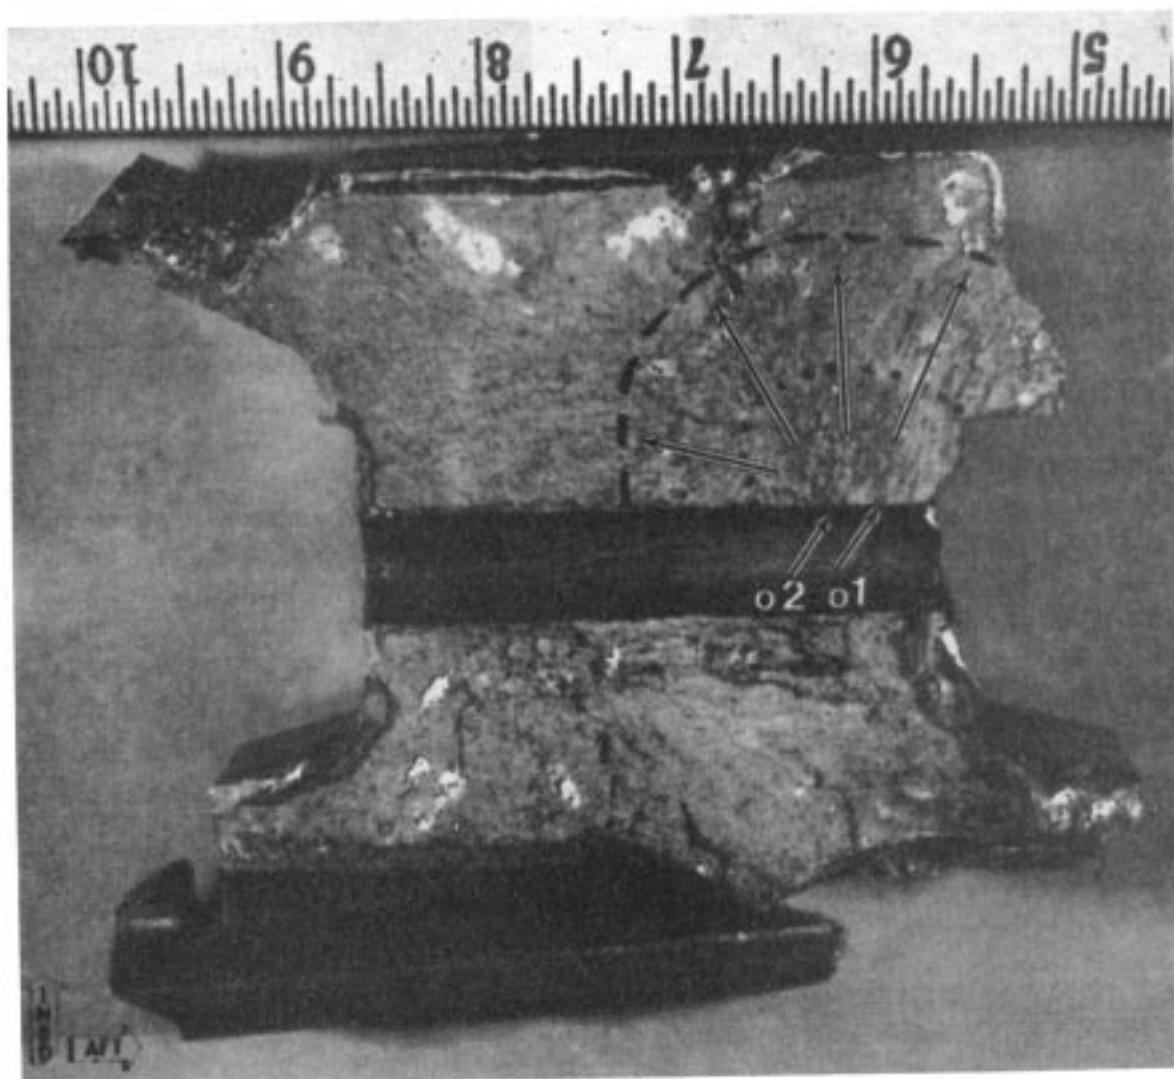
A scanning electron microscope (SEM) examination of the fracture face in the origin areas showed evidence of overstress to a depth of about 0.002 inch adjacent to the hole wall. The overstress fracture region was followed by an area about 0.006 inch deep that contained fracture features consistent with a fast-propagating fatigue crack. From a depth of 0.006 inch to the end of the fatigue region, striations were found consistent with a slower propagating fatigue crack.

Figure 9b.—View of fatigue crack.

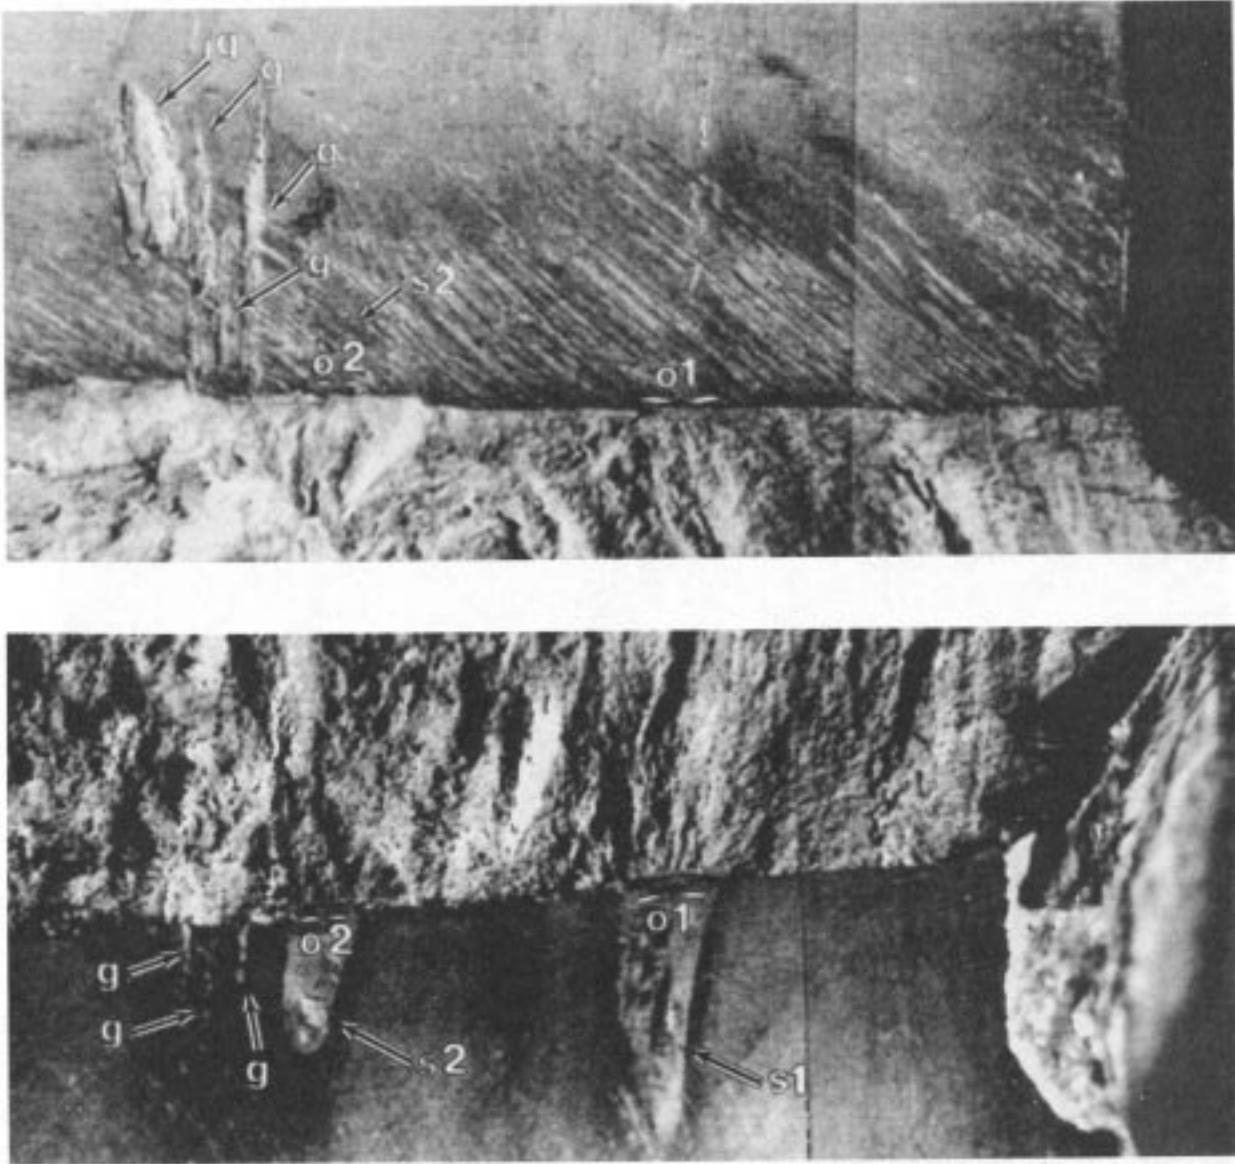
Figure 9c.—Magnified view of fatigue fracture features.

About 12,887 fatigue striations were found in the fatigue fracture region, roughly equivalent to the number of the hub's flight cycles. A portion of the fatigue fracture surface adjacent to the origin area was discolored slightly darker than other parts of the fatigue region. This discolored fracture region extended about 0.7 inch radially inboard from the origin area. At the aft face of the hub, the fracture discoloration extended about 0.46 inch inboard from the hole. Along the hole wall, this discoloration extended about 0.90 inch forward from the aft inboard corner of the hole. The number of striations in the discolored part of the fracture was approximately the same as the number of flight cycles recorded for the hub at the last FPI performed by Delta.

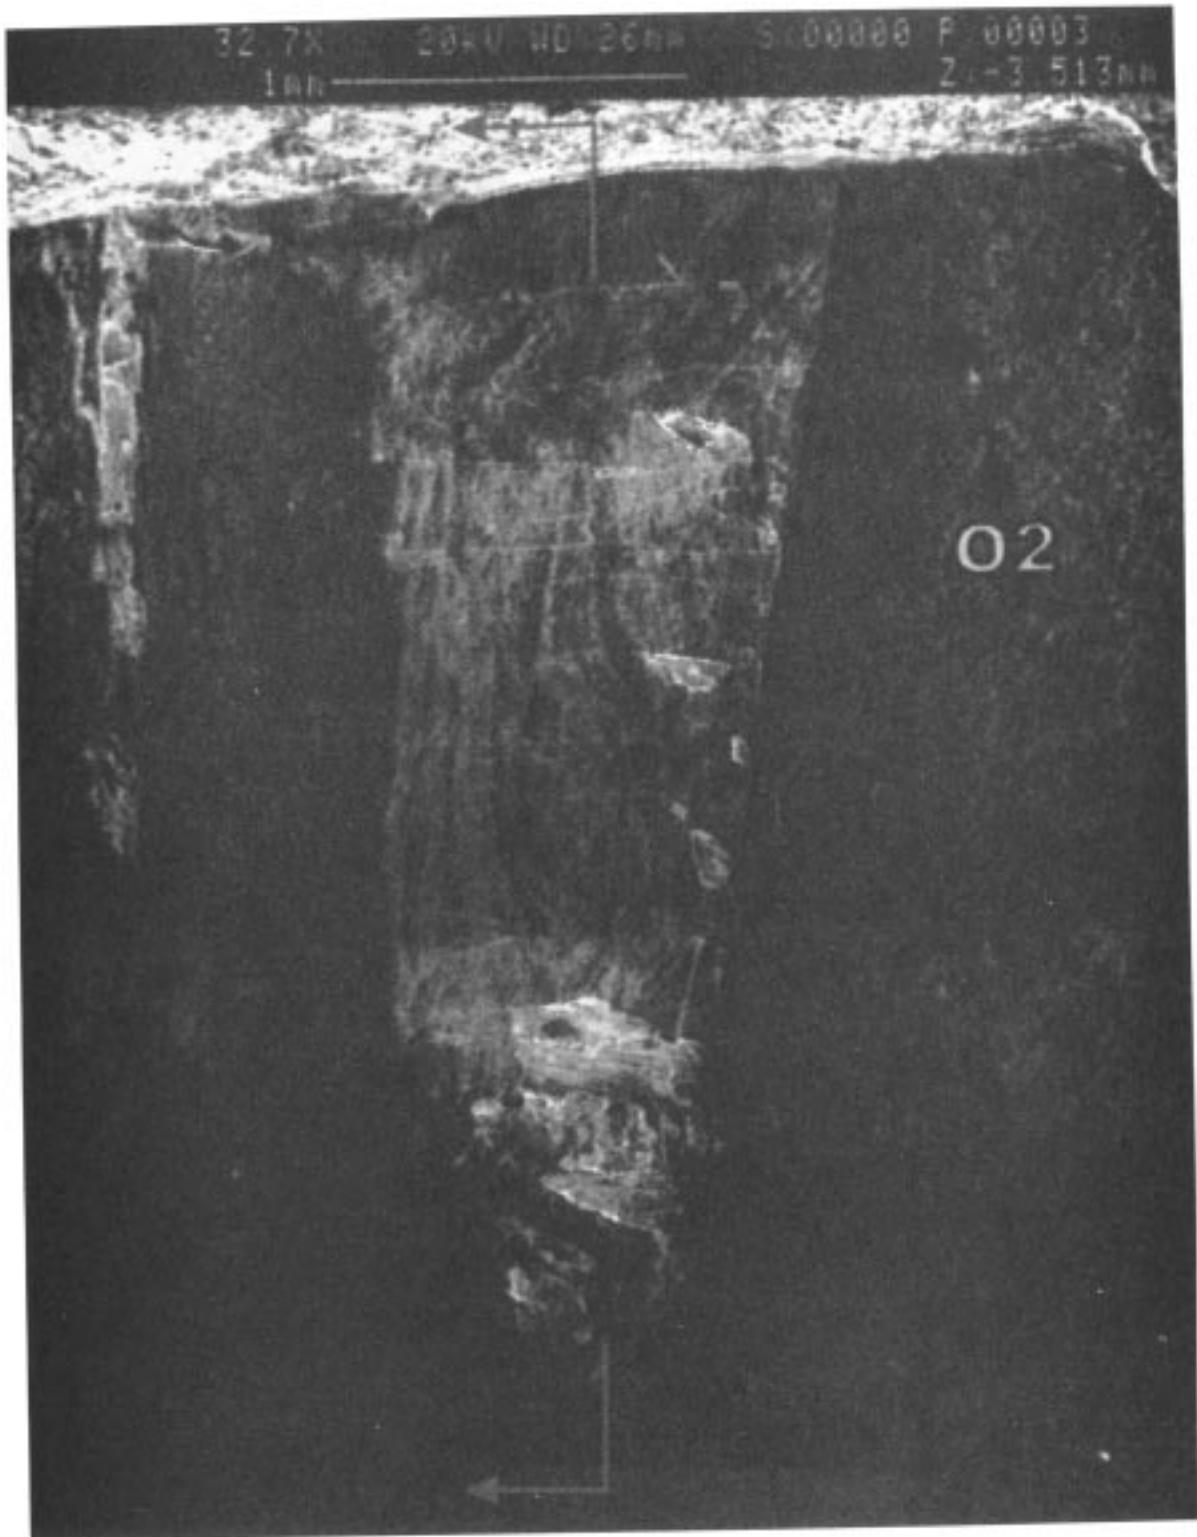
Figure 10.—Magnified view of hole wall.
