NATIONAL TRANSPORTATION SAFETY BOARD

AIRCRAFT ACCIDENT REPORT

UNCONTROLLED DESCENT AND COLLISION WITH TERRAIN
USAIR FLIGHT 427
BOEING 737-300, N513AU
NEAR ALIQUIPPA, PENNSYLVANIA
SEPTEMBER 8, 1994

AIRCRAFT ACCIDENT REPORT
NTSB/AAR-99/01 (PB99-910401)

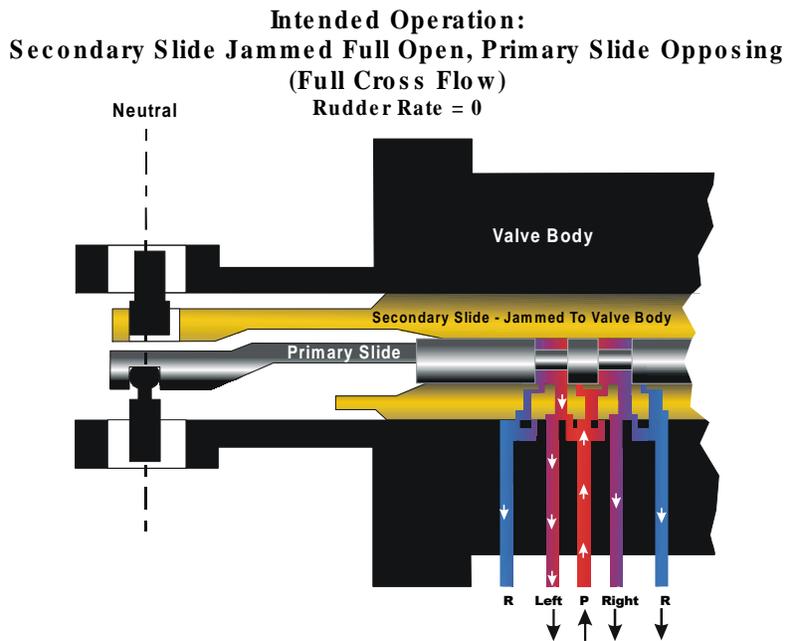
Figure 16. PCU servo valve intended operation with the secondary slide jammed to the servo valve housing and primary slide opposing.

Figures 14 and 15 show normal operation of the servo valve. Figure 16 shows the servo valve with a secondary slide jam (normal operation). Figure 17 shows the servo valve with a secondary slide jam and primary slide in the overtravel condition.

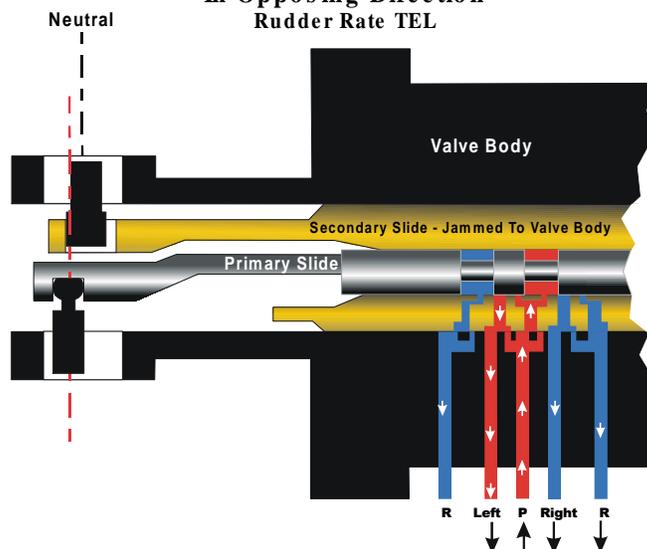
Figure 17. PCU servo valve with the secondary slide jammed to the servo valve housing and the primary slide in the overtravel condition.

**Newly Discovered Failure Effect:
Secondary Slide Jammed Full Open, Primary Slide Over-Stroke
In Opposing Direction
Rudder Rate TEL**

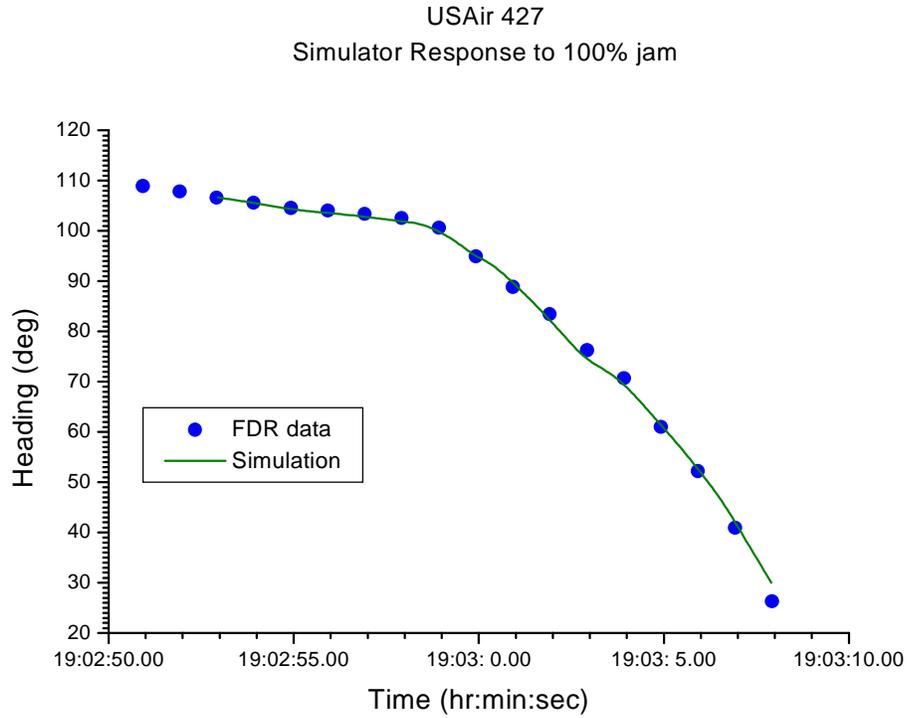
Figure 18d. Heading data for USAir flight 427.

The heading data that resulted from the simulation with the secondary slide jammed to the servo valve housing at the 100-percent position matched the FDR heading data better than simulations with the secondary slide jammed at the other three positions. Control surface position data are presented for the 100-percent jam. The pilot rudder pedal force time history is shown in figure 18a.¹⁷⁶ The rudder surface and control wheel positions are shown in figures 18b and 18c, and the resultant heading, bank angle, pitch angle, and vertical acceleration data, compared with the FDR data, are shown in figures 18d through 18g, respectively.
