# NATIONAL TRANSPORTATION SAFETY BOARD

## AIRCRAFT ACCIDENT/INCIDENT SUMMARY REPORT

NEWARK, NEW JERSEY - - NOVEMBER 13, 1986

NTSB/AAR-87/04/SUM

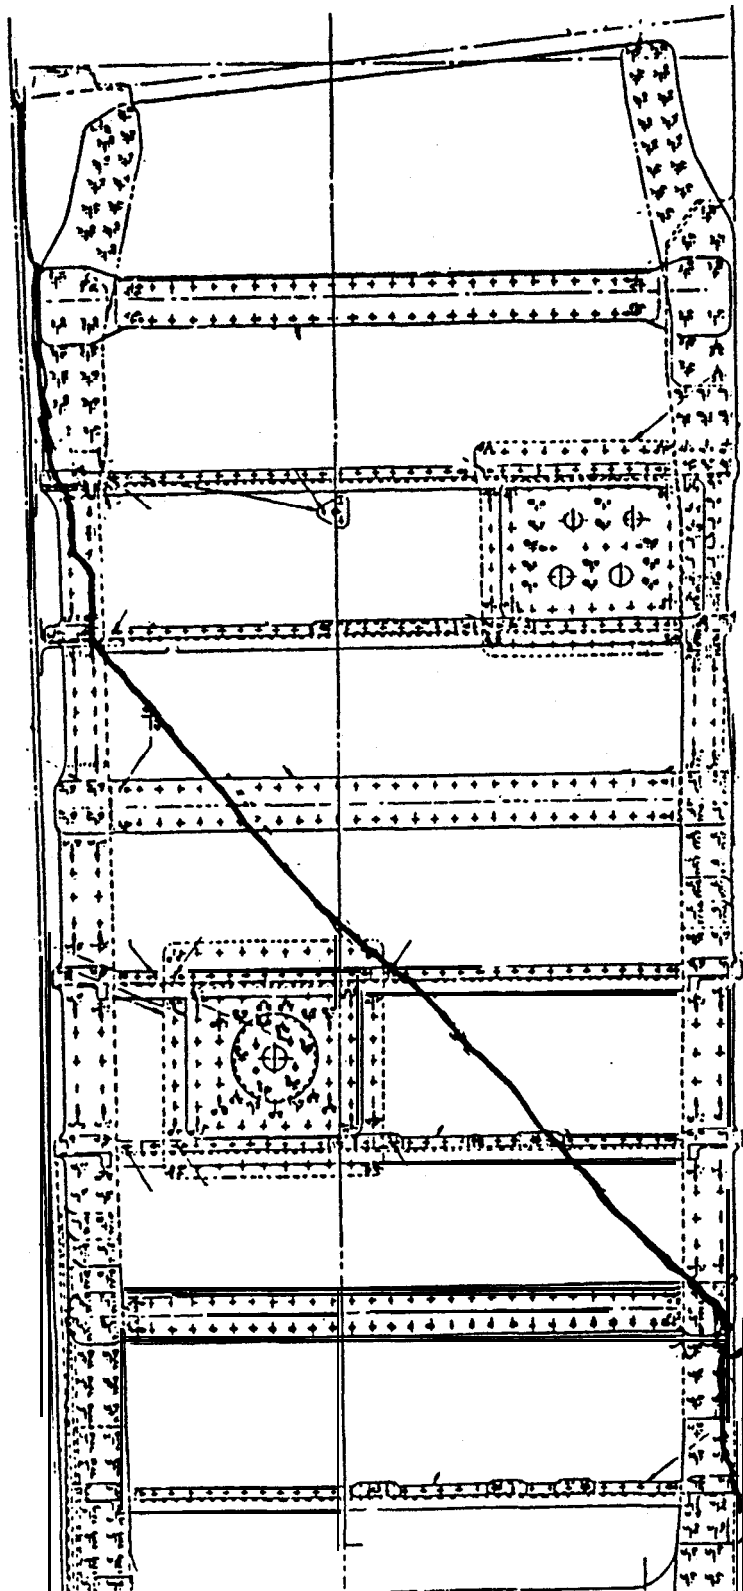
Figure L--Inboard rear spar fracture line.

The airplane sustained substantial damage, which was confined to the right wing and included upper and lower skin panel deformation and the separation of the rear wing spar. The rear spar was separated outboard and diagonally downward, between inboard wing station 241.0 (IWS 241.0) and IWS 293.5. (See figure 1.)

**Inboard Rear Spar Fracture Line-Looking Aft (Left Spar Shown)**

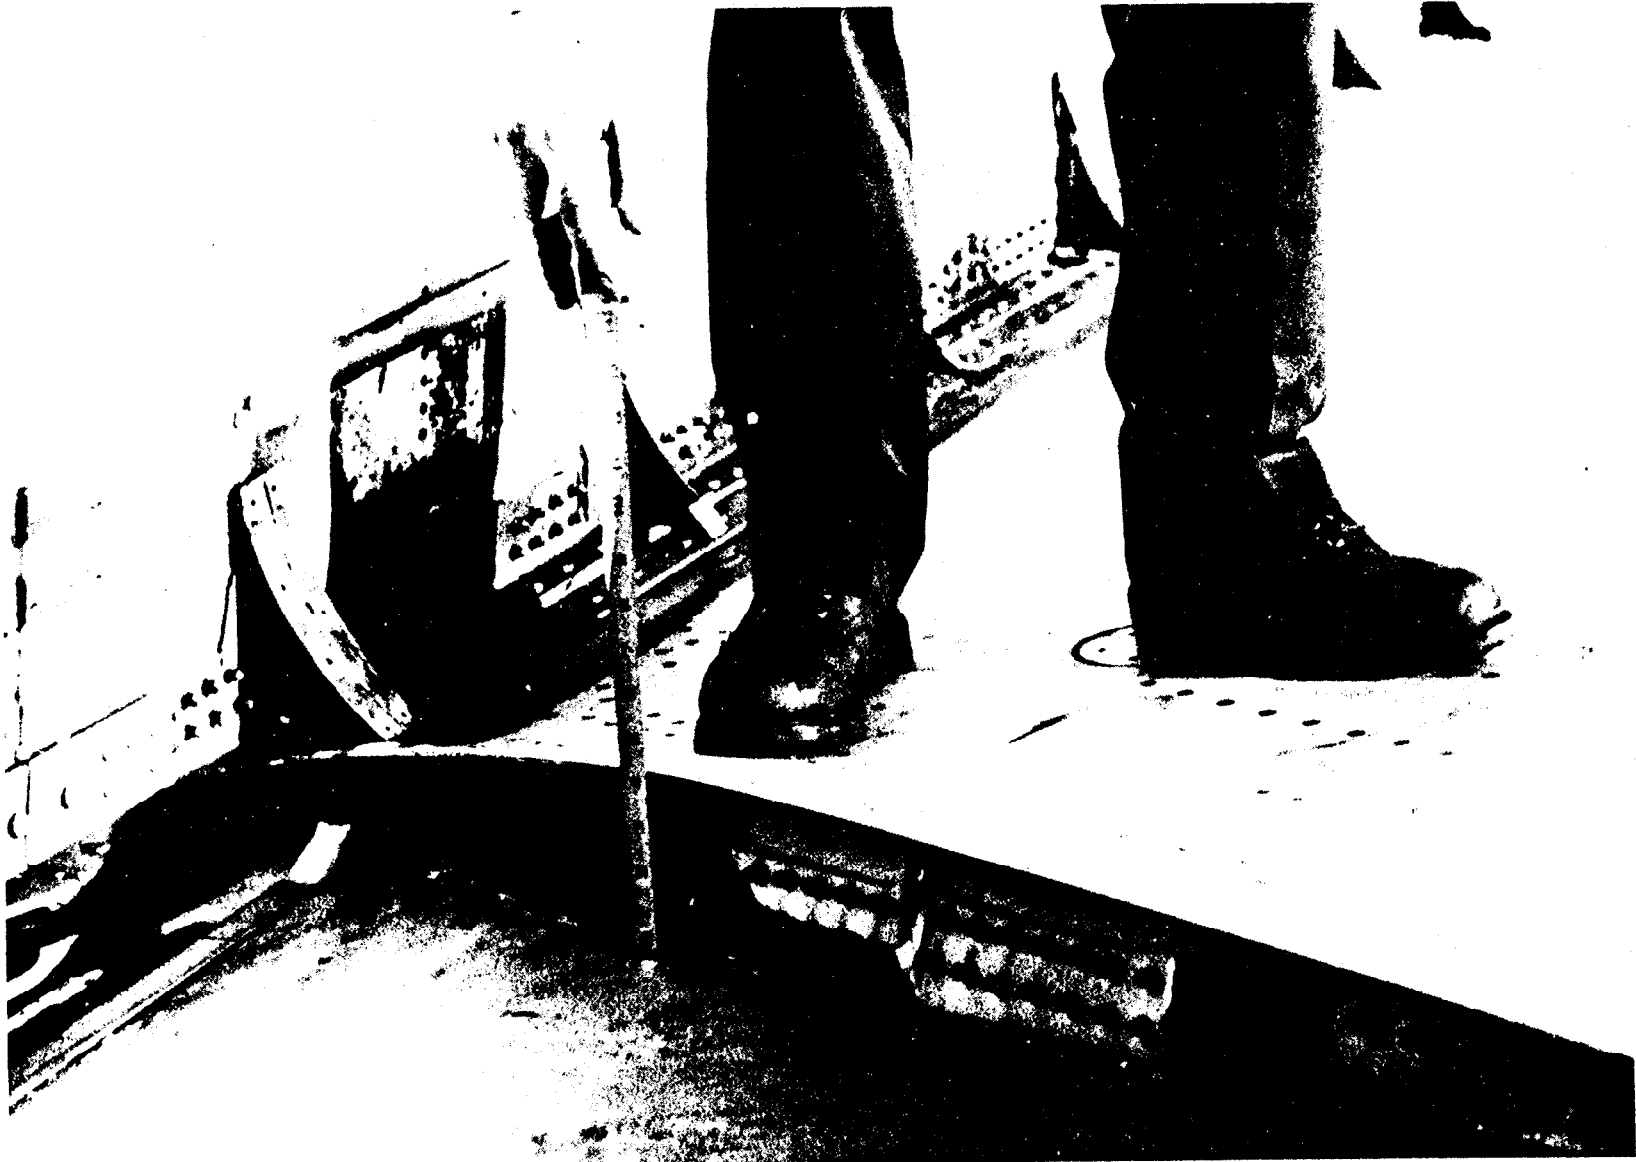
The other damage to the upper wing skin panels at the wing root is shown in figure 3. The wing spar forms the aft section of the wing integral fuel tank; therefore, when the spar separated, fuel leaked from the tank.

Figure 3.--Distortion of rear spar and upper skin of the right wing.

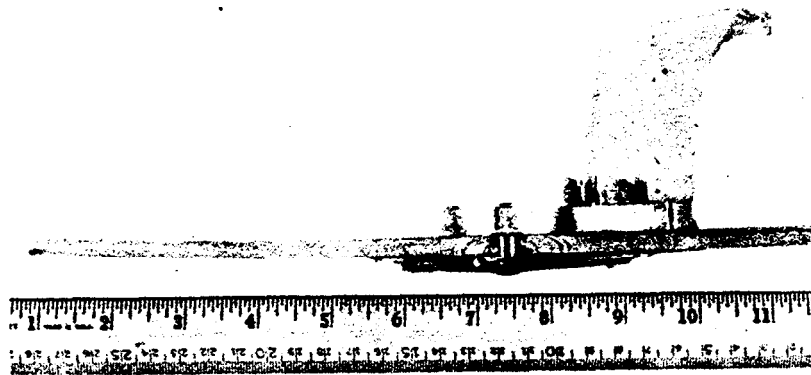
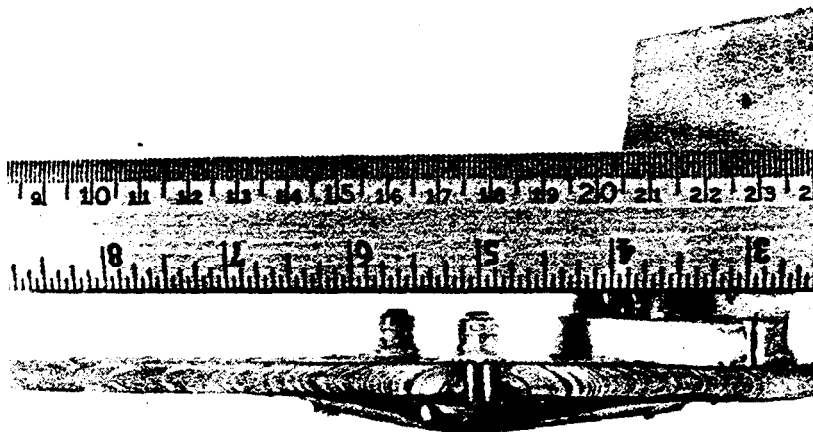
The fatigue cracks initially propagated aft through the web thickness and away from the fastener hole. The fatigue cracks propagated approximately **4 1/4** inches inboard and up, and about **2 3/8** inches outboard and down from the fastener hole. (See figures 4 and 5.) The fatigue crack in the latter stages appeared to be growing rapidly, which is typical of a crack reaching critical crack length. As a result, the total fracture of the rear spar could have resulted from the fatigue region under normal loading conditions. The weakening of the wing structure by the complete fracture of the rear spar was considered critical to the operation of the airplane within the design flight envelope.

Figure 4.--Fatigue crack in rear spar web of the right wing.

The fact that **ADs were** required to institute inspection procedures to detect cracks in other airplanes, and the fact that the fatigue crack was able to propagate to failure without being detected by an approved inspection procedure, **led** the Safety Board to conclude that this deficiency was not adequately considered during the airplane's design.

Require an immediate inspection using methods adequate to detect fatigue cracking of the wing rear spar with emphasis on the spar web at the lower inboard fastener hole for the forward side doubler reinforcing the fuel filler valve hole of all Lockheed L-1011 airplanes having more than a conservatively established threshold of both flight hours and flight cycles; the threshold should be predicated upon the time and cycles on the accident airplane. (Class I, Urgent Action) (A-86-128)

Revise the approved inspection programs for Lockheed L-1011 airplanes as necessary to establish inspection thresholds, intervals, and methods which are adequate to detect fatigue cracking of primary wing structure. (Class II, Priority Action) (A-86-129)

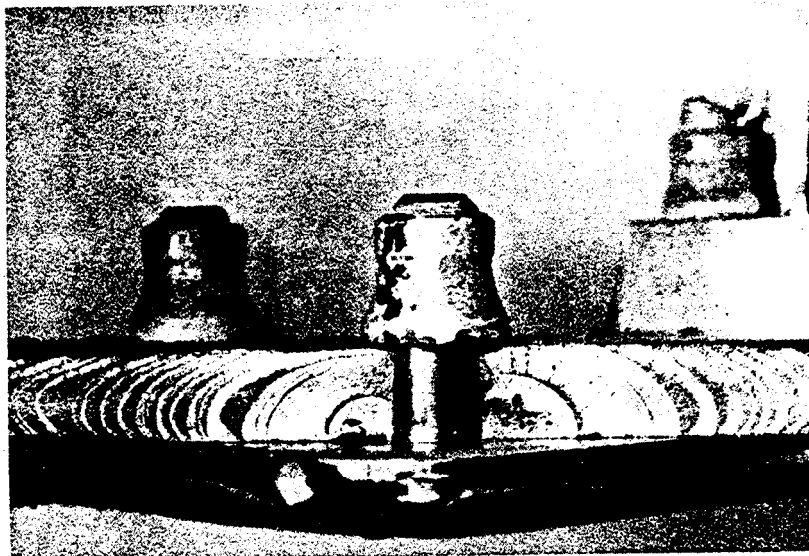
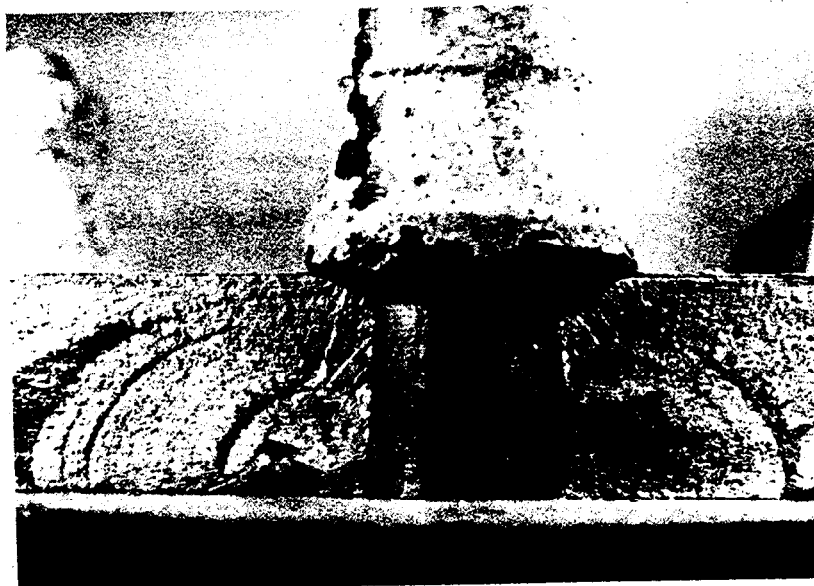
Figure 5.--Fatigue crack in rear spar web of the right wing.
