# NATIONAL TRANSPORTATION SAFETY BOARD

## AIRCRAFT ACCIDENT/INCIDENT SUMMARY REPORTS

BELLEVILLE, ILLINOIS--AUGUST 22, 1987  
PENSACOLA, FLORIDA--DECEMBER 27, 1987

NTSB/AAR-89/02/SUM

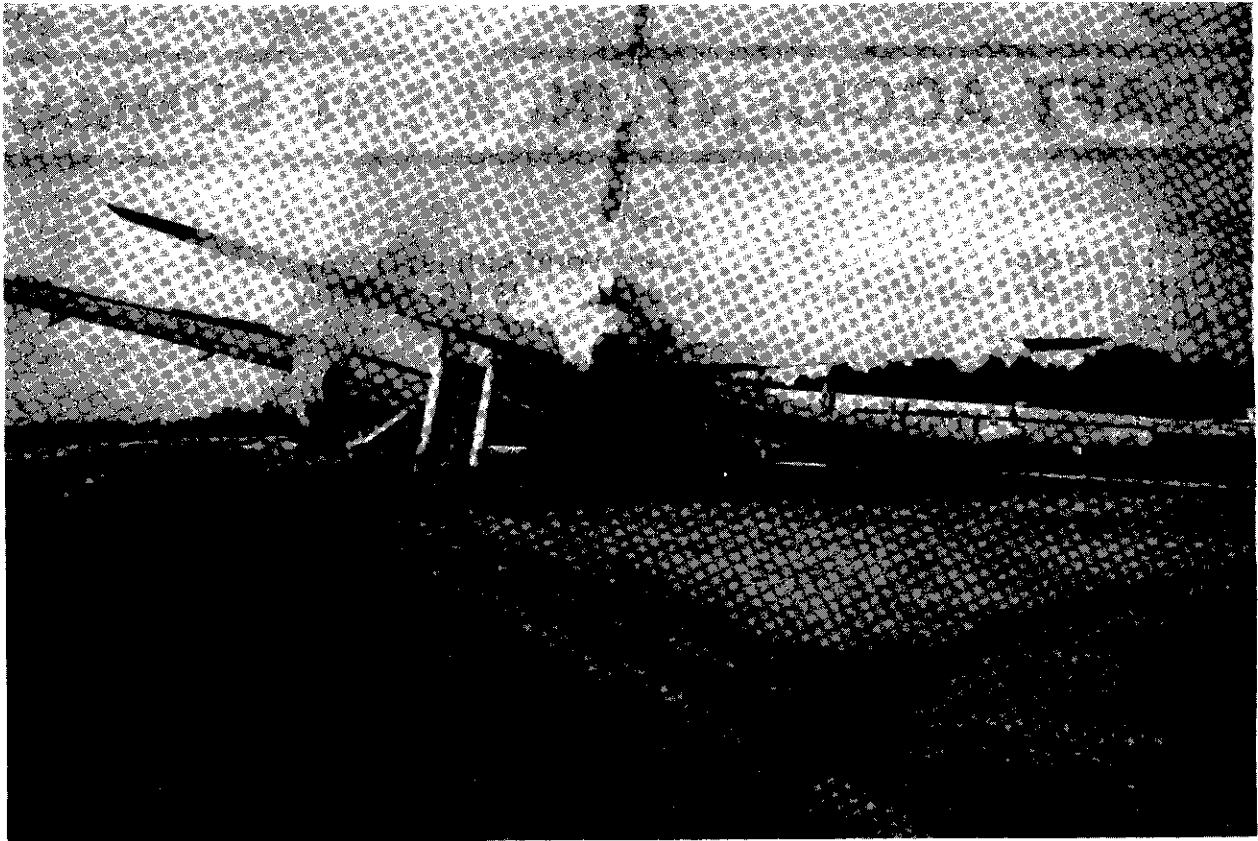
On August 22, 1987, at 1312 c.d.t., a Trans World Airlines (TWA) Boeing 767, N609TW, landed at Scott Air Force Base in Belleville, Illinois, with the right main landing gear fully retracted. The airplane came to rest in a nose-high, right-wing-low attitude with the right engine supporting the weight of the right wing. (See figures 1 and 2.) The 181 persons aboard evacuated using the emergency exits and slides. Three passengers received minor injuries; there were no serious injuries. The airplane sustained minor damage.

Figure 1.--Rear view.

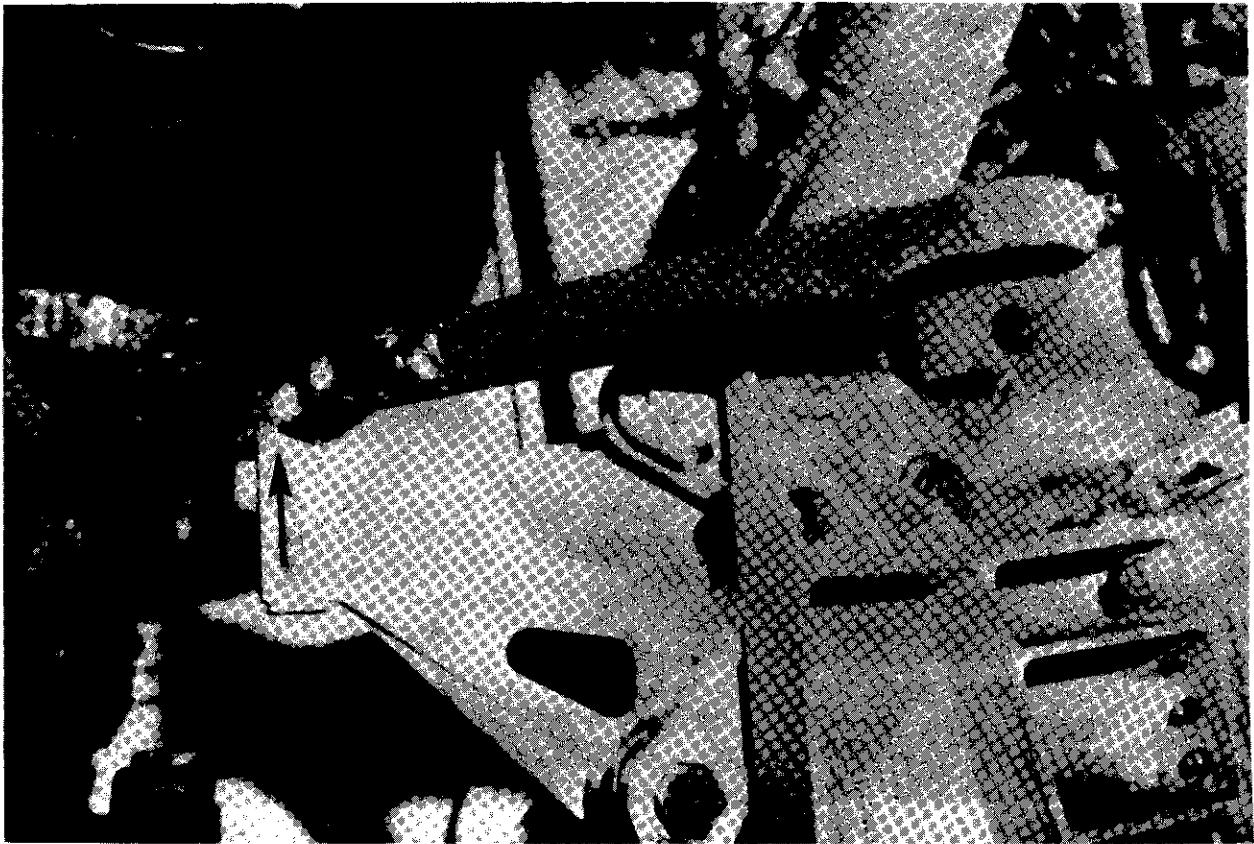
Figure 3.--Brake rod jammed over the gear door pad.  
Arrow shows brake torque arm with the pin missing.

The Safety Board believes that during the installation of the wheel/brake assemblies, the mechanics installed the pin through the end of the brake rod, but only partially into the brake torque arm. The bolt used to secure the pin in the torque arm and prevent it from migrating outward probably was not inserted through the hole in the pin. The Safety Board believes that the brake rod was partially attached to the brake torque arm throughout taxi, takeoff, and gear retraction because the brake stack had not moved in the direction of rotation when brake pressure was applied during taxi; the hydraulic lines were not broken; and the bottom of the brake rod was not marred or scratched from dragging on the ground. However, when the landing gear was retracted, the No. 3 brake rod connector pin would have been head end downward. The Safety Board believes that during the en route phase of the flight, the pin dropped out of the brake torque housing allowing the brake rod to move horizontally until coming to rest on the landing gear door pad, preventing the landing gear from extending before landing.

The National Transportation Safety Board determines that the probable cause of this incident was the improper installation of the No. 3 right main landing gear wheel/brake assembly and the inadequate inspection of the maintenance.

Issue an airworthiness advisory to illustrate the proper procedures for replacement of Boeing 767 wheel/brake assemblies. (Class II, Priority Action) ( A-89-24)

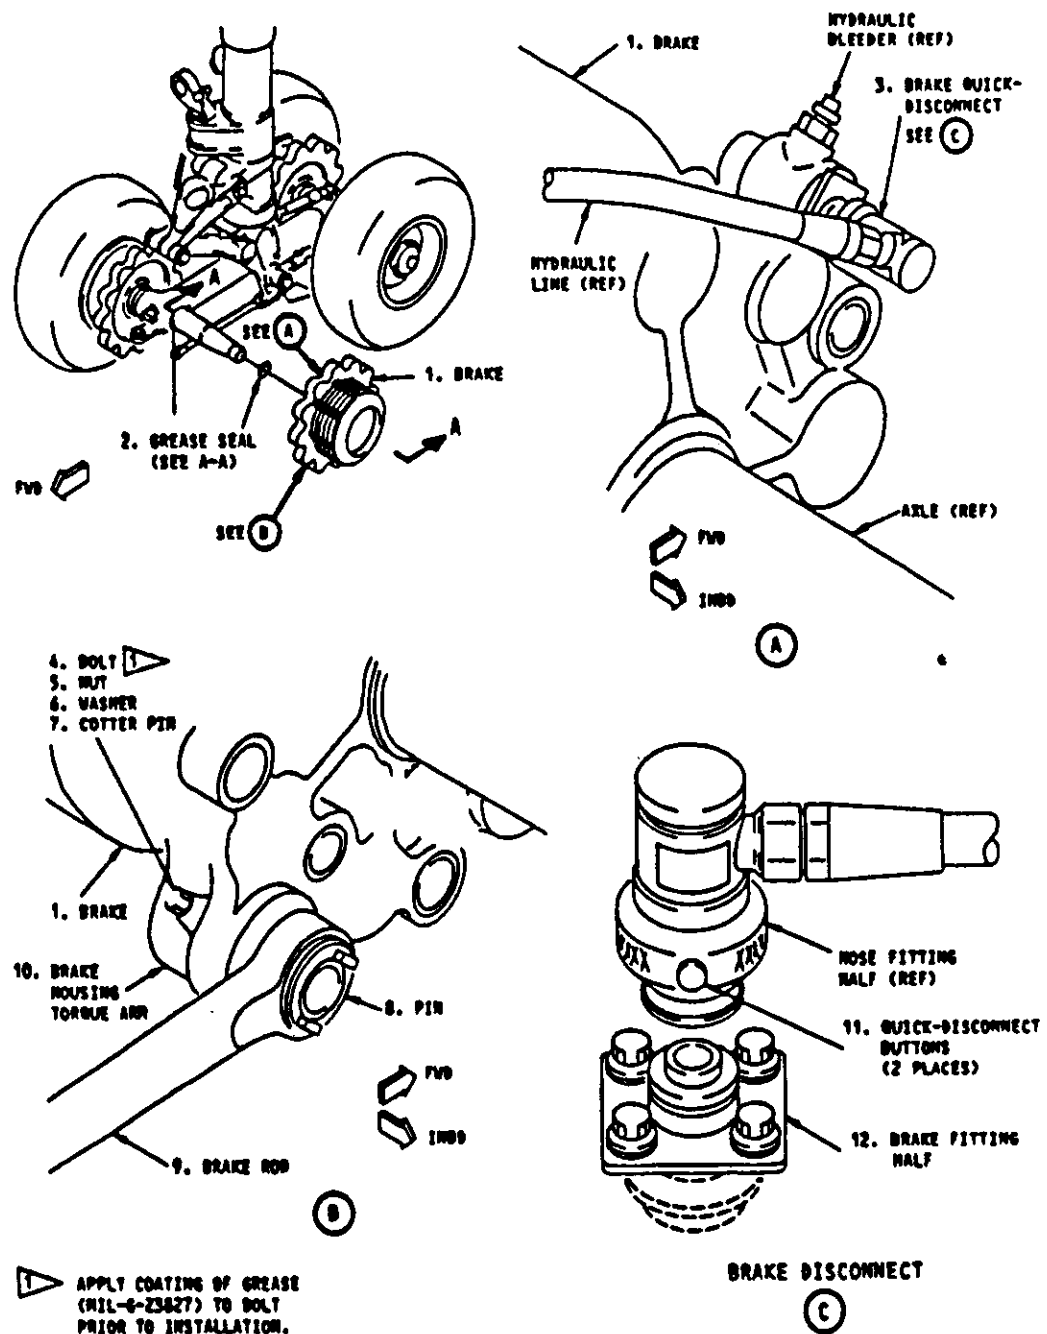
Main Gear Brake Installation  
Figure 401 (Sheet 1)

According to the Boeing 767 maintenance manual, the correct procedure to remove the main gear wheel/brake assembly requires mechanics to first remove the

bolt that holds the pin in the brake torque arm. When the pin is pulled out far enough from the brake torque arm, the brake rod is free to move vertically. The mechanics who changed the brake and wheel at SFO stated that they removed the bolt and then, without the use of a puller, slid the pin out only far enough to free the brake rod from the brake. The free end of the rod was placed on the ground with the pin still retained in the rod.

During the investigation, the Safety Board examined the procedure for removal/installation of the main landing gear wheel/brake assembly. There were specific procedures pertaining to the removal/installation of the assembly that were not clear, and there were inconsistencies in existing nomenclature. These anomalies were discussed with Boeing, and it published and distributed revisions to the Boeing 767 maintenance manual to provide more specific and clear procedures. (See figure 4.) These changes included illustrating a larger and clearer cross section of the axle with the wheel removed, positive identification of the "brake housing torque arm," the listing of a "cotter pin" as a part of the pin retaining bolt assembly, and a procedure to re-install the pin and retaining bolt to the brake torque arm housing.

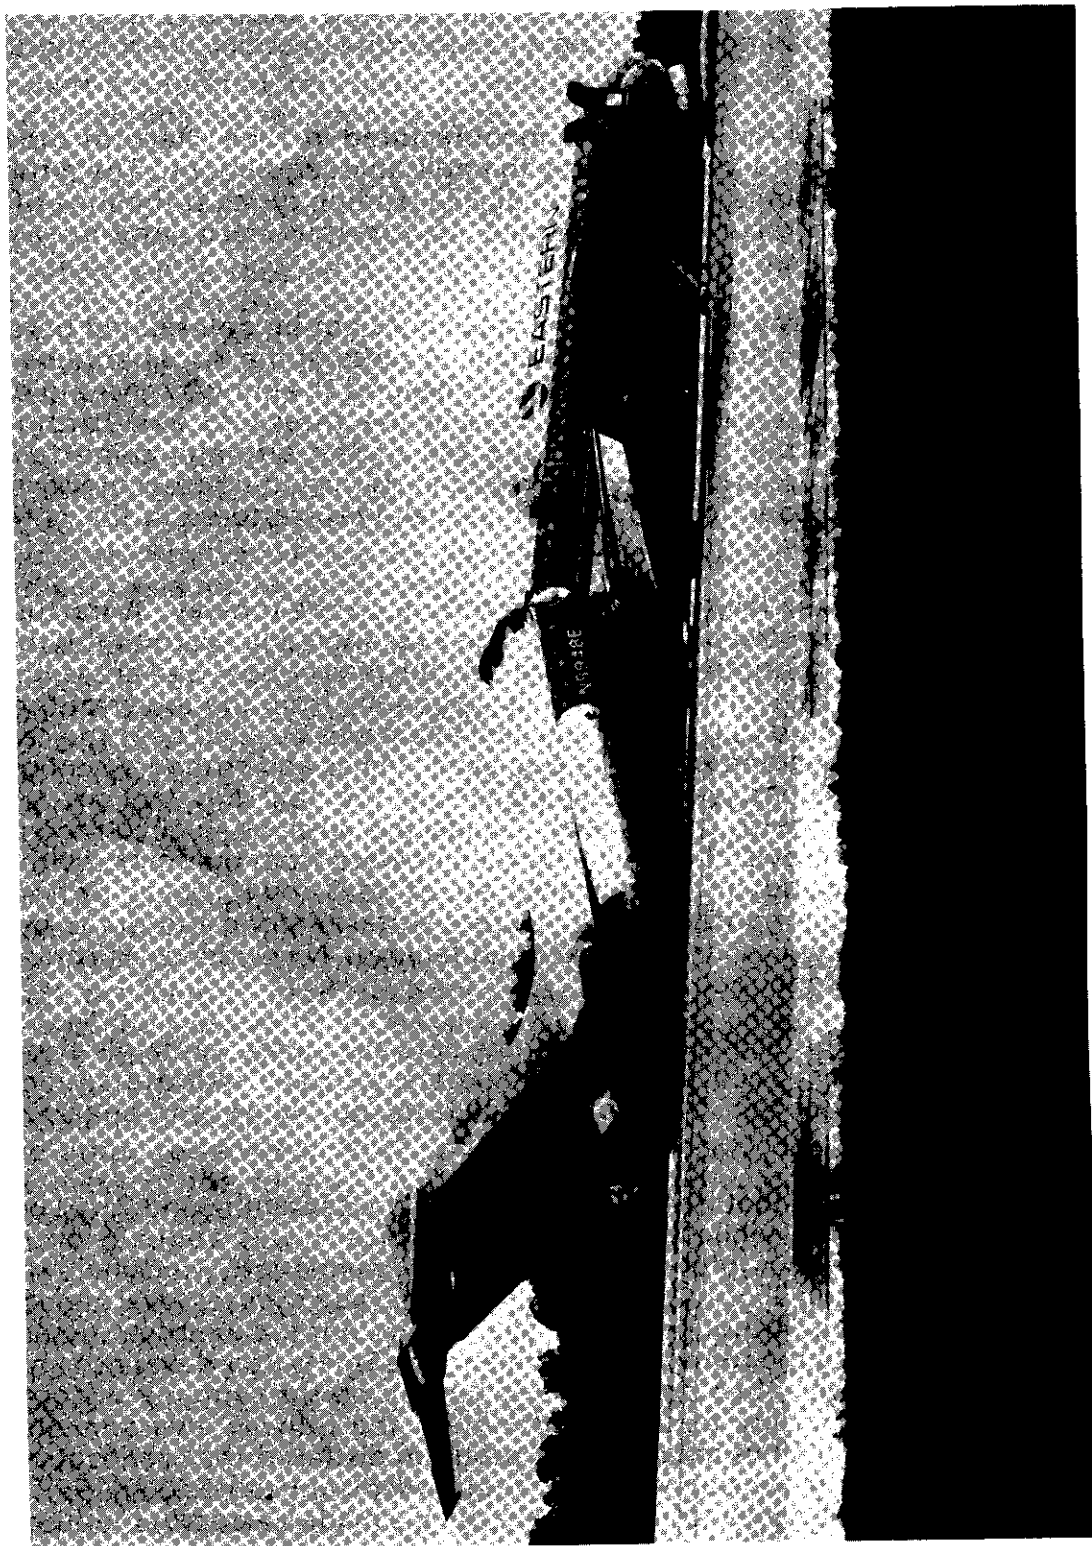
EA573 stopped with the lower empennage resting on the runway. A fracture in the top of the cabin originated at fuselage station 813, angled forward to the top of the cabin windows, and continued downward into the main wheel well areas. In the left wheel well, the aft bulkhead was cracked diagonally from the lower outboard corner to the upper inboard corner, and the keel beam was buckled near the center of the wheel well. Broken and upwardly displaced frames and stringers, and sheet metal tearing and abrasions were observed where the tail skid and aft lower fuselage were in contact with the runway. Inside the airplane, a circumferential separation between seat rows 21 and 22 extended upward from the floor. With the tail resting on the ground, the cabin area aft of seat row 21 was deflected downward about 20° (see figure 1.) The fracture surfaces along the break in the fuselage structure were typical of static overload failures. No evidence of corrosion or preexisting cracks were found.

Figure 1.--Side view of fuselage after the hard landing.
