Aircraft Accident/Incident Summary Report - Midair Collision  
Involving Lycoming Air Services Piper Aerostar PA-60 and  
Sun Company Aviation Department Bell 412  
Merion. Pennsylvania, April 4, 1991

## AIRCRAFT ACCIDENT/INCIDENT SUMMARY REPORT

MIDAIR COLLISION INVOLVING  
LYCOMING AIR SERVICES PIPER AEROSTAR PA-60 AND  
SUN COMPANY AVIATION DEPARTMENT BELL 412,  
MERION, PENNSYLVANIA  
APRIL 4, 1991

ADOPTED: September 17, 1991  
NOTATION 5489A

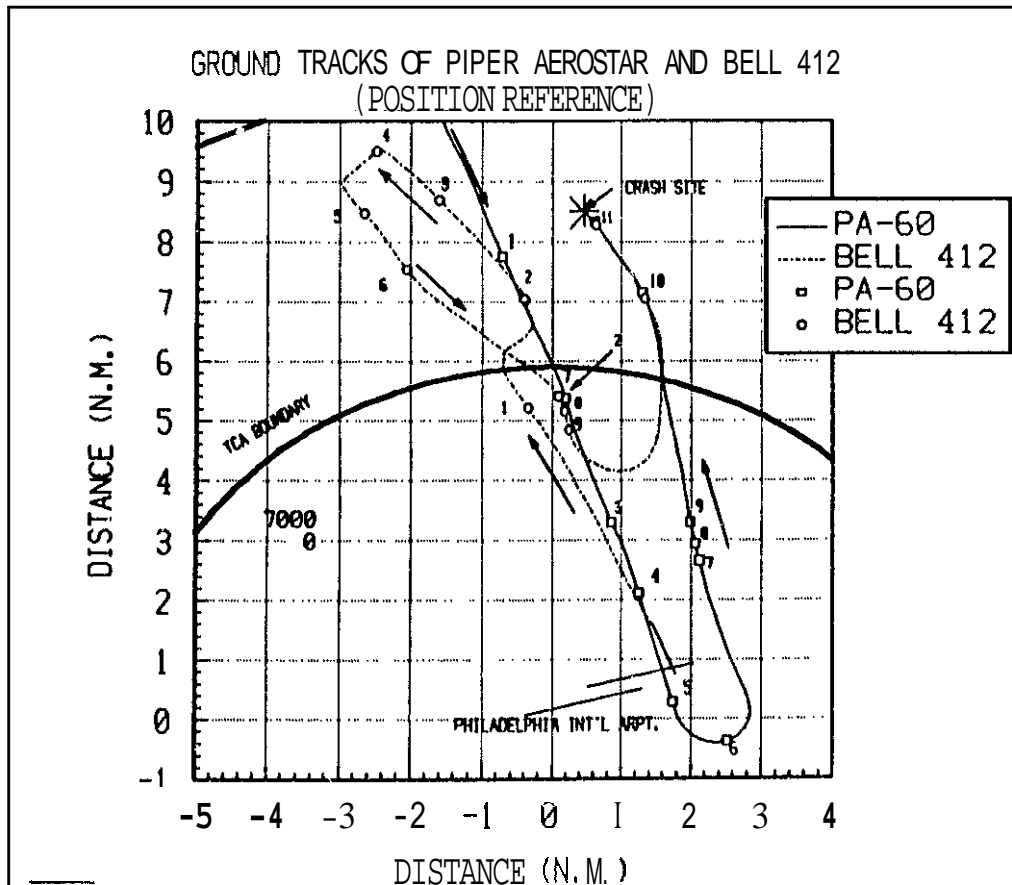
Figure 1.--Ground tracks of N3645D and N785.

Figure 1 represents the ground tracks of N78S and N3645D. Since the encoded altitude (Mode C) coordinates of the radar data have a resolution of 100 feet for a tolerance of plus or minus 50 feet, it was not possible to develop definitive plots of the altitude and airspeed profiles of the two aircraft. However, within the accuracy limits of the data, it would appear that their altitudes and airspeeds were relatively constant during and after the join up maneuver, although there were variations in the altitudes for both aircraft, including a possible gain in altitude by N78S just prior to the collision. Since the helicopter was behind and below N3645D, it would have been virtually impossible for either the captain or first officer of N3645D to maintain a continuous observation of N78S. This situation was further complicated by the need to maintain visual contact with the antenna towers that were nearly directly ahead. The Safety Board believes that during the join up and while the crew of N78S was inspecting the landing gear, it would have been incumbent upon the pilot of N3645D to maintain a constant altitude and airspeed. Such action would have minimized the efforts of the pilots of N78S to maintain position with N3645D. However, the pilot of N78S had a responsibility to maintain a safe distance from the aircraft to allow for any possible deviations in the flightpath of N3645D.

- 1) N3645D "we don't have a nose gear indication"
- 2) N3645D "I can tell it's down but I don't know if its locked that's the only problem"
- 3) lower "if you want to make it pass by the tower maybe we can take a look at it"

- 1) N78S "tower seven eight sierra could ah take a real close look at that if you want"
- 5) lower "gear looks down... I've got a helicopter north of the airport ha said he could take a look at it if you like"

- 6) Tower "that helicopter is about a mile south of the airport... '11 point ha out as you get closer"
- 7) N3645D "four five delta has the hallcopter in sight"

- 8) lower "helicopter seven eight sierra the aerostar is on your left northbound"
- 9) N78S "we have the aerostar w'll uh we'll turn left and follow him northbound and take a look at the gear"

- 10) N78S "aerostar we're gonna pass around your right side now and take a look at everything as we go by"
- 11) N78S "everything looks good from here"

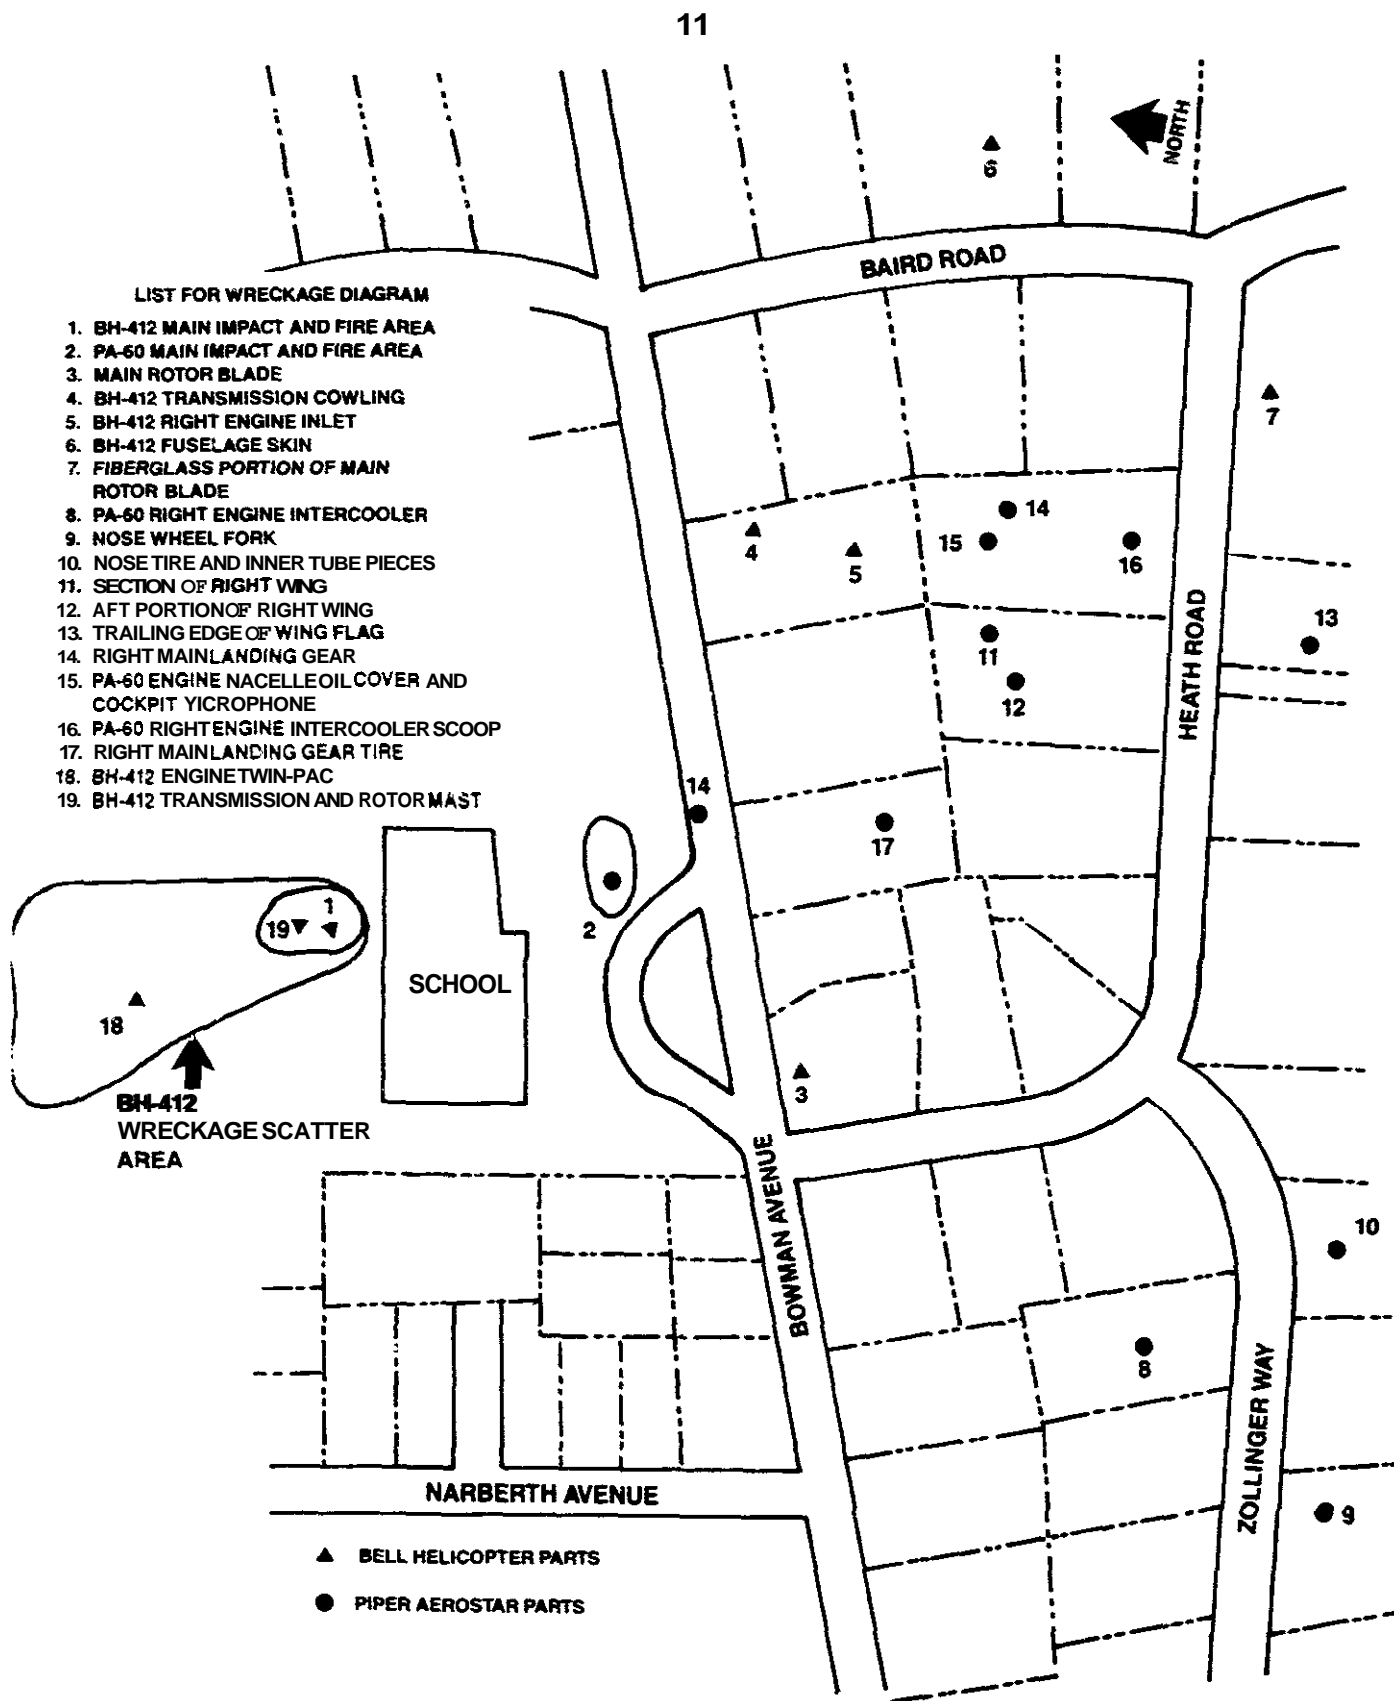
Figure 2.--Wreckage diagram.

Figure 2 shows the wreckage diagram and relative positions of the two aircraft on the ground. Numerous parts of both aircraft were located on residential properties near the school. A piece of the helicopter's main rotor blade, the most distant component found, was about 1,000 feet southeast of the main helicopter wreckage. The airplane's nose wheel fork was located about 875 feet southwest of the main airplane wreckage. Additionally, the right main landing gear had separated from its wing structure and was found 500 feet southeast of the main wreckage.

Inspection of the nose landing gear of N3645D revealed that the gear assembly had separated from the airplane structure during the collision sequence. The majority of the assembly, including the oleo strut, was found near the main wreckage. The drag link was found 675 feet southwest of the main wreckage. The tire remained attached to the rim and was 750 feet southwest of the main wreckage; however, a section of the tire, approximately 2 inches below the edge of the hub had been severed and was completely missing. The cut was very clean as if it was made by a sharp object. The hub and tire exhibited no evidence of foreign material, paint transfer, fire, or heat damage.

The nose gear down-lock micro switch remained attached to the strut. Subsequent testing of the switch revealed normal operation. Damage to the nose landing gear and linkage did not allow a functional check of the position indicating system. The landing gear indicator panel was recovered from the wreckage. However, no useful information could be obtained because of impact and fire damage. The tire for the right main landing gear was located 250 feet south of the main wreckage and was cut from tread to bead on one side and was torn on the other side. The wheel hub rim had a sharp impact mark that aligned with the cut on the tire. Neither the tire, wheel, nor landing gear assembly exhibited any fire or heat damage. No foreign material or paint transfer was noted on the tire or rim.

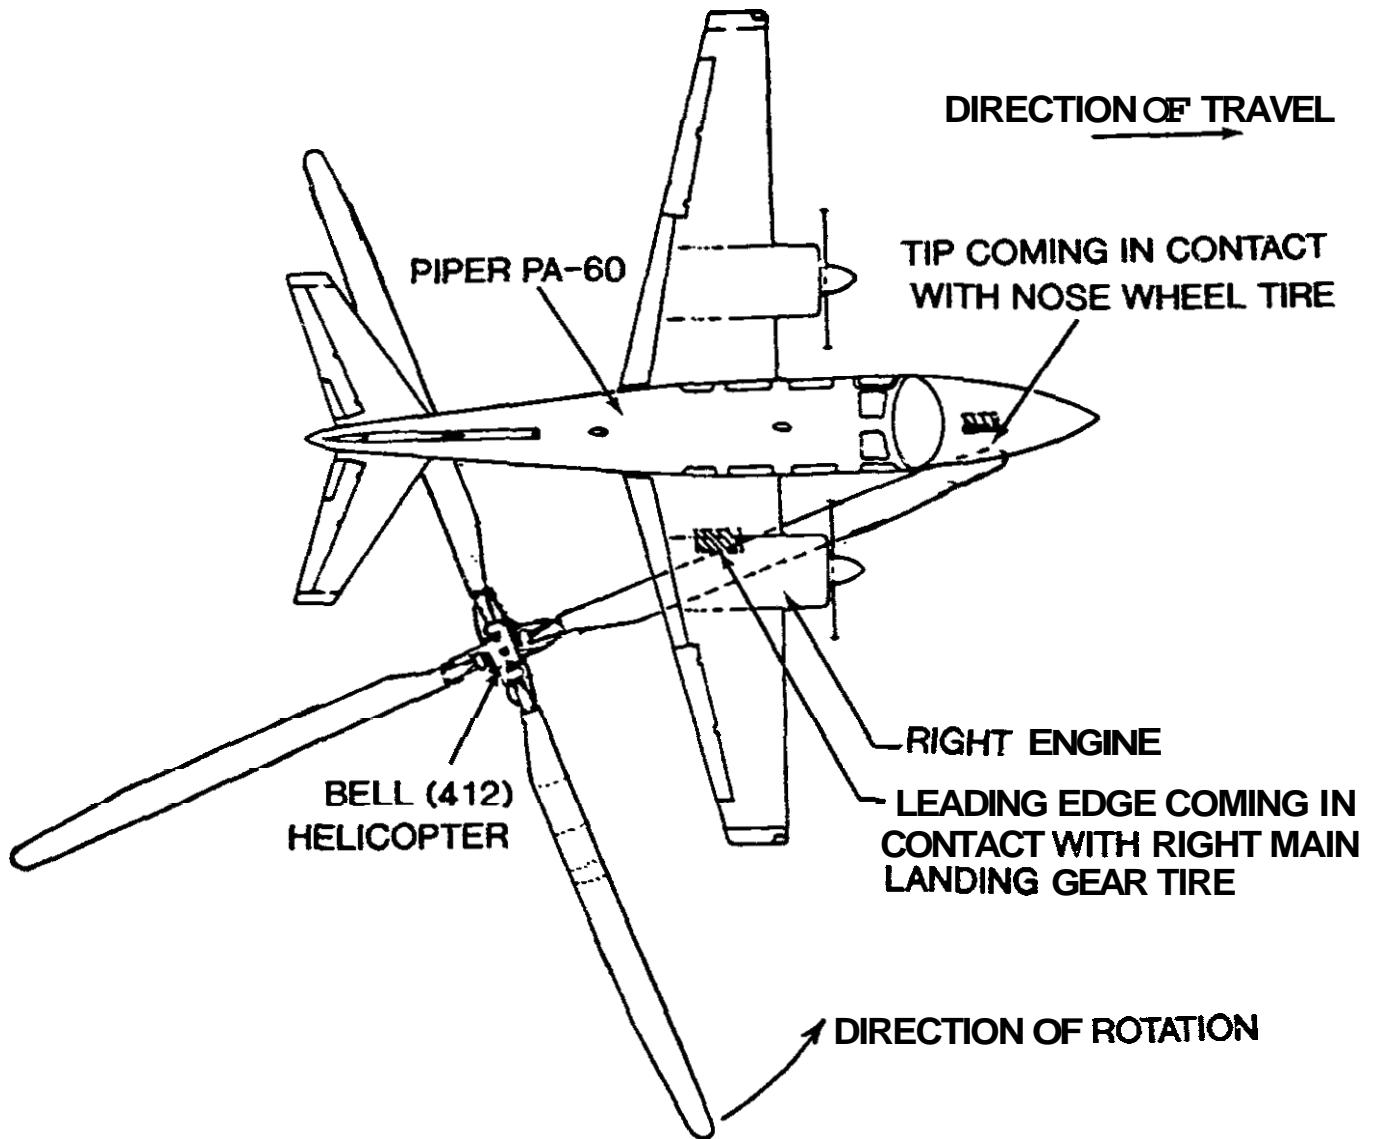
Figure 3.--Relative positions prior to collision.

One of the four rotor blades on N78S had separated from the main rotor hub assembly and was 450 feet southwest of the main wreckage; it was bent in two areas, and a large portion of the fiberglass trailing edge was missing. There was no fire damage to the blade. Rubber transfer marks were observed on the leading edge of the blade from its tip to 16 inches inboard. A portion of the blade's leading edge was cut 82 inches inboard from the tip. Rubber and metal slash marks, and a dent 13 inches long, were observed 150 inches from the tip. Another blade was also detached from the rotor head and was located near the wreckage; the tip of the blade (4 inches long) was broken and missing. The blade was slightly bent and contained oil marks 22 inches from its tip. The leading edge, from 90 to 132 inches inboard of the tip, was completely destroyed. The other two blades remained attached to the main rotor hub assembly and displayed multiple breakages and fire damage. Evidence of slash or impact marks could not be found on the blades because of extensive fire damage.

Figure 3, based upon the impact marks found on the helicopter's rotor blades and the marks on the airplane's tires, indicates the position of the airplane relative to the helicopter's main rotor blade. It was not possible to develop an exact orientation of the two fuselages to each other or their positions relative to the ground at the time of the collision because of the large number of indeterminate variables involved. Additionally, because of the dynamics of the collision and possible gyrations of the helicopter's damaged main rotor, the investigation was unable to determine the exact breakup sequence following the initial rotor blade impact.
