AIRCRAFT ACCIDENT/INCIDENT SUMMARY REPORT

LOSS OF CONTROL
BUSINESS EXPRESS, INC.,
BEECHCRAFT 1900C N811 BE
NEAR BLOCK ISLAND, RHODE ISLAND
DECEMBER 28, 1991

Accident No. :	NYC-92-FA-053
Airplane Owner/Operator:	Business Express, Inc.
Airplane Type:	Beechcraft 1900C, N811BE
Location:	near Block Island, Rhode Island
Date and Time:	December 28, 1991, 2147 est
Injuries:	3 Fatal
Type of Occurrence:	Loss of Control

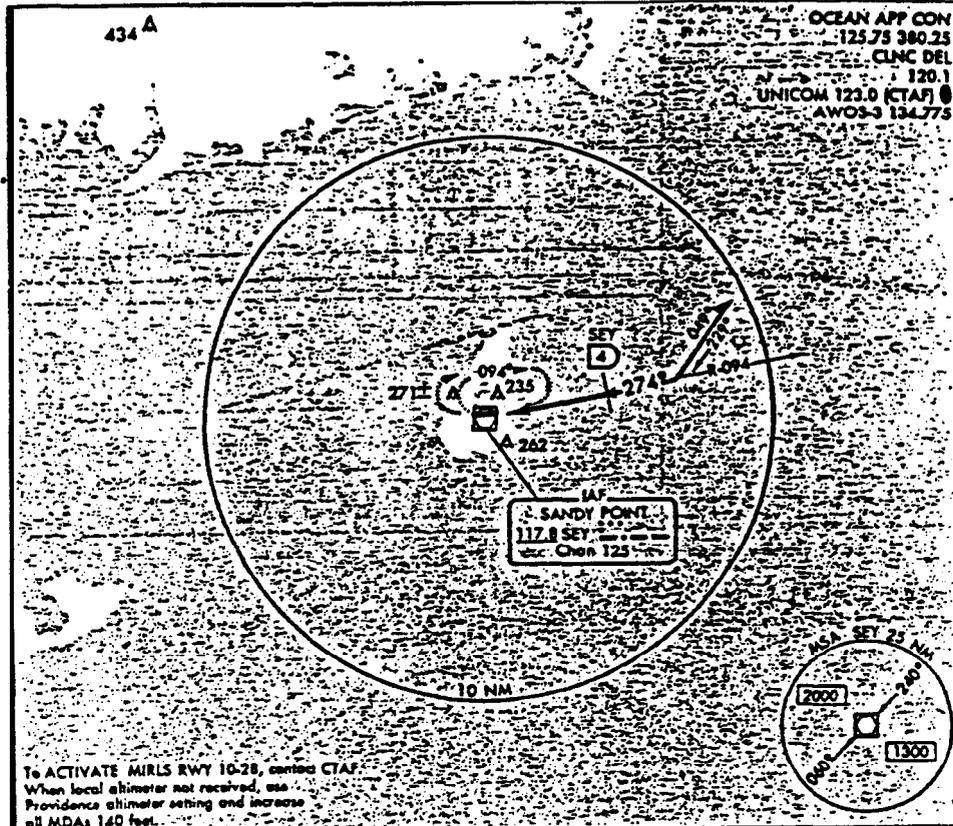
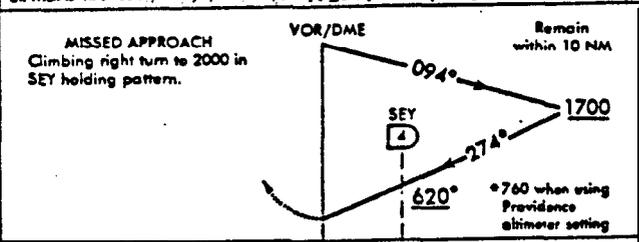
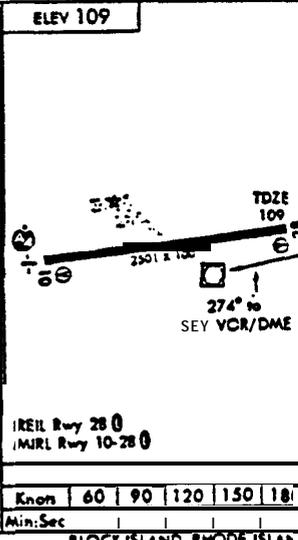
Figure 1--VOR Instrument Approach Procedure

At 2136:27, the IP specified a very high frequency omnidirectional radio (VOR) approach to runway 28 (see Figure 1) and, at 2136:46, the trainee stated, "have a failure on the attitude indicator." At 2139:04, the descent check was accomplished, and the approach check was begun. At 2144:22, a failure of the right engine was simulated by retardation of the power lever to the flight idle position; at 2144:38, the IP confirmed that the right power lever was in flight idle. At 2145:15, the trainee said, "it'll be a single-engine landing...ref gonna be one oh three...that'll be one twenty-three as it stands now."

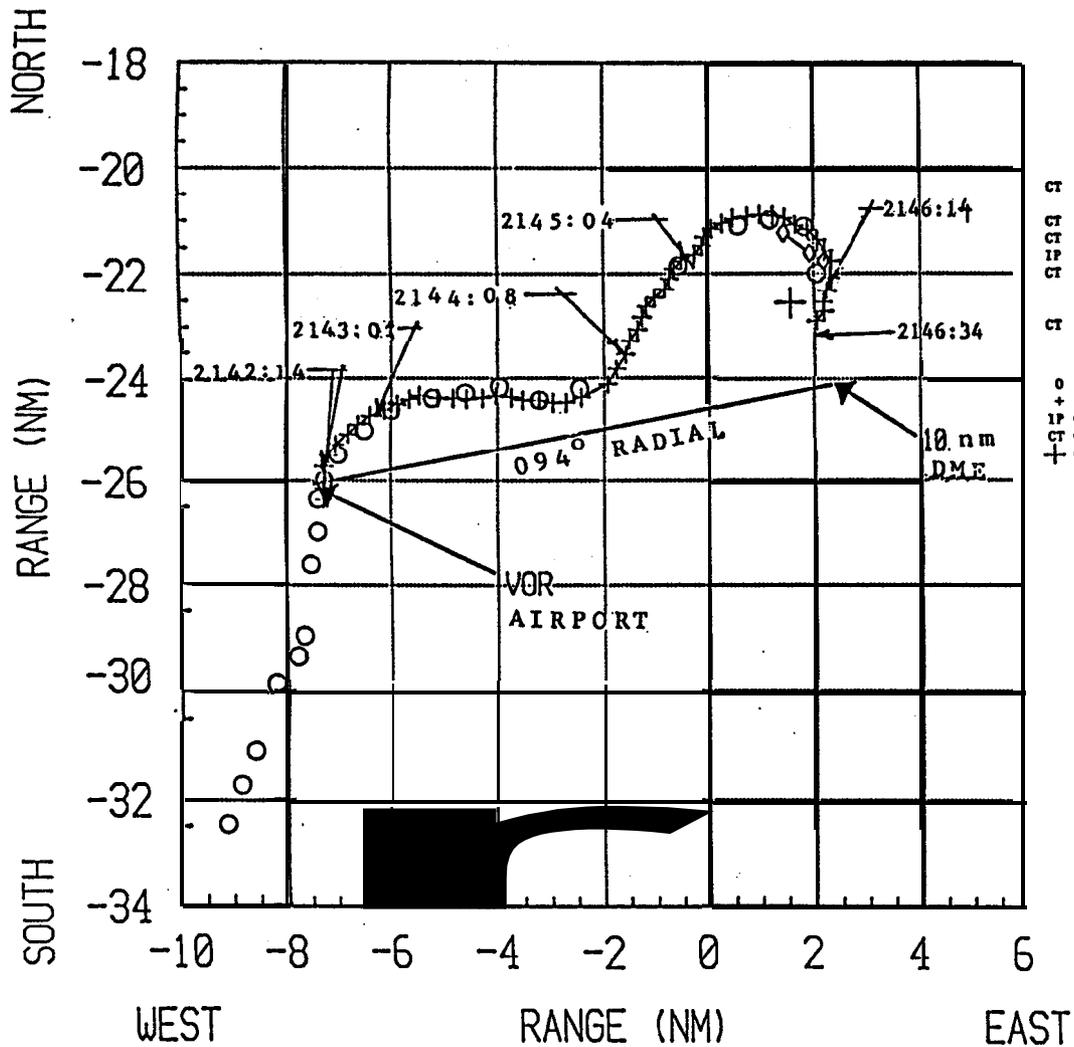
Figure 2--Ground Track of N811BE

The ground track of **N811BE** was established by aligning both sets of radar data. Figure 2 shows the airplane's ground track as identified by both sets of radar data. The ground track is related to a grid south of the Ocean TRACON antenna site and east and west of a true north-south line through the site. The small open circles represent **N811BE**'s mode C returns recorded at Boston Center and the cross marks represent returns recorded at Ocean TRACON. The final portions of the track are shown in Figure 3. The black dots in Figure 3 show the position of **N811BE** with respect to the Ocean TRACON antenna site. The dots represent every other transponder-reported position, with the related altitude above each dot, as the airplane was flown into the procedure turn for the VOR approach to runway 28 at Block Island. The last recorded transponder return occurred at **2146:24**; the reported altitude was 1,900 feet. The actual times are related to each dot with the hour digits omitted; e.g., **43:47.2** equals **2143:47.2** eastern standard time. Part of the CVR comments are included with "CT" identifying the captain-trainee's comments and "IP" identifying the instructor pilot's comments.

- CT 2142:14 "And out of two and a half for two thousand"
- CT 2143:01 "You want to start the time"
- CT 2144:08 "Okay start one minute time"
- IP 2145:04 "Okay there's a minute"
- CT 2146:14 "And just kinda skosh in here on the ah little close on the ah my ten mile"
- CT 2146:34 "Oh # ((sound of altitude alert chime))"

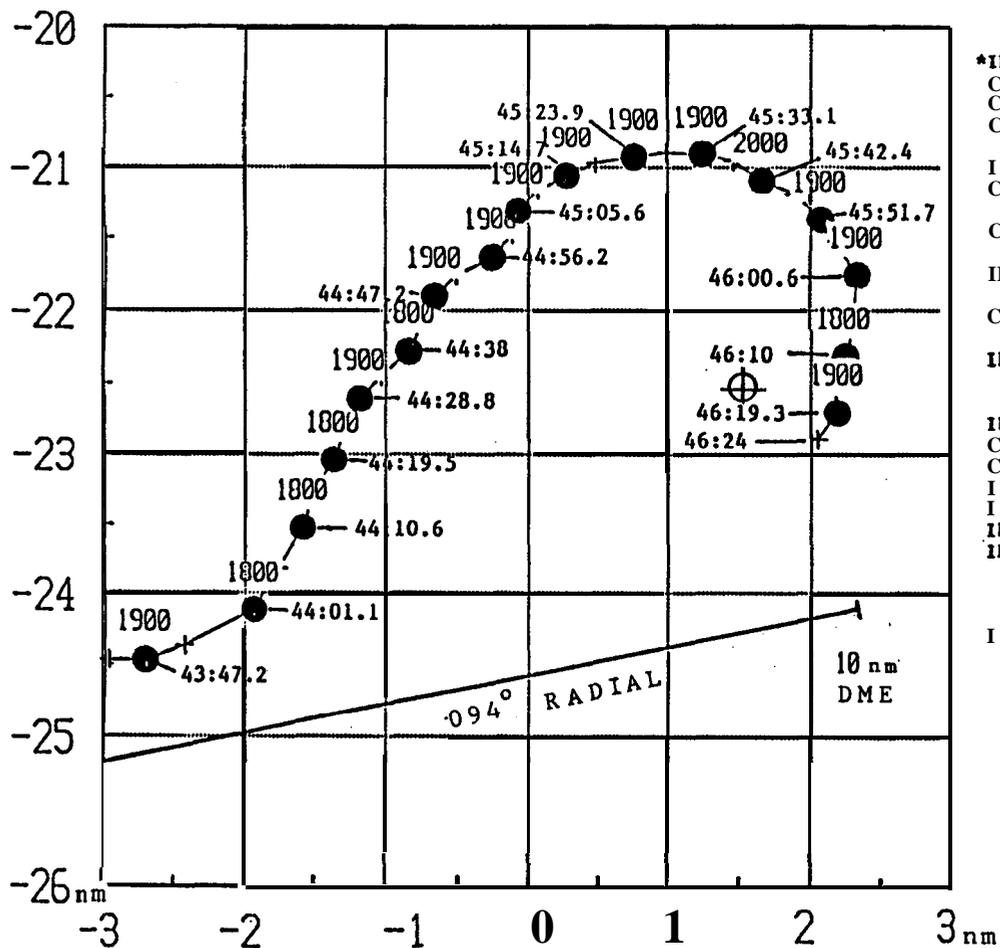
Figure 3--Ground Track of N811BE (expanded continuation)

- *IP 2145:04 "Okay there's a minute"
- CT 2145:05 "Okay end in a right turn"
- CT 2146:06 "Course looks to be alive"
- CT 2146:14 "...close on the ah my ten mile"
- IP 2146:17 "Yeah"
- CT 2146:19 "I probably should be wary of that"
- CT 2146:27 "Whet altitude am I good down to?"
- IP 2146:29 "Ah once you're established inbound you're good to what?"
- CT 2146:34 "Oh # ((sound of altitude alert chime))
- IP 2146:35 "Stop one thing at a time you're in a bed situation so correct one thing first" ∞
- IP 2146:39 "Nope"
- CT 2146:40 "Whoa"
- CT 2146:42 "Your aircraft?"
- IP 2146:42 "No take it"
- IP 2146:44 "Get the bank"
- IP 2146:45 "Power to idle"
- IP 2146:46 "What are you doing that for?"
- 2146:46 Sound of landing gear warning horn starts and continues to the end of the recording
- IP 2146:47 "All right"
- 2146:49 End of Recording
