Safety Recommendation Report
**Preventing Incorrect Installation of the Beta Arm in
Pratt & Whitney Canada PT6A Engines**

| Accident Number: | IAD01LA048 and ANC13WA057 |
| Adopted: | December 5, 2016 |

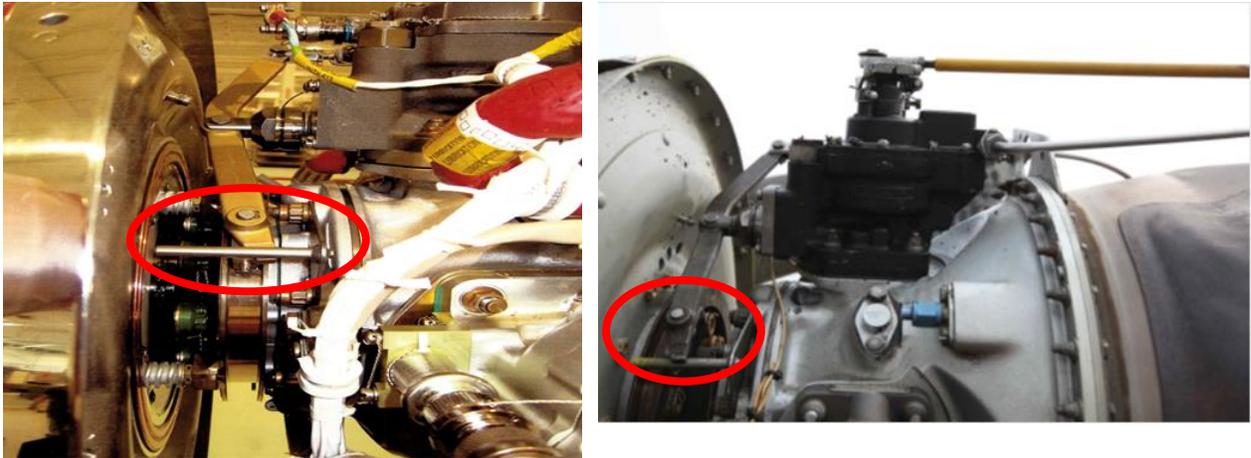
As a result of a previous NTSB investigation, we became aware of a safety issue concerning the possibility of the reversing lever (beta arm) and related components in PT6A engines being incorrectly positioned.² If the beta arm is not positioned such that it is secured under its guide pin, the unsecured linkage could release oil pressure in the beta valve and cause uncommanded travel of the propeller to the feather position (figure 1 shows exemplar engines with correctly and incorrectly positioned beta arms.)

Figure 1. Photographs of exemplar engines showing correct (left) and incorrect orientation (right) of the beta arm

Because the beta arm-to-guide pin connection and orientation are clearly visible between the front of the engine and the rear of its propeller spinner, minimal additional effort would be necessary to visually verify that the beta arm is positioned correctly. Therefore, the NTSB recommends as a short-term mitigation that the FAA issue a special airworthiness information bulletin that directs maintenance personnel, during routine scheduled inspections of and after propeller installation on Pratt & Whitney model PT6A engines, to visually verify that the propeller beta arm and guide pin are correctly installed and, if necessary, to fix any improper installations. Such an action would not only detect errors during inspections but also heighten awareness in the

Issue a special airworthiness information bulletin that directs maintenance personnel, during routine scheduled inspections of and after propeller installation on Pratt & Whitney model PT6A engines, to visually verify that the propeller reversing lever (beta arm) and guide pin are correctly installed and, if necessary, to fix any improper installations. (A-16-53)

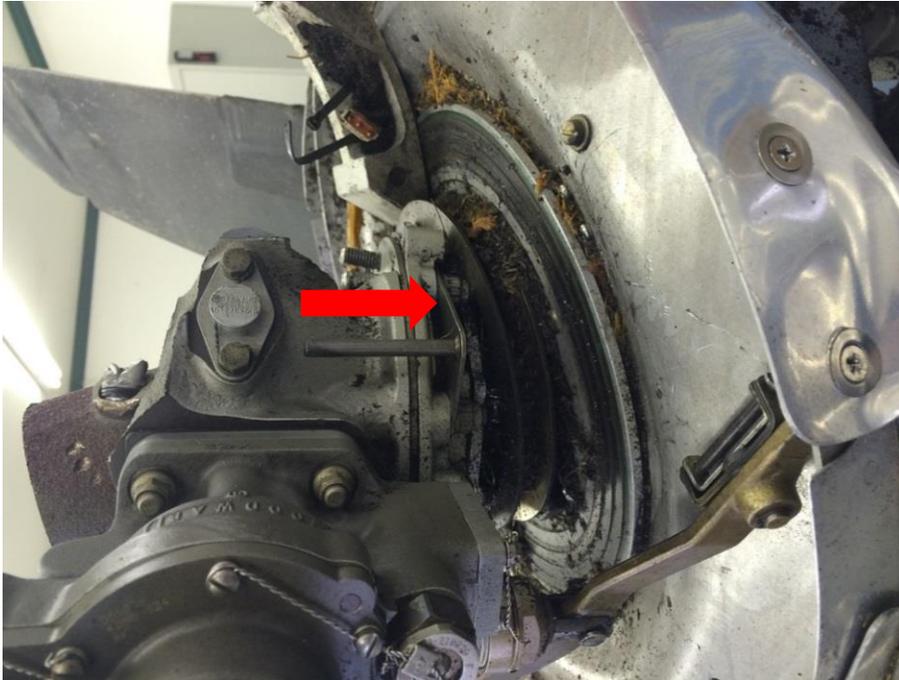
The NTSB's review found four events in which the incorrect position of the beta arm in a PT6A engine was noted and that occurred within 100 flight hours after maintenance of the beta arm or related components.³ In a fifth event (NTSB case number ERA15FA297), the investigation found that the guide pin had been installed backward, which allowed the beta arm to be free-floating, that is, neither above nor below the guide pin (figure 2 shows the installation on the engine involved in this accident).⁴ The NTSB is aware that one operator has welded a tab to the top of guide pins to make it physically impossible to incorrectly install the beta arm over the pin but notes that this fix would not prevent an intentional reversal of the guide pin if, for example, a mechanic chose to do so to provide clearance for maintenance work.

Figure 2. A photograph showing a beta arm guide pin installed incorrectly in the aft direction (the red arrow points forward, indicating the pin's correct orientation).

maintenance community about the importance of properly installing the beta arm and guide pin. In the longer term, the NTSB also recommends that Pratt & Whitney Canada, as soon as practicable, complete the development and implementation of a redesigned guide pin assembly for PT6A engines to prevent the possibility of the beta arm and guide pin being incorrectly installed.

As soon as practicable, complete the development and implementation of a redesigned guide pin assembly for PT6A engines to prevent the possibility of the reversing lever (beta arm) and guide pin being incorrectly installed. (A-16-54)
