AAIS Case Reference: 13/2010

AIR ACCIDENT INVESTIGATION REPORT

**Uncontained Cargo Fire Leading to Loss of Control
Inflight and Uncontrolled Descent Into Terrain**

Boeing 747-44AF
N571UP
Dubai
United Arab Emirates
03 September 2010

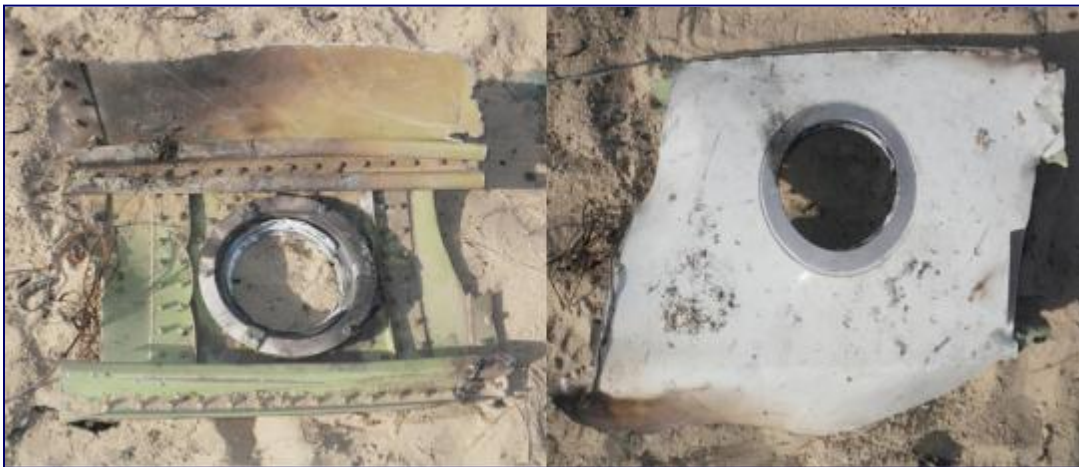
The piece of the fuselage observation window, or viewport, had sooting around the viewport opening and the viewport seal was charred and reduced to a white powder. An area of the green primer had evidence of thermal degradation of the primer paint. The level of damage sustained by the viewport window and seal in contrast to the level of damage to the surrounding material and primer paint is consistent with the thermal exposure having occurred while the viewport was covered by the bezel leaving only the window portion exposed to the interior of the main deck cargo compartment. This viewport was located on the right side of the aircraft at approximate station number 840, which is also cargo position 6R

Photo 4 Fuselage Viewport

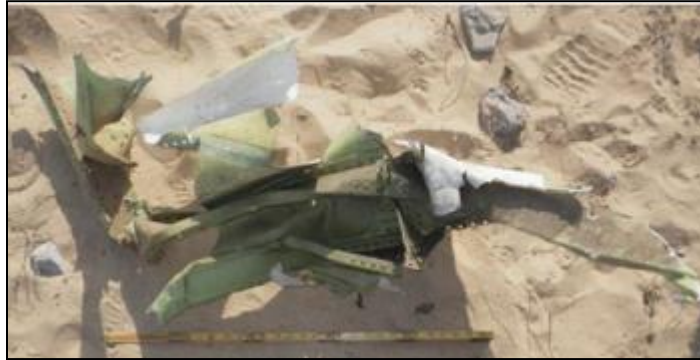
The fuselage skin and structure piece originated from the right hand side of the aircraft's fuselage skin between station 460 and 488 and somewhere between stringer 17 and 24. This item was found to have soot trapped within impact induced folds.

Photo 8 Fuselage skin and structure piece

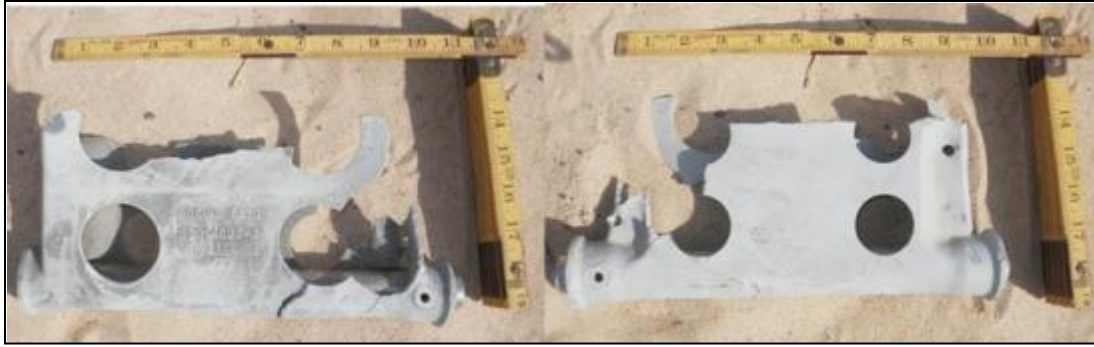
The hinge casting (PN:65b14006-3) piece was found with soot on one side and clean on the other. This item belonged to the escape slide mechanism on the right side of the upper lobe just aft of the flight deck

Photo 12 Hinge casting component

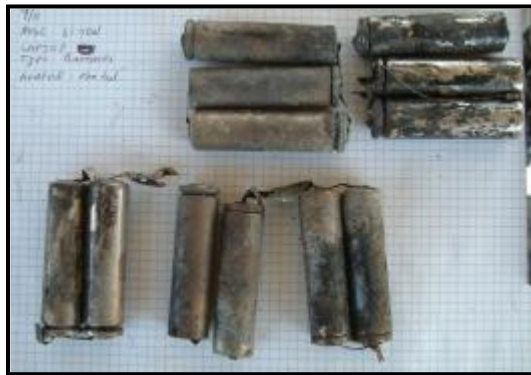
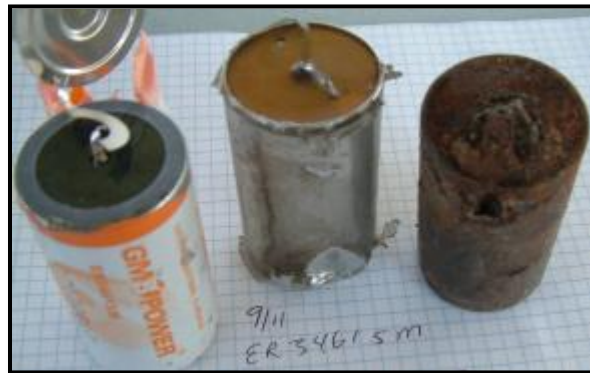
Additional battery pack remains [LH]/D-Cell size lithium primary batteries. Photo shows fire damaged and undamaged batteries [RH]

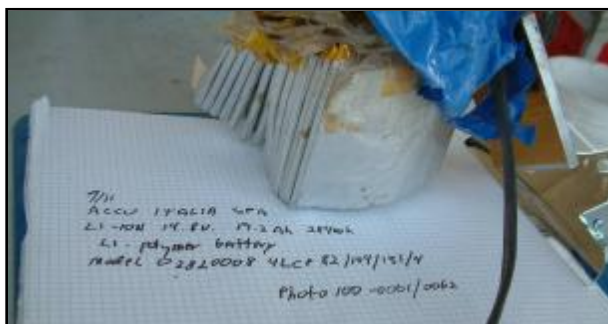
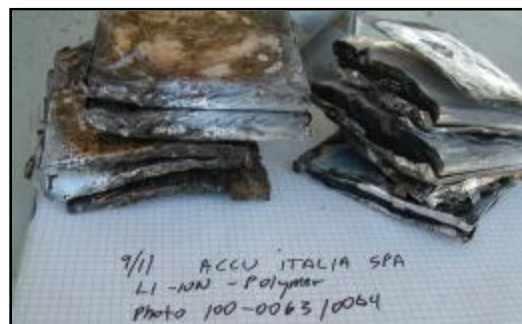
Lithium-ion polymer type battery pack [LH]/ Lithium-ion polymer type battery pack with thermal damage [RH]

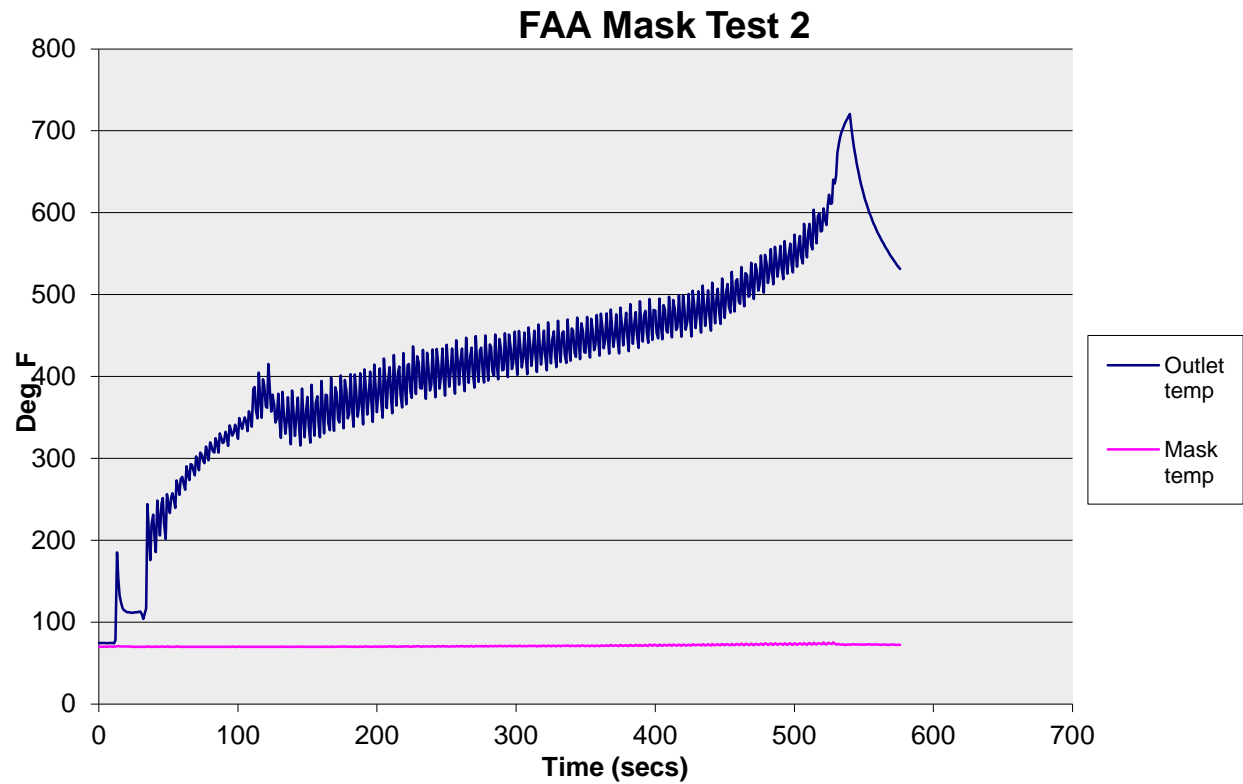
Mask Test #2 Flex Hose 60B50059 hose failure

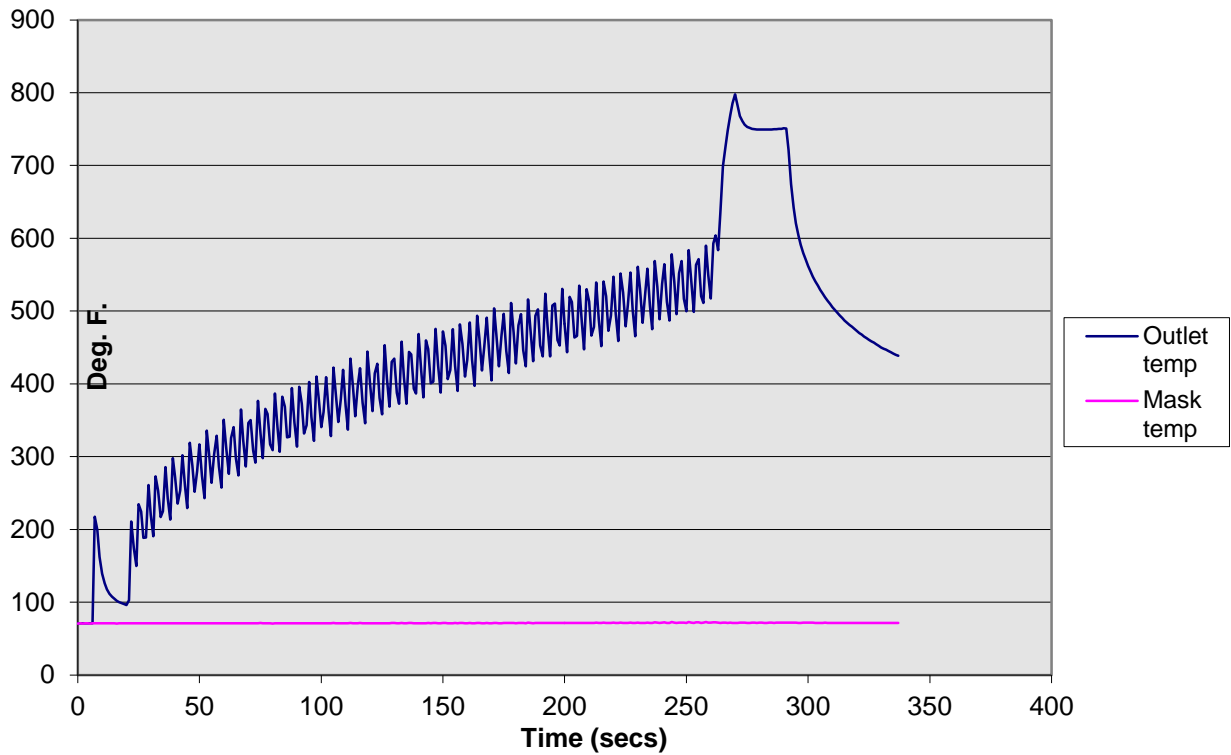
Mask Test #3 Flex Hose 60B50059 hose failure
