Interim report

on the accident on **1st June 2009**
to the **Airbus A330-203**
registered **F-GZCP**
operated by **Air France**
flight AF 447 Rio de Janeiro – Paris

Bureau d'Enquêtes et d'Analyses
pour la sécurité de l'aviation civile

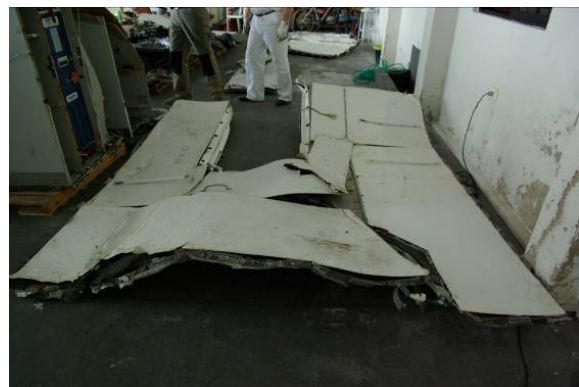
Fragments of the walls of the flight crew rest module were crumpled and those of the ceiling were deformed downwards. The floor was curved under the effect of a strong upward pressure from below. The connecting brackets between the floor and the walls were bent backwards.
