*Accident  
on 25 July 2000  
at "La Patte d'Oie"  
in Gonesse (95),  
to the Concorde,  
registered F-BTSC,  
operated by Air France*

**Preliminary report  
translation  
f-sc000725pa**

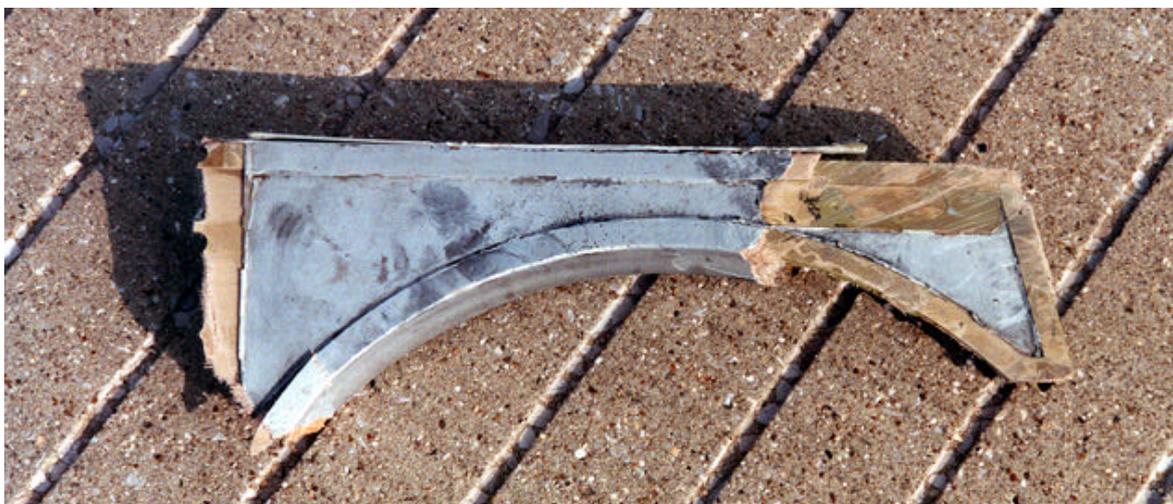
Parts of the water deflector of the left main landing gear were found between Slabs 139 and 166, that is 1 642 to 1 845 m from the beginning of runway 26 right, more precisely at 139, 149, 151, 157 and 166. The parts found did not include metallic parts.

*Part found at Slab 166 level: right part of the deflector*

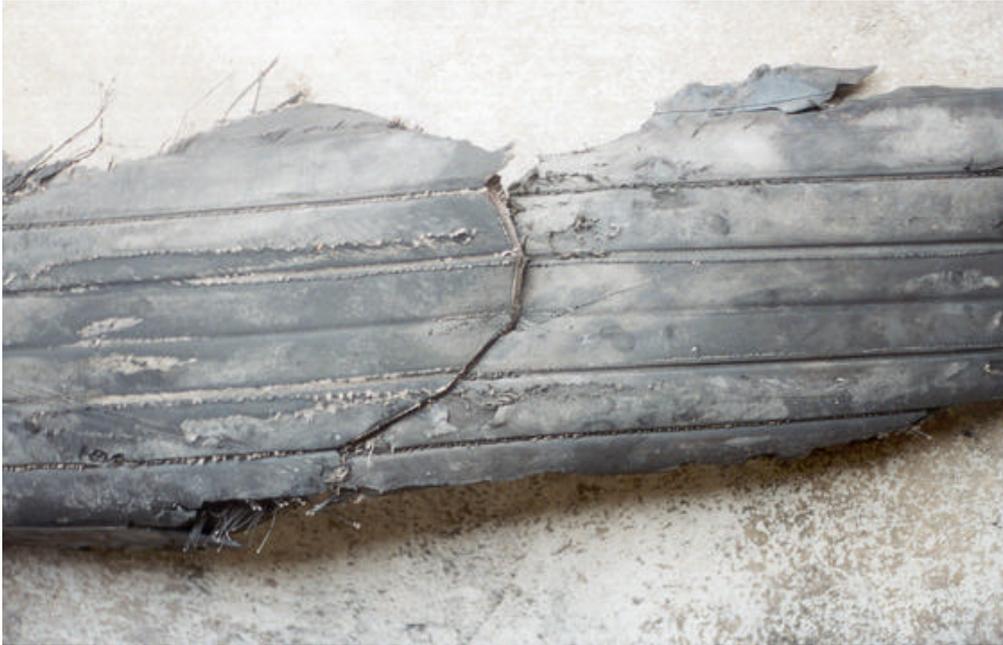
Pieces of tyre from the Concorde were found at slab levels 146, 152, 166, 180, 186 and 187. The parts found at Slab 152 level (a piece measuring 100 x 33 cm and weighing more than 4 kg) and that found at Slab 180 level fitted together. Vis-

ual inspection revealed a transverse cut about 32 centimetres long.

*Piece of tyre at Slab 180 level*

*Piece of tyre at Slab 152 level*

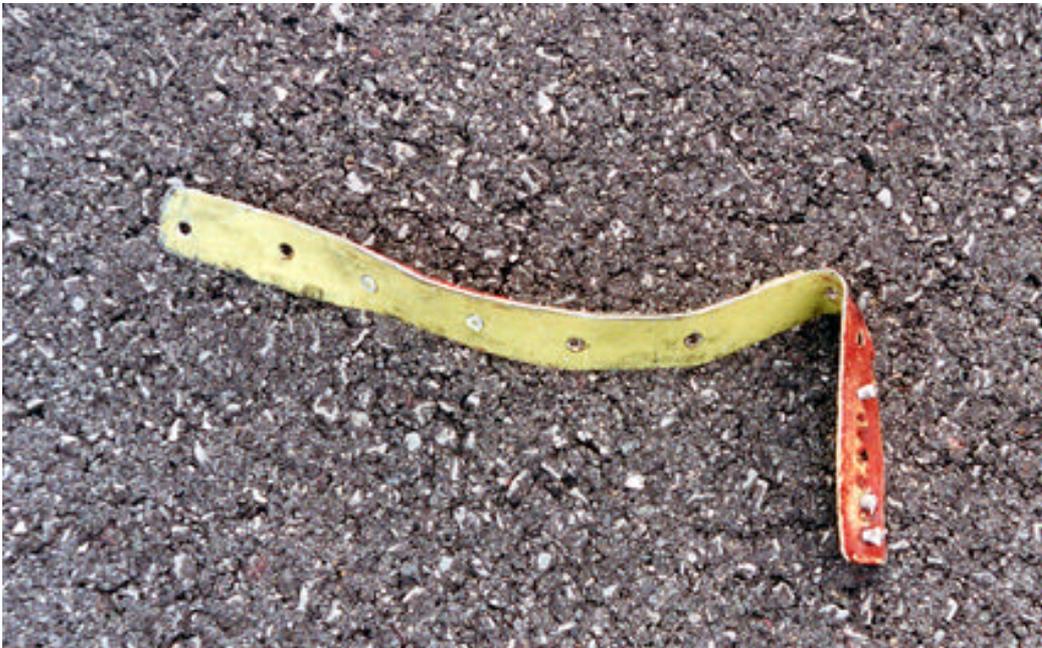
*Piece found at Slab 152 level*

A strip of metal about 43 centimetres long, bent at one of its ends, was found on the runway shoulder at Slab 152 level. Its width varies from 29 to 34 mm and it has drilled holes, some containing rivets, similar to the Cherry aeronautical type. The holes are not at regular intervals.

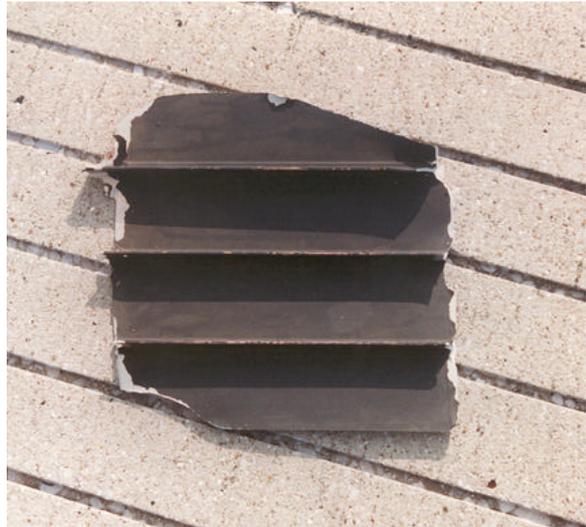
A ribbed structural part measuring about 30 x 30 cm was found at Slab 160 level. It was white on the external side and dark on the ribbed side. It came from the aircraft's No. 5 fuel tank. It showed no signs of impact damage.

*Part found at Slab 160 level*

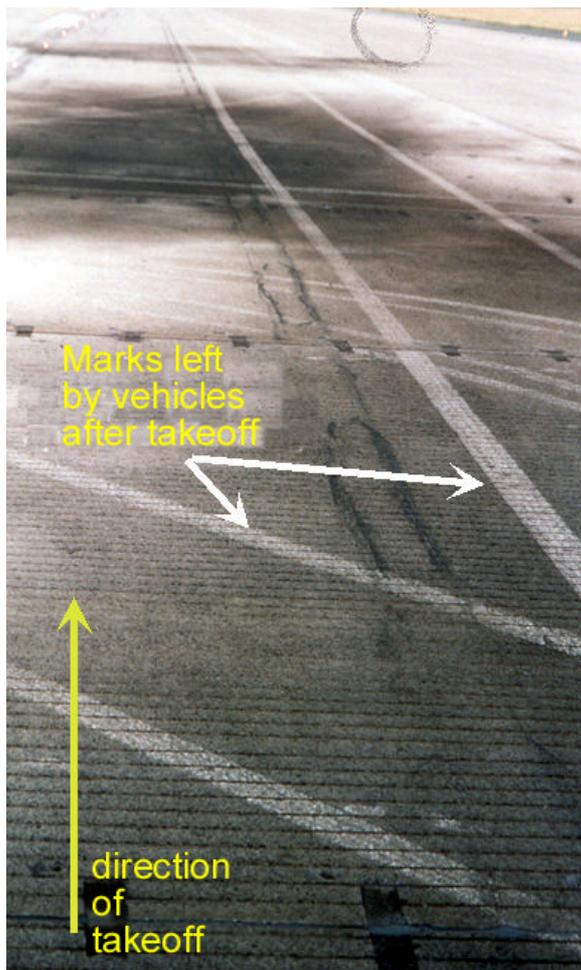
Irregular marks made by the left landing gear were noted up to the broken light (around 2 800 metres).

After this point, the marks became intermittent then disappeared at about 2 830 m from the runway threshold.

From Slab 161 level to Slab 232 level, that is between 1 807 and 2 340 m, the mark of a flat tyre with an incomplete tread was observed.

This mark was parallel to the runway axis (at about 3.8 m) then diverged at about 2 200 metres.

When this mark disappeared at about 2 340 m, its displacement from the centreline was about 8 m. This corresponded to the right front tyre of the aircraft's left landing gear.

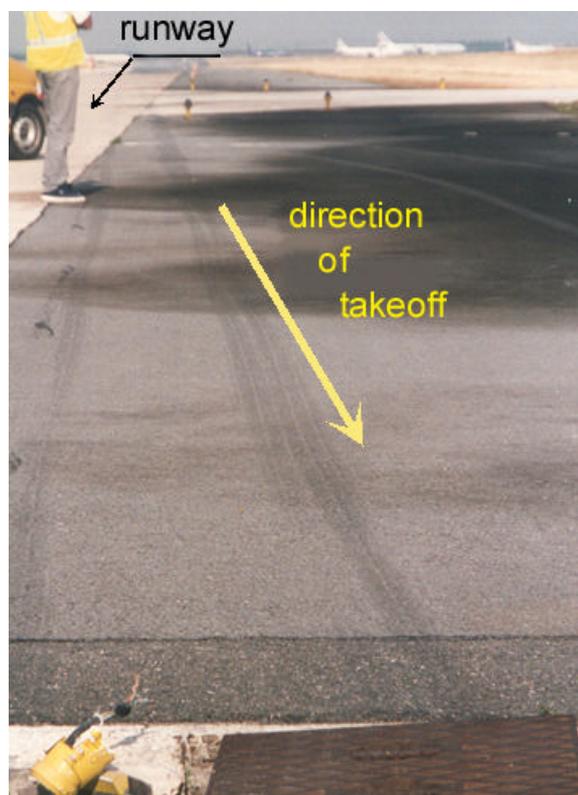
The runway edge light at the Slab 293 level (about 2 800 m from the origin) was broken and small pieces of the light were found nearby. Ground marks showed that this light was broken by the Concorde's left main landing gear.

*Mark left by the left truck and broken light*

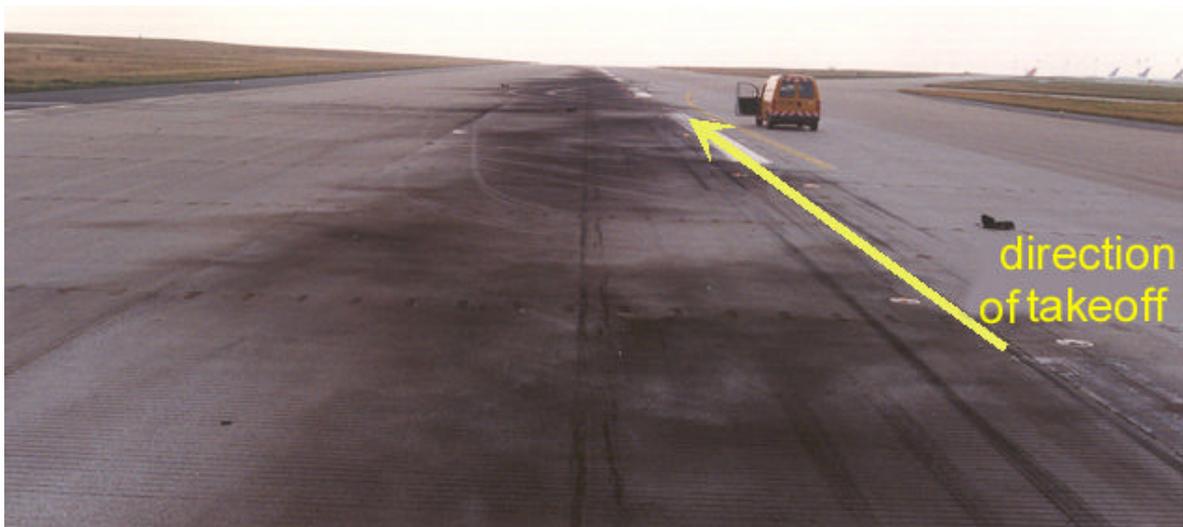
Slab 202

Traces of soot, produced by incomplete combustion of kerosene, were apparent on the runway 1 860 m onward from the origin (Slab 168). These were large and dense up to 2 300 m and then became less dense and rich in carbon up to taxiway S4, at 2 770 metres. The traces, which were on average 7 m wide, were initially centred on the damaged wheel ground mark and progressed to a position corresponding to the far left of the aircraft.

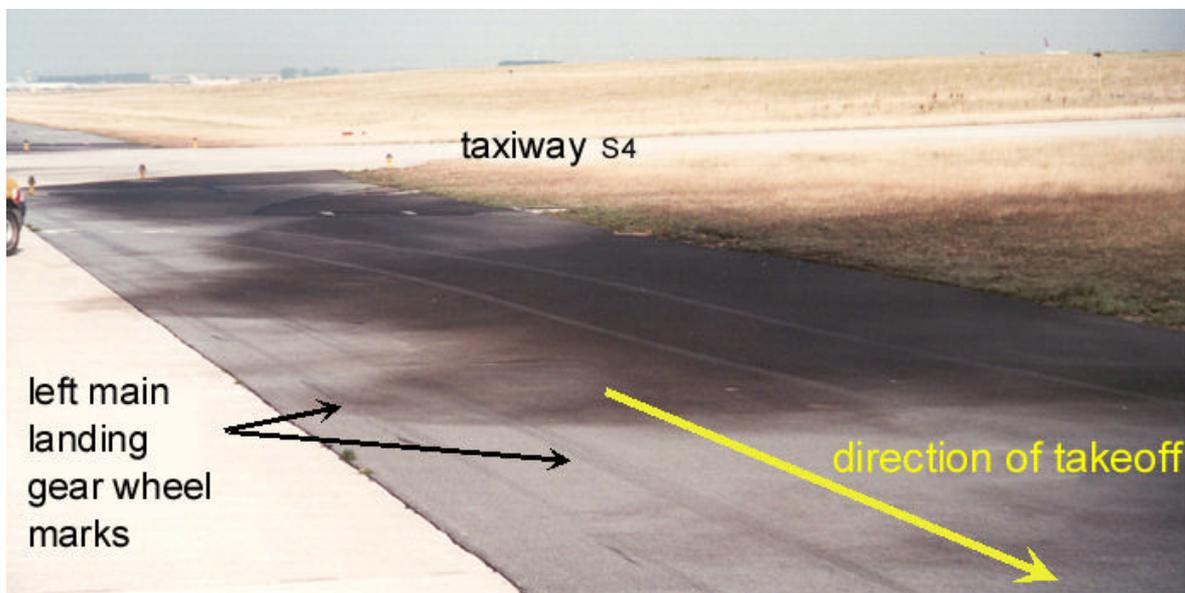
Slab 290

A further sooted area was apparent after taxiway S4 up to the broken edge light.

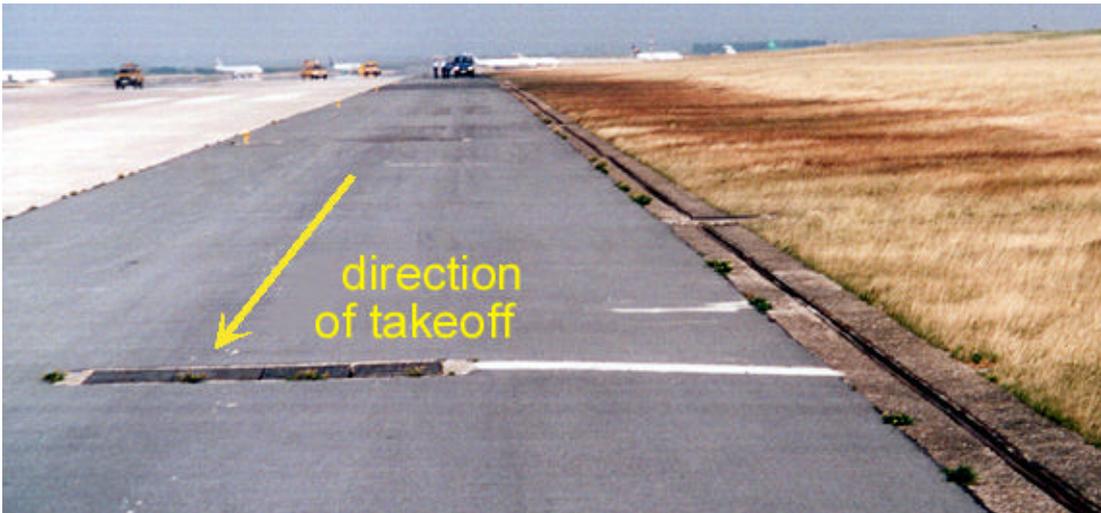
*Between Slabs 310 and 340*

The grass was burnt adjacent to the runway edge, between 2 902 and 3 165 metres. This area, also featuring soot deposits, indicated that there was an extensive flame after the aircraft became airborne.

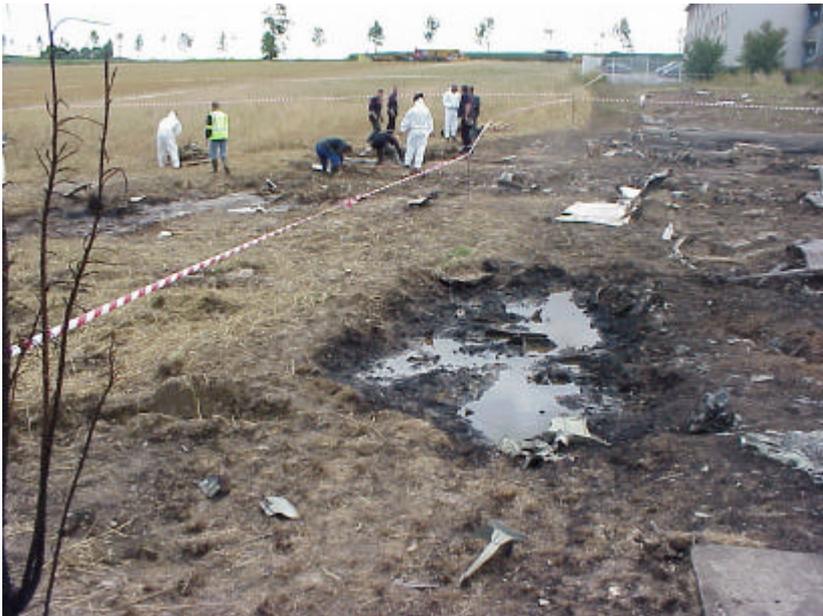
Signs of ground impact were found to the north of the site at the intersection of areas A and B. There was a row of trees about three metres high, oriented east to west, then a crater at the bottom of which was rear tank No. 11. Pieces of engine air intake were found half-buried at A3 and signs of ground impact were apparent at A3 and CB2-North. Wheel N° 6 was embedded in the ground.

*Ground impact marks*

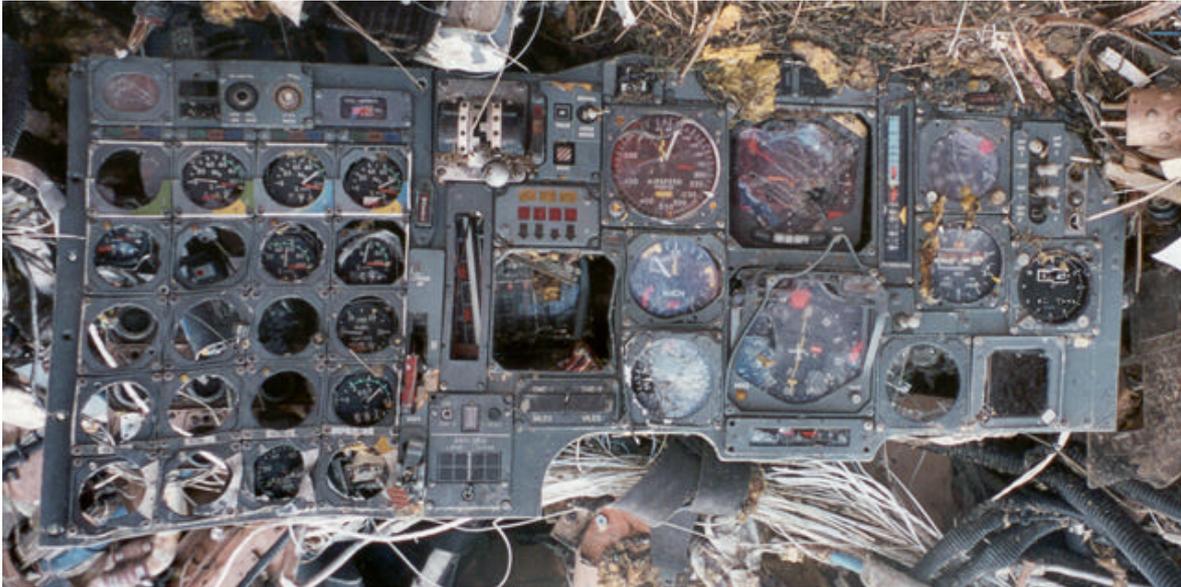
- the Nose/Visor lever was in the "Down" position
- the landing gear selector was towards the "Down" position, past the gate
- on the rudder position indicator (damaged on impact), the rudder indicators were at 20° left for the upper control surface and 12° right for the lower control surface on "G" (Green). The indicators for the elevons were on "M" (Mechanical) and provided no information
- the airspeed shown on the airspeed indicator was 99 Kt, "STBY" flag, and V2 bug was on 230 kt
- HSI heading 105°, ADI 30° roll to the left and 32° nose down. Vz – 1 800 ft/min, altimeter - 240 feet "STBY" flag, radio altimeter unreadable, VOR1 028°, VOR2
- FD switch on number 2
- attitude selector on ATT INS3, comparator on COMP2, deviation on DEV2, navigation on NAV INS2
- clock on 14 hours 45 UTC

*Instrument panel*

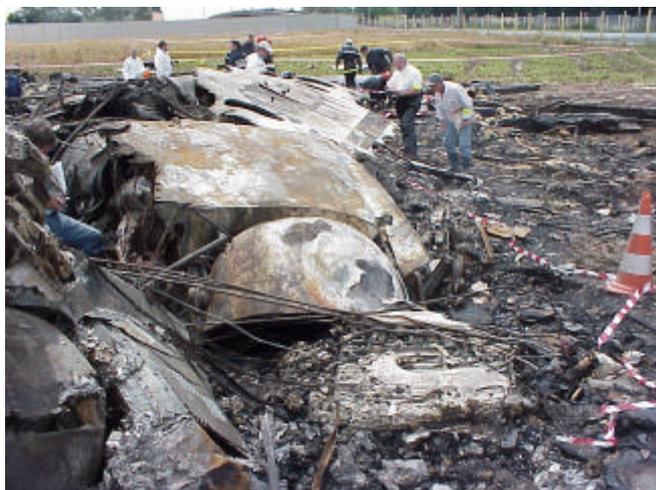
*General view of engine n° 4 upper secondary exhaust nozzle*

The upper secondary exhaust nozzles were still in place on engines 1, 2, 4 and separated from the nozzle structure on engine 3. The lower secondary exhaust nozzles were separated from the structure and three of them were found intact. The upper actuators from engines 2 and 4 were attached to the structure and to the nozzles. The lower actuators were found at the site with the exception of that of engine 3.

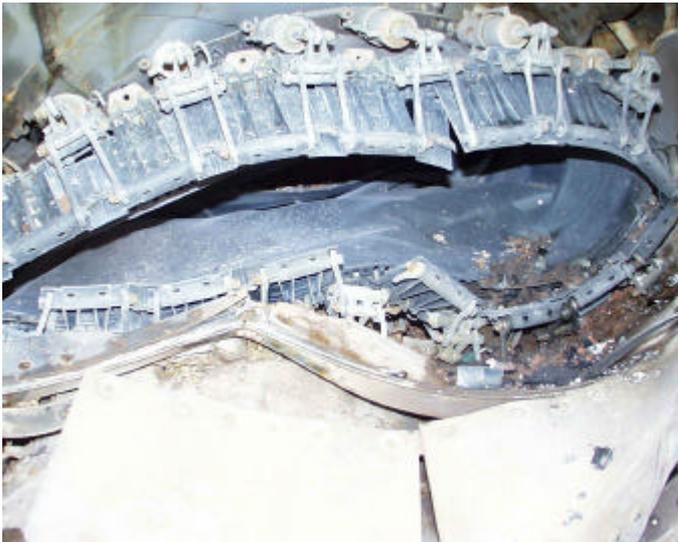
The primary exhaust nozzle from engine 3 was separated from the structure of the secondary nozzle. The latter was torn away from the rest of the engine. The nozzles from engines 1, 2 and 4 were in place but flattened by the impact with the ground.

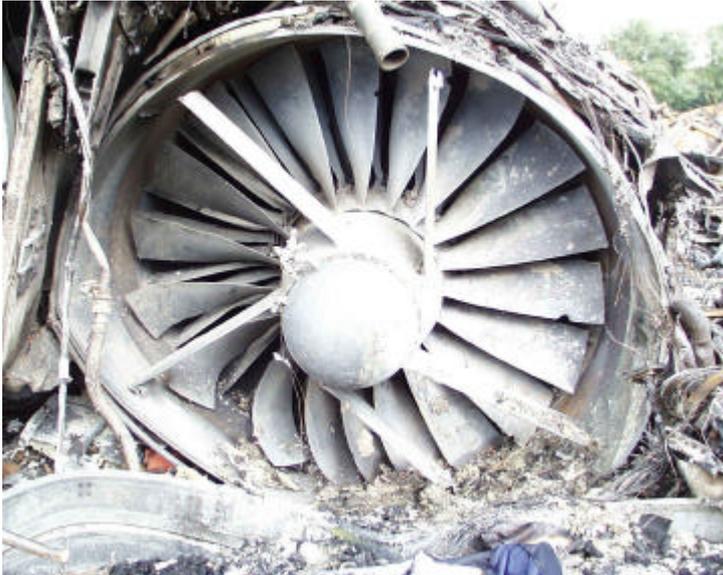
Examination of engine n° 2 appears to indicate a negligible N1 before impact. The rotor of the LP compressor of engine n° 1 apparently made less than a quarter of a revolution after the impact before being stopped by the casing being crushed.

*Engine n° 1 LP compressor*

Engines 1 and 2 showed signs of damage (FOD) by a soft object on the LP compressor rotor blades. Engine 1 also showed signs of FOD by a hard object. The damage found on engines 3 and 4 showed that they hit the ground with an N1 much higher than that of engine n° 1.

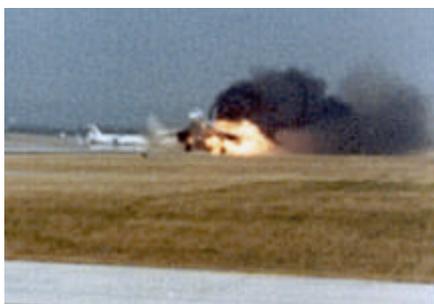
The initial fire began under the wing, between the left engine nacelles and the fuselage, a few seconds before the start of takeoff rotation, the aircraft being in the vicinity of W7 or S5. A small flame apparently appeared suddenly, similar to a blowtorch, and then got wider (enveloping the left engines) and longer (about the length of a fuselage). This flame was accompanied by thick black smoke. The noise of the aircraft was perhaps different from normal.

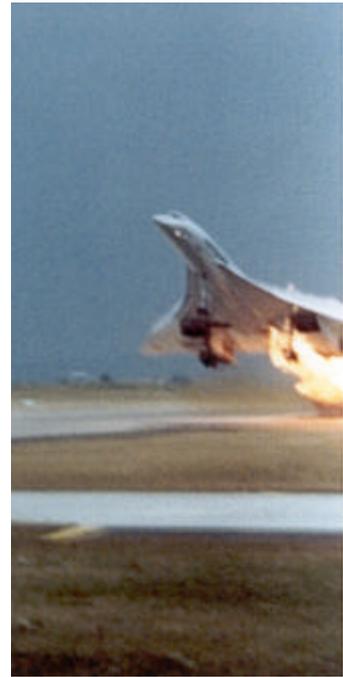
After having passed over the freight zone, the aircraft stopped climbing, with an apparently constant pitch attitude and with the landing gear extended. It flew over the N17 road at about two hundred feet, turned to the left at a steep bank angle, pitched nose up and crashed left wing first. There was a conflagration followed by one or more explosions.
