National Transportation Safety Board
FACTUAL REPORT
AVIATION

NTSB ID: MIA95FA224A

Aircraft Registration Number: N117ER

Occurrence Date: 09/15/95

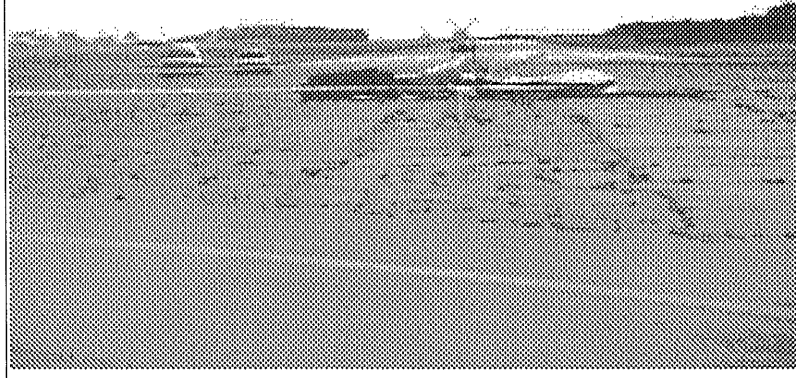
Post crash examination of N117ER showed that the aircraft impacted at about a 70-80 degree nose down attitude. The post crash fire consumed the fuselage, inboard wings, and tail sections of the aircraft. The outboard portion of the right stabilator had separated from the aircraft and was found forward or southeast of the aircraft wreckage, outside of the fire area. Examination of this portion of right stabilator showed damage and transfer of black paint consistent with it having been contacted by the propeller of N2351A. The propeller of N117ER had damage consistent with it rotating at the time of impact. The engine assembly rotated after the accident. All engine accessories were consumed or damaged by the post crash fire.

Photograph 1: View of main wreckage of N117ER on threshold of runway 11.

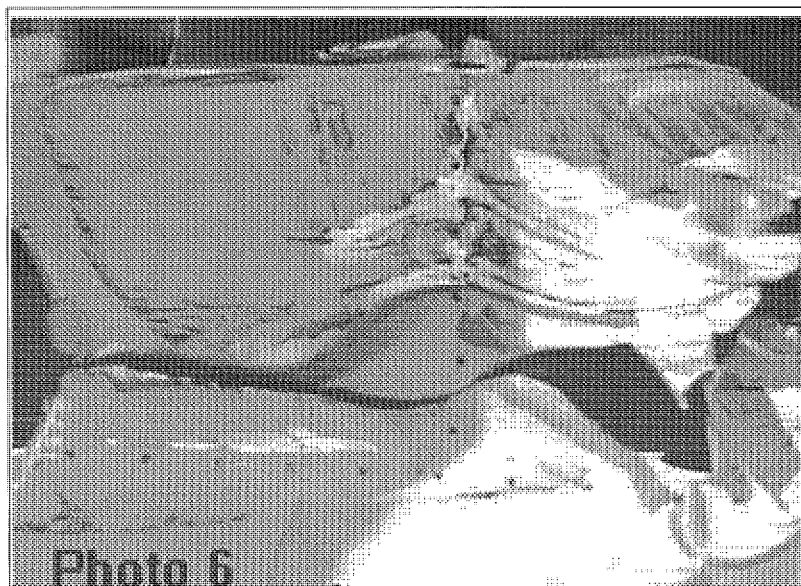
Examination of N2351A showed that the 3 inch piece of propeller tip found in the area of the collision had come from its propeller. Small pieces of sheet metal debris with white and blue paint similar to the colors of N117ER were found in the propeller spinner of N2351A. Blue scrape marks similar to the color of N117ER were found on the belly of N2351A, just aft of the engine.

Photograph 6: View of bottom of right stabilizer of N117ER. Note paint transfer

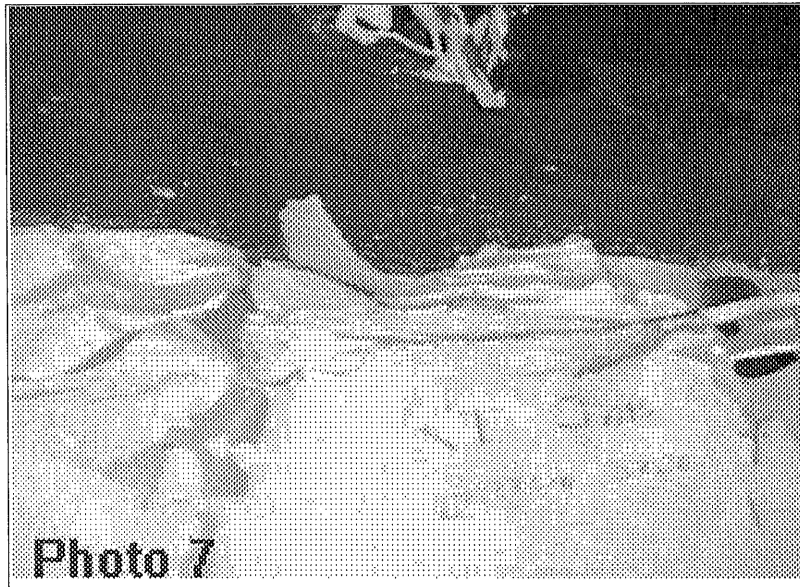
| Item No. | Description of Item | Doc | Photo |
|---|--|---|---|
| 29 | Photograph 7: View of top of right stabilizer of N117ER. Note crush damage on the leading edge. | | 1 |

Photograph 7: View of top of right stabilizer of N117ER. Note crush damage on the leading edge

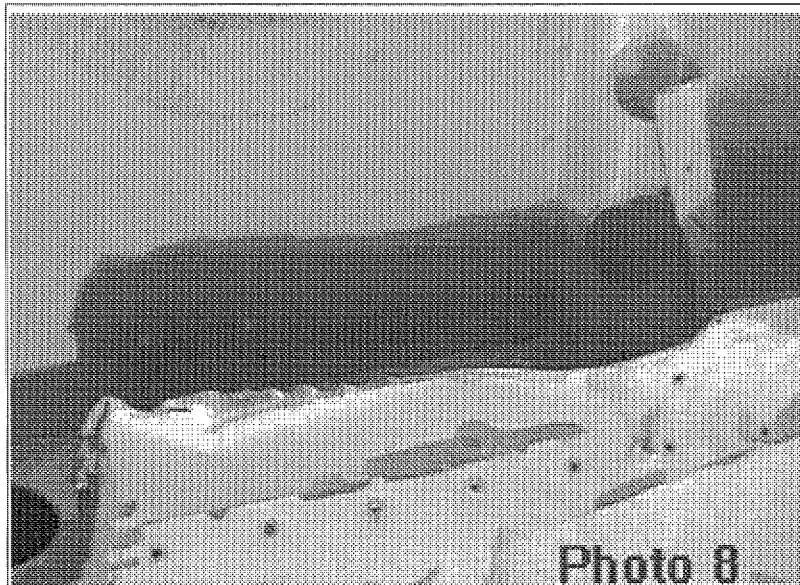
Photograph 8: Another view of remains of right stabilizer from N117ER. Note paint transfer

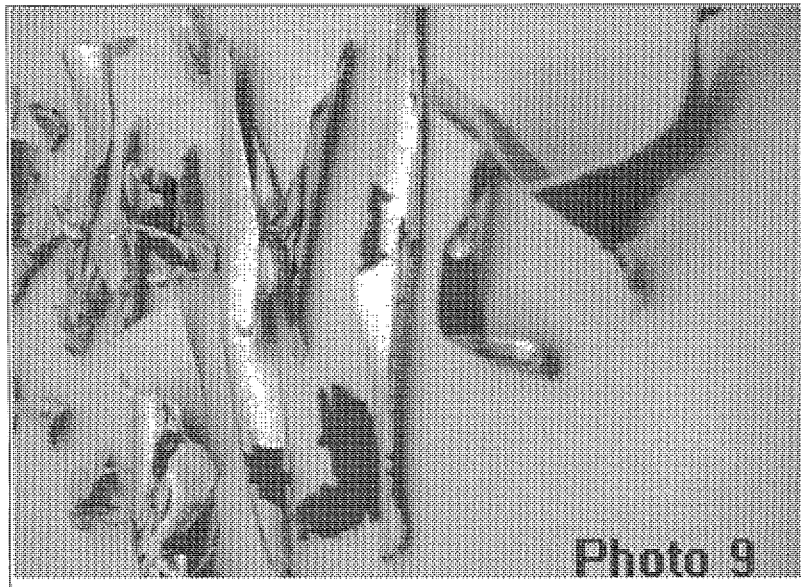
N117ER and N2351A collided over the displaced threshold of runway 11 at the New Smyrna Beach Airport. Debris from the vertical stabilizer, rudder, and right stabilator of N117ER and about a 3 inch portion of propeller tip from N2351A were found in the displaced threshold area. After the collision N117ER pitched down and impacted nose first on the displaced threshold, about 300 feet past the point of collision. A post crash fire erupted. N2351A continued and landed.

| Item No. | Description of Item | Doc | Photo |
|---|--|---|---|
| 31 | Photograph 9: View of debris from tail section of N117ER which was found in the area of the collision with N2351A. | | 1 |

Photograph 9: View of debris from tail section of N117ER which was found in the area of the collision with N2351A

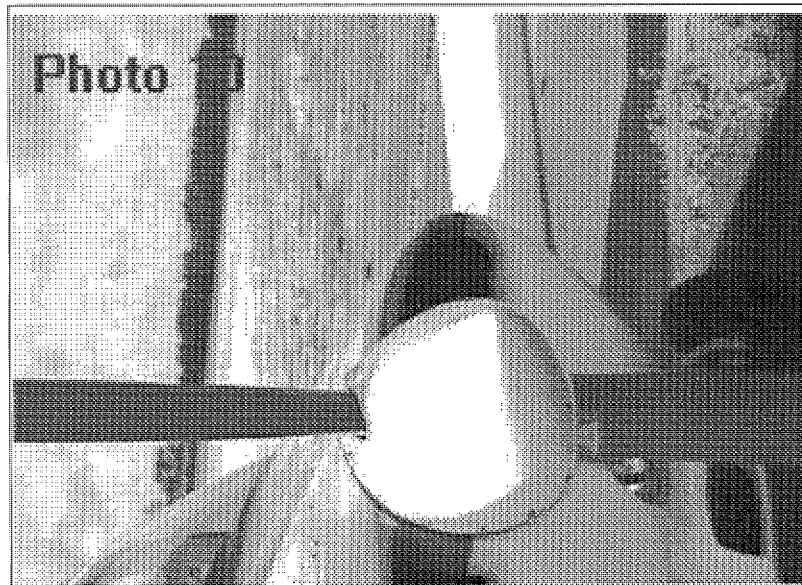
| Item No. | Description of Item | Doc | Photo |
|---|--|---|---|
| 32 | Photograph 10: View of propeller from N2351A. Note damage. | | 1 |

Photograph 10: View of propeller from N2351A. Note damage.

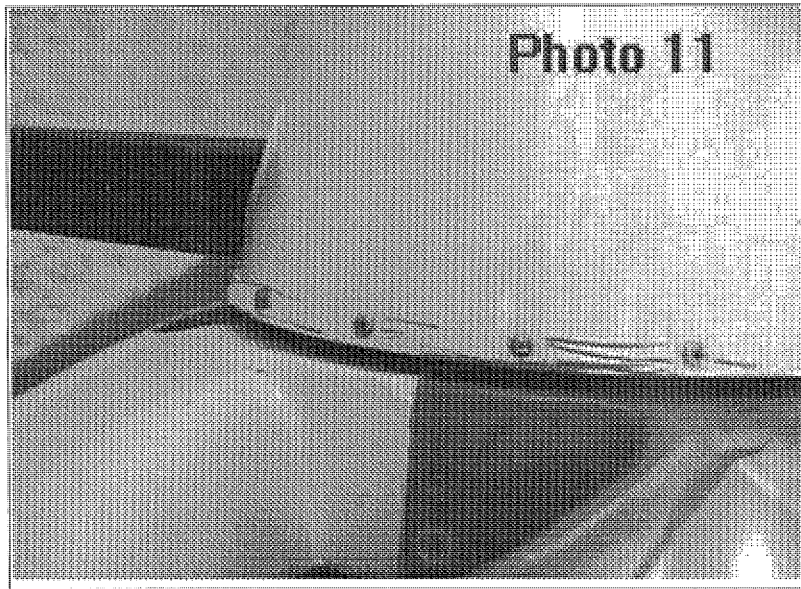
| Item No. | Description of Item | Doc | Photo |
|---|--|---|---|
| 33 | Photograph 11: View of rotational damage to propeller spinner from N2351A. | | 1 |

Photograph 11: View of rotational damage to propeller spinner from N2351A.

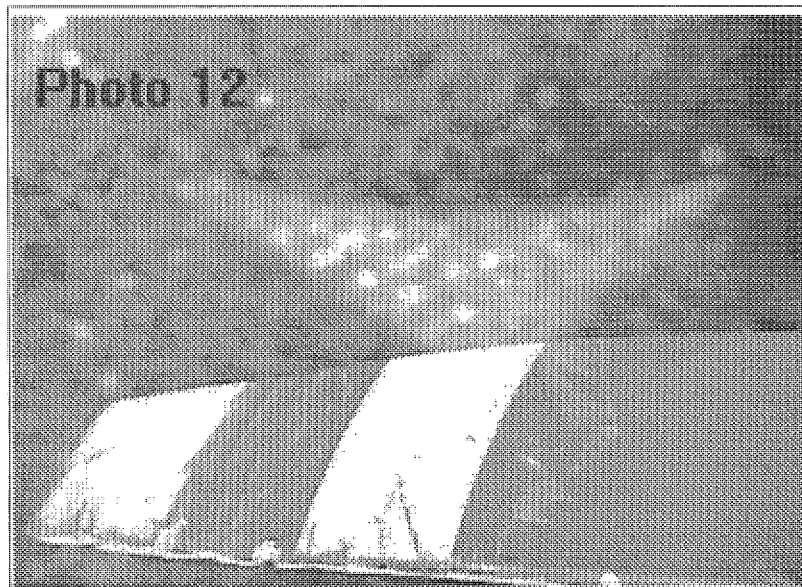
| Item No. | Description of Item | Doc | Photo |
|---|--|---|---|
| 34 | Photograph 12: View of damage to one propeller blade of N2351A. | | 1 |

Photograph 12: View of damage to one propeller blade of N2351A.

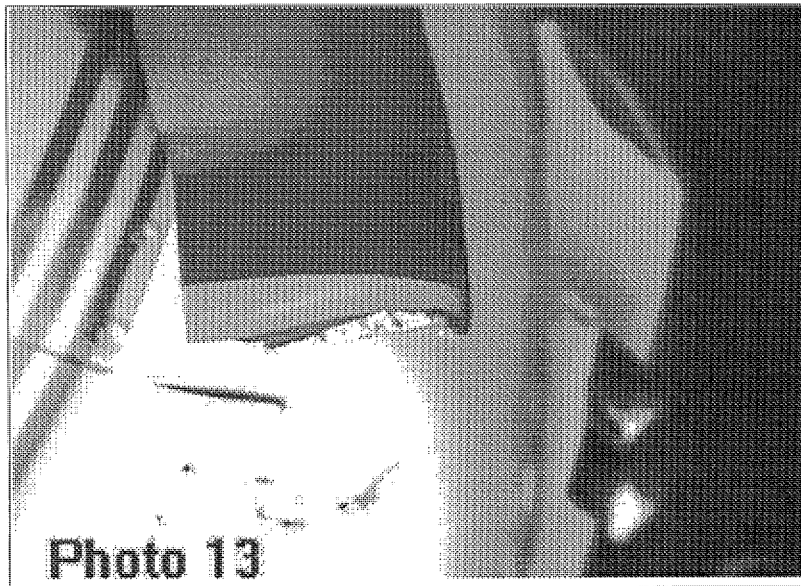
| Item No. | Description of Item | Doc | Photo |
|---|--|---|---|
| 35 | Photograph 13: View of damage to other propeller blade of N2351A. | | 1 |

Photograph 13: View of damage to other propeller blade of N2351A.

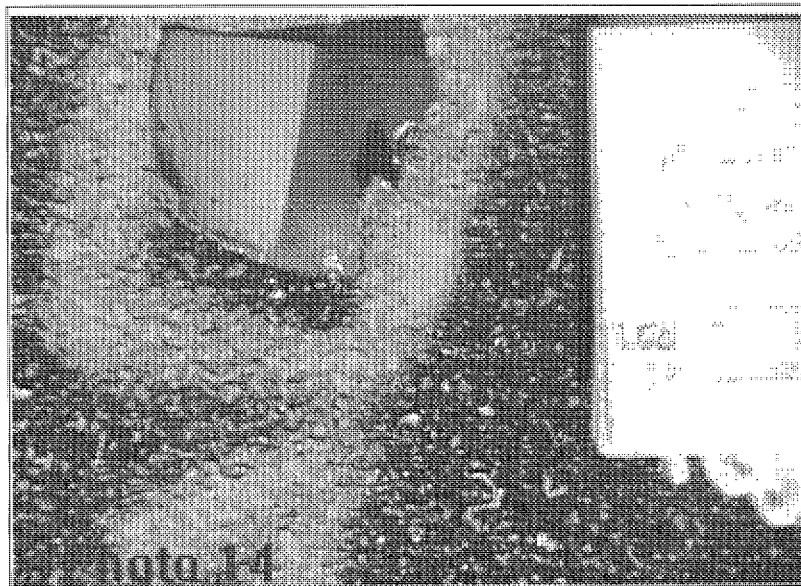
| Item No. | Description of Item | Doc | Photo |
|---|--|---|---|
| 36 | Photograph 14: View of piece of propeller blade from N2351A which was found on the runway threshold at the point of collision with N117ER. | | 1 |

Photograph 14: View of piece of propeller blade from N2351A which was found on the runway threshold at the point of collision with N117ER

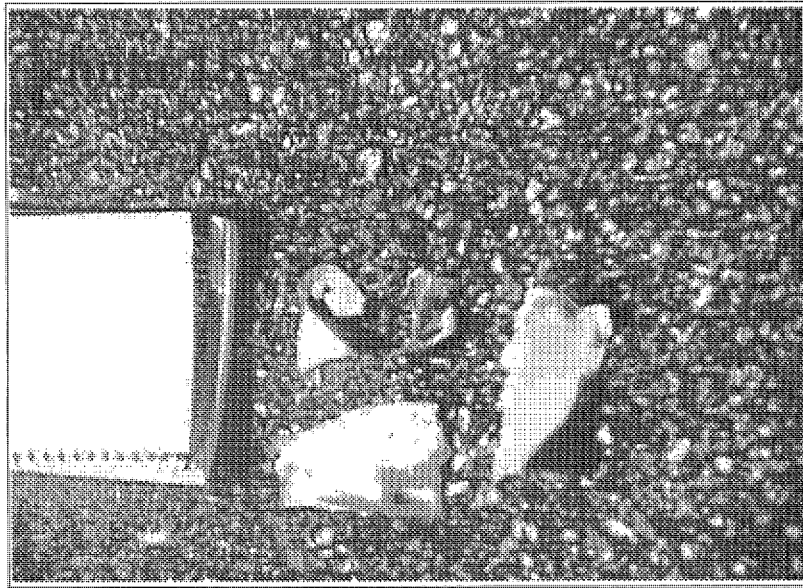
| Item No. | Description of Item | Doc | Photo |
|---|--|---|---|
| 37 | Photograph 15: Debris from the tail section of N117ER which was found in the propeller spinner of N2351A. | | 1 |

Photograph 15: Debris from the tail section of N117ER which was found in the propeller spinner of N2351A
