Special Investigation Report--Search and
Rescue Procedures and Arming of Emergency
Locator Transmitter: Aircraft Accident near
Michigan City, Indiana, December 7, 1980

11 Aug 81

SPECIAL INVESTIGATION REPORT

NTSB-SIR-81-2

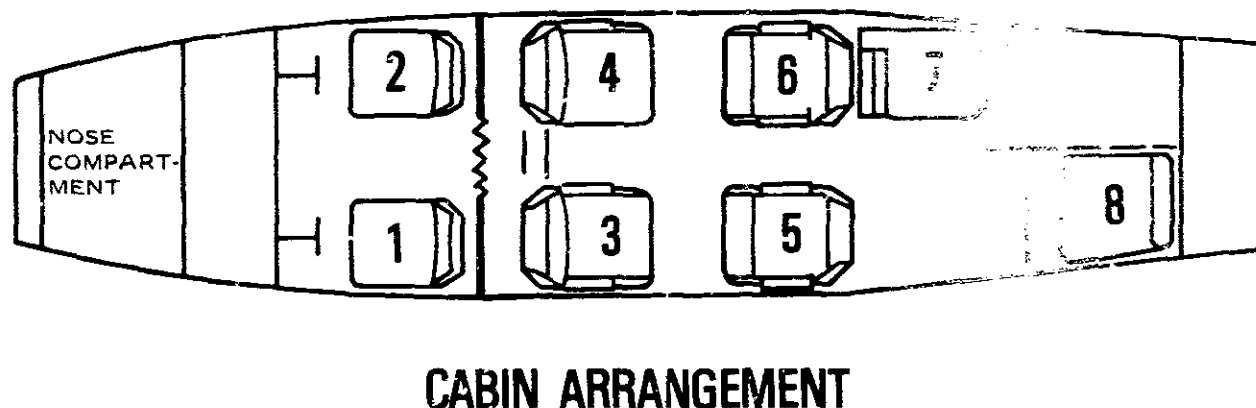
Figure 2.--Interior and exterior of N2181L.

The cabin and cockpit areas were undamaged--there was no loss of occupiable space because of crushing. The cabin interior revealed no evidence of smoke or burned upholstery. The passengers' luggage was stored in the aft compartment. The sliding door was partially opened. There were eight seats in the aircraft, including the cockpit. (See figure 2.) All seats and restraint systems were essentially undamaged.

Examination of the aircraft wreckage before and after it was recovered from the lake indicated this was a survivable crash. The cockpit and cabin areas were practically undamaged, there was no loss of occupiable space due to crushing, and there was no evidence of material or section rebound. The seatbelts were not damaged and all seats, except the left forward facing seat, were attached to the floor tracks.

The minimal damage to both the exterior and interior of the aircraft suggests a high probability that some or all of the occupants survived the crash. This probability is reinforced by the recovery of the shoes and suit coats found in the cabin. By far, the most convincing evidence to support this probability is the fact that no bodies were found in the aircraft, yet all the doors and windows except the emergency hatch were closed, and the pathological report on the two bodies recovered in the water disclosed that both persons died from hypothermia, not crash-related injuries. The autopsies were unable to establish how soon the victims died. The anticipated survival time in 38° F water temperature (the temperature of Lake Michigan on December 7, 1980) is 20 minutes or less. However, it is not known how long the aircraft stayed afloat before the survivors were forced into the water.

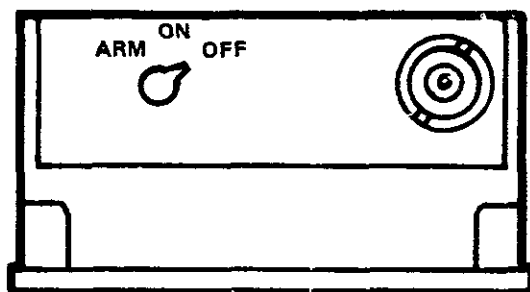
Figure 3.—Emergency locator transmitter.

The Collins CIR-11-2 ELT unit installed on N2181L was mounted inside the aft section of the fuselage on the right side. The position of the transmitter function switch on the ELT could not be seen through the inspection hole. The aircraft operator is responsible for ensuring that the ELT is armed and functioning.

Investigation of the wreckage disclosed that the ELT antenna was connected and the unit was secured in the bracket. The transmitter function switch on the ELT was found in the OFF position.

The remote switch on N2181L was accessible through a spring loaded, 1 1/8 inch diameter inspection hole which was located on the right side of the fuselage below the leading edge of the horizontal stabilizer. The remote switch had three positions as shown on the placard on the side of the fuselage just below the inspection hole. (See figure 3.) The placarded remote switch positions on N2181L read from left to right, "ARM", "OFF", "ON". The remote switch, when moved to the left toward the ARM position, was spring loaded so that the switch would return to the center OFF position.

The ELT on board N2181L had been installed on October 15, 1980, by the pilot who was flying N2181L when it crashed. It is possible that, from installation until the crash, the ELT transmitter function switch had been in the OFF position and would not have been automatically activated under any condition. Or, the operator may have incorrectly assumed that the ELT was properly armed by turning the remote switch to ARM.

Examination of N2181L revealed that the remote switch for the ELT was located in the rear section of the aircraft. When the ELT was tested and the wiring diagram was checked, the ARM position on the remote switch actually acted as a reset when the ELT impact switch was activated. Further testing of the remote switch revealed that a signal could be transmitted through the ELT, regardless of the position of the transmitter function switch on the ELT. Thus, a CIR-11-2 ELT unit can be installed with the transmitter function switch in the OFF position and a normal test signal will be radiated by momentarily placing the remote switch to the ON position. With the transmitter function switch on the ELT unit in the OFF position, the emergency, or automatic "g" function of the unit, is eliminated. The possibility of confusion of the operators on these functions was recognized and responded to (1) by Collins General Aviation Division when it issued Service Information Letter 1-81, "Supplemental Information on ELT Remote Functions" dated July 15, 1981, and updated the ELT owner's manual and by (2) Beech Aircraft when it provided a modification kit for all Beech aircraft equipped with the CIR-11-2 ELT.

Since this accident, the ELT owners manual, Document 950012, has been updated to include supplementary information regarding the function of the remote switch, and Beech Aircraft has designed a modification consisting of a bracket which will not allow the remote switching plugs to be plugged into the unit unless the ELT transmitter function switch is in the ARM position. The expanded description of the ELT remote switch functions and the modification, which includes new labeling of the remote switch, should reduce misunderstanding of its use. The modification insures that the remote switch is only operational when the ELT transmitter function switch is in the ARM position. As a result, the problem of testing the ELT by turning the remote switch to ON and generating a positive test signal with the ELT transmitter function switch OFF should be eliminated. For example, the old label read "ARM-OFF-ON", which may have suggested to some operators that activation of the remote switch to the ARM position would arm the ELT. The new label reading "REARM-ARM-XMIT" should make the remote switch function clearer to operators. This modification, Beech Kit No. 101-3062-1, applies to all Beech aircraft which have this ELT installed; however, installation of the modification is not required.

Issue an Airworthiness Directive to require that Beech Kit No. 101-3062-1 be installed on all Beech aircraft which have the remote ELT switch installed. (Class II, Priority Action) (A-81-90)

Issue a General Aviation Airworthiness Alert, advising all owners of ELT Model CR-11-2 that they should obtain and retain an updated owner's manual, Document 950012, for use in the installation and operation of this unit. The changes in the manual should also be summarized in the Airworthiness Alert. (Class II, Priority Action) (A-81-91)
