SPECIAL INVESTIGATION REPORT

ROBINSON HELICOPTER COMPANY R22 LOSS OF MAIN ROTOR CONTROL ACCIDENTS

**Adopted: April 2, 1996
Notation 6405B**

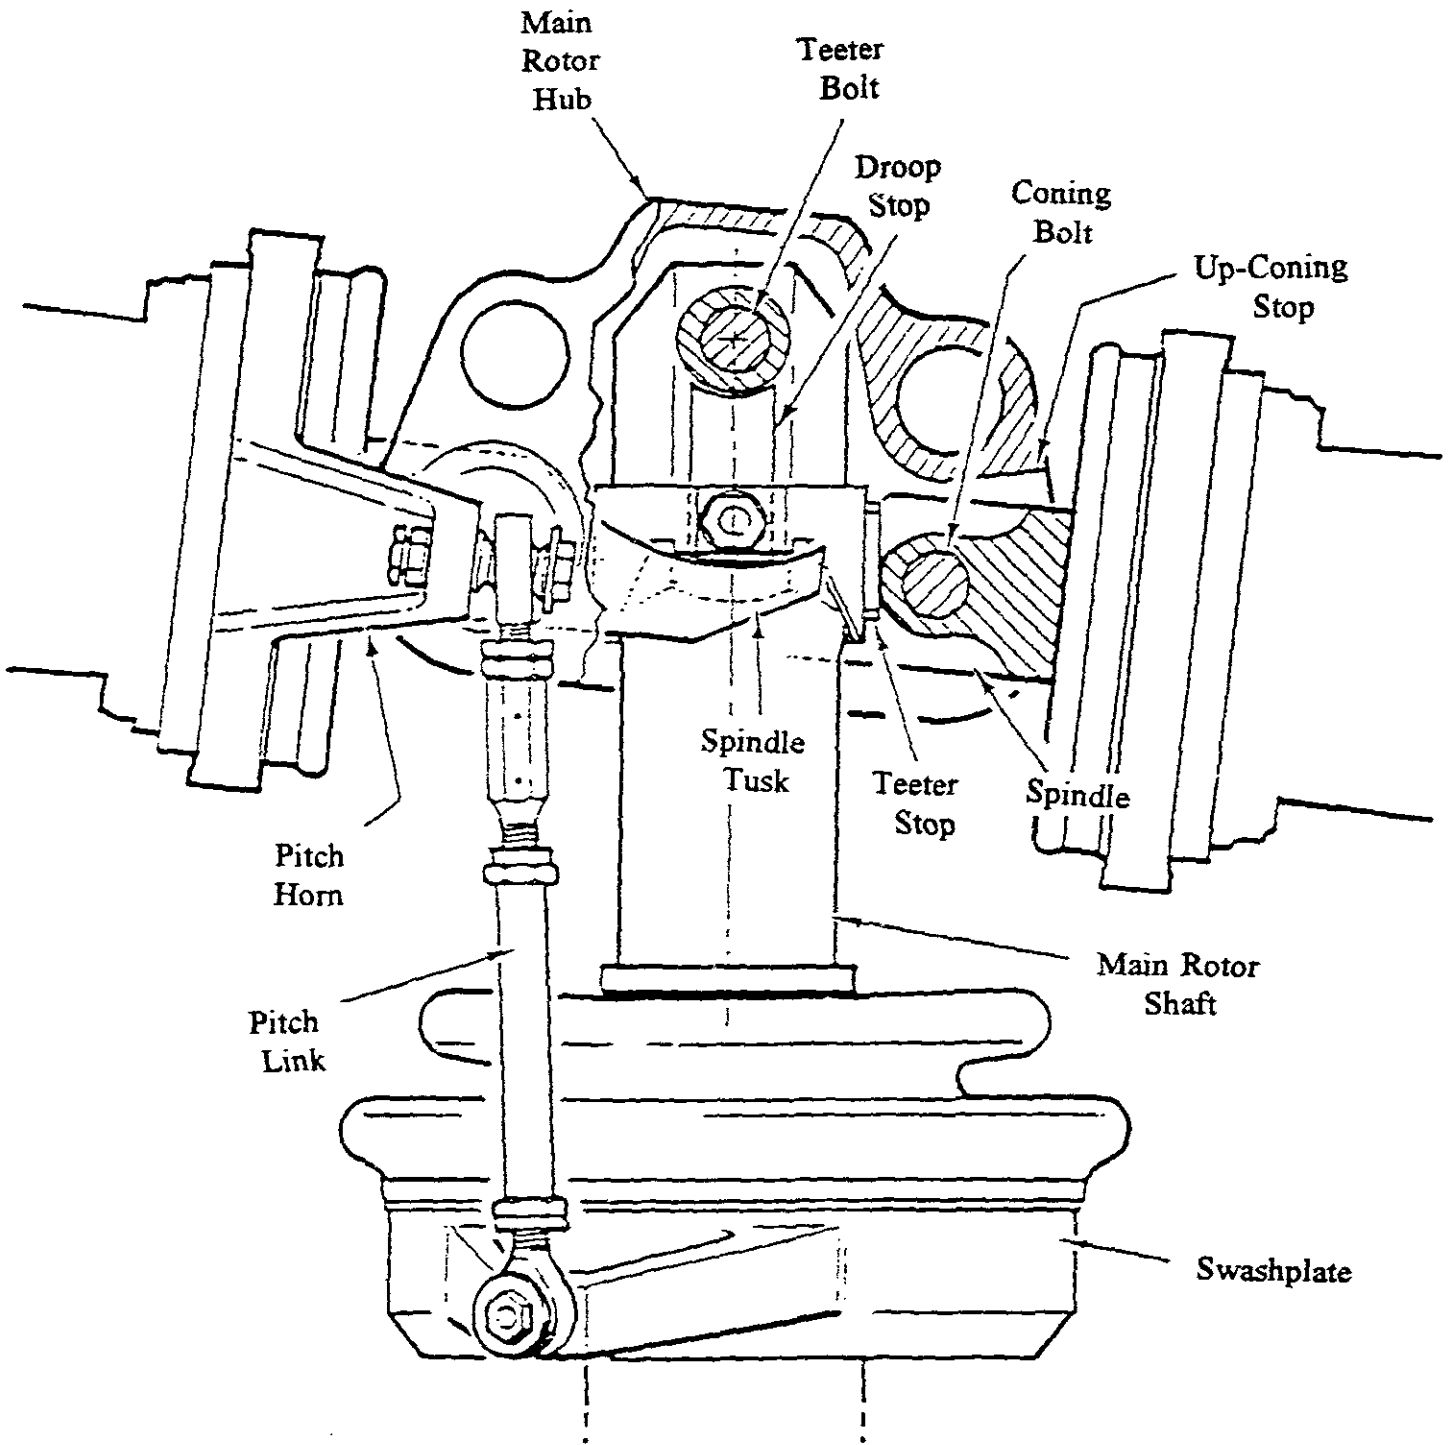
Figure 1--R22 Main Rotor Hub and Assembly
