**EVACUATION PATTERN  
ANALYSIS OF A SURVIVABLE  
COMMERCIAL AIRCRAFT CRASH**

**FEDERAL AVIATION AGENCY  
Aviation Medical Service  
Research Division  
Civil Aeromedical Research Institute  
Protection and Survival Branch  
Oklahoma City, Oklahoma**

MAY, 1962

The evacuation pattern of 99 of 106 survivors of a jet transport crash involving a post crash fire is described, factors possibly effecting the suffocation and ultimate death of 16 passengers are listed and photographs and diagrams are presented.

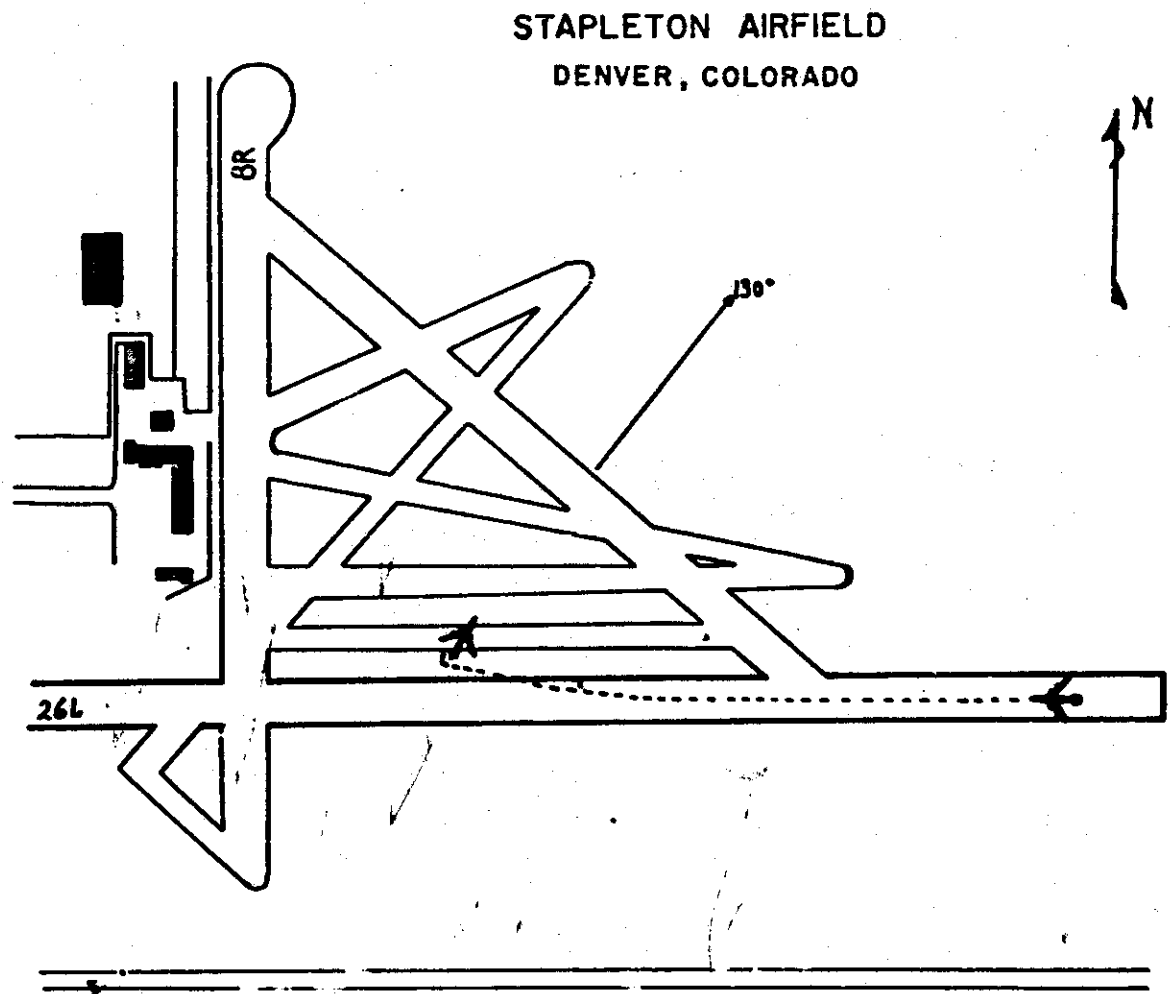
FIGURE 1

According to witnesses, the plane touched down normally within fifteen hundred feet of the rear end of the runway and proceeded down the runway in a straight line for several hundred feet, before it began to veer off to the right. As it skidded off the runway, it gradually yawed to the right and slid almost sideways across open ground, striking a panel truck - killing the driver. Toward the end of this gradual deceleration, the aircraft struck the sheer edge of an incomplete taxiway, on which the aircraft finally came to rest (Fig. 1).

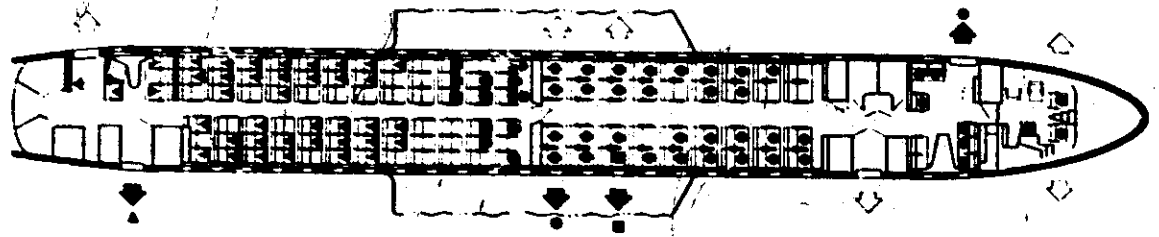
FIGURE 6.

vides an interesting picture (Fig. 6 — it was impossible, due to legal complications, to obtain information from some of the survivors and therefore, the seating diagram is not complete). There were thirty-six passengers and five crew members in the forward cabin-cockpit area; three exits were available in this accident for evacuation of these forty-one persons — a ratio of one exit for each 14 persons.

Seventy-nine passengers and two crew members occupied the tourist compartment, for which there was only *one* exit (a service door) available for evacuation. *All of the fatalities were in this rear compartment*, whose ratio of exit to occupants was 1:81, as compared to 1:14 in the forward compartment.

(6) Requirements and regulations governing the number and location of exits in transport aircraft be re-evaluated in relation to aisle width, passenger capacity and cabin compartmentation.

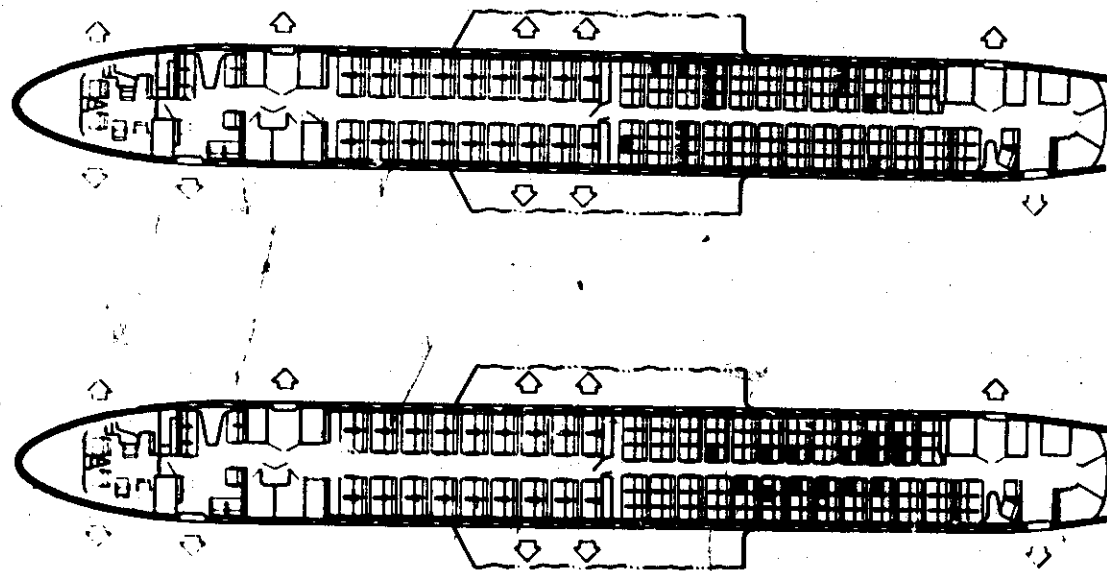
FIGURE 7.

During the routine CARI investigation of this accident, in cooperation with the Civil Aeronautics Board, it was determined that the persons, who had succumbed from carbon monoxide poisoning while attempting to evacuate the tourist section, died in the seats shown in the lower portion of Fig. 7; these were not the seats for which they had been ticketed. It is of interest that these seats in which they died are predominantly spaced at random along the aisle. This indicates that these persons must have left their own seats and were attempting to move down the aisle toward the rear exit when they were overcome; it may be assumed that they collapsed into, or sat down in these seats to try to regain their senses and to await clearing of the aisle.

A portion of this evidence was obtained by noting unburned areas on the covering of backrests and armrests of numerous seats (Fig. 8):

The upper portion of Fig. 7 shows the assumed location of the fatally burned persons, according to the recollections and statements of rescue personnel given during the official hearing several weeks after the accident. The variation between the location of the fatally injured persons, according to the memory of rescue personnel, as compared to the locations determined by findings of experienced investigators at the scene of the accident (as shown in the lower portion of Fig. 7), is easily apparent; this would appear to indicate that information obtained from witnesses who have been involved in a psychologically shocking experience — such as the removal of human bodies from an aircraft — should be treated with utmost caution.
