1. Report No. FAA-AM-72-15	2. Government Accession No.	3. Recipient's Catalog No.	
4. Title and Subtitle CRASH SURVIVAL ANALYSIS OF 16 AGRICULTURAL AIRCRAFT ACCIDENTS		5. Report Date April 1972

CRASH SURVIVAL ANALYSIS OF 16 AGRICULTURAL AIRCRAFT ACCIDENTS

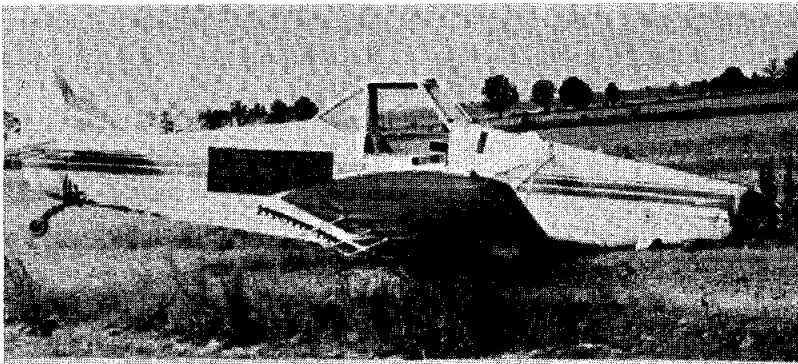
a. Side view of aircraft showing minor damage mostly to landing gear and propeller.

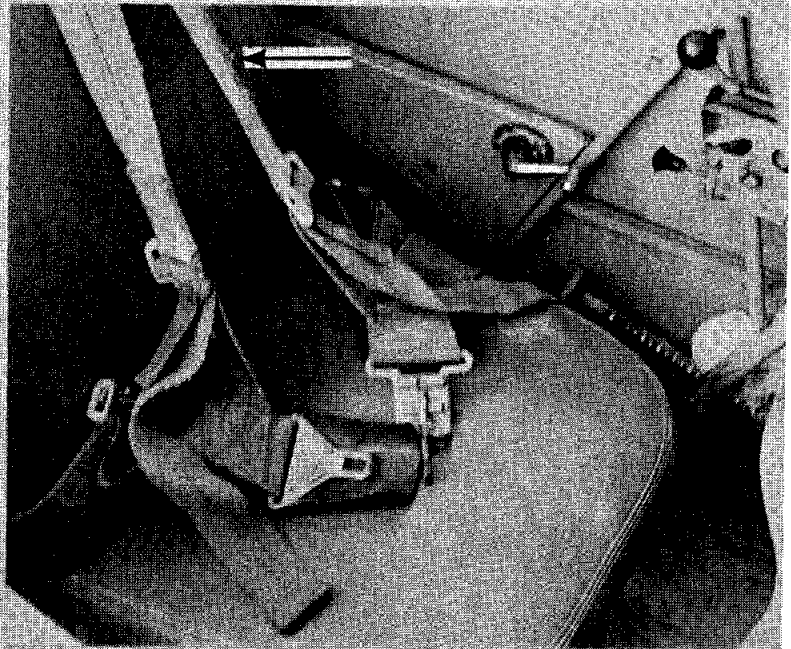
injuries. The upper torso restraint, lap belt, and crash helmet protected the pilot from injury. However, the frayed shoulder straps indicated by an arrow in Case 1-b are indicative of a potential hazard. This aircraft was less than three years old and, while the frayed straps were strong enough to hold in this accident, they probably would have failed in a more severe crash. In addition, please note the metal-to-metal attachment of the shoulder harness to the lap belt buckle.

b. Shoulder straps and lap belt held in this minor accident but it should be noted that the shoulder straps are becoming frayed (see arrow) and would be sure to fail in an accident of greater crash severity.

Minor accident of a 1968 Piper Pawnee (PA-25-235) presented to show the use of frayed shoulder straps. No injuries were inflicted in this accident.

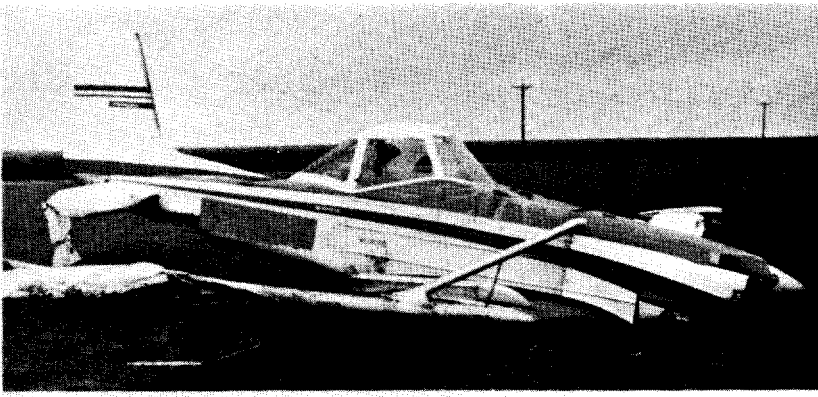
a. Minor crash landing of a 1968 Cessna Agwagon (A-188).

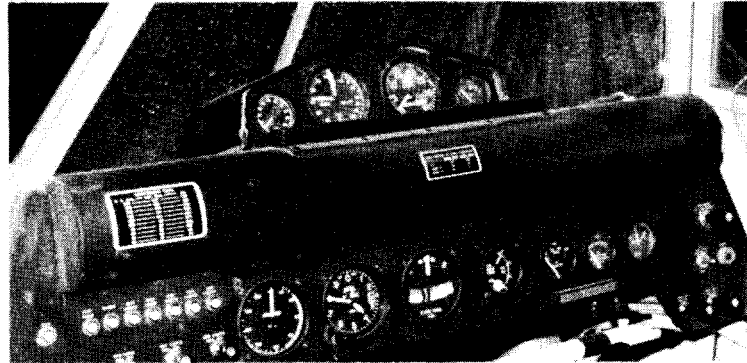
b. Protective aluminum roll undamaged.

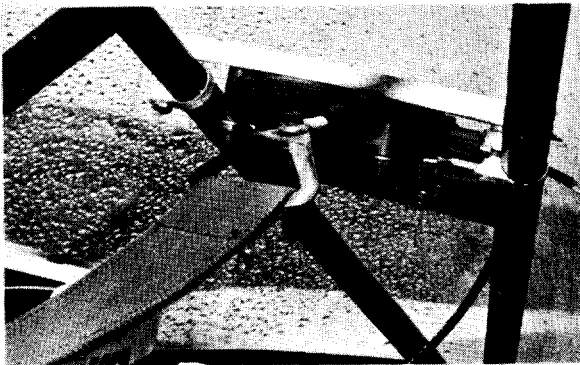
c. Shoulder straps attached to inertia reel fastened to strong tubular structure high in the aircraft.

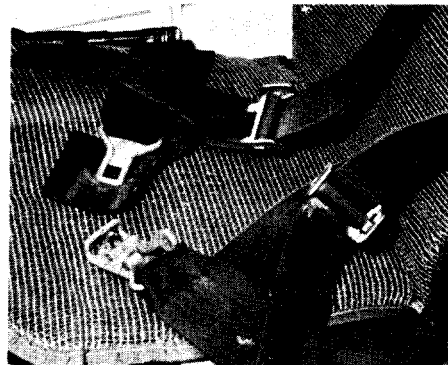
d. Shoulder straps sewed flat to one face of the lap belts.

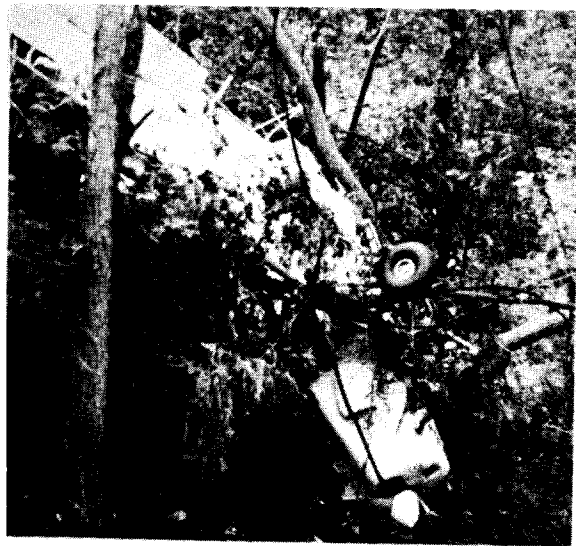
a. A 1969 Aerocommander Callair A-9B involved in a moderately severe crash in trees.

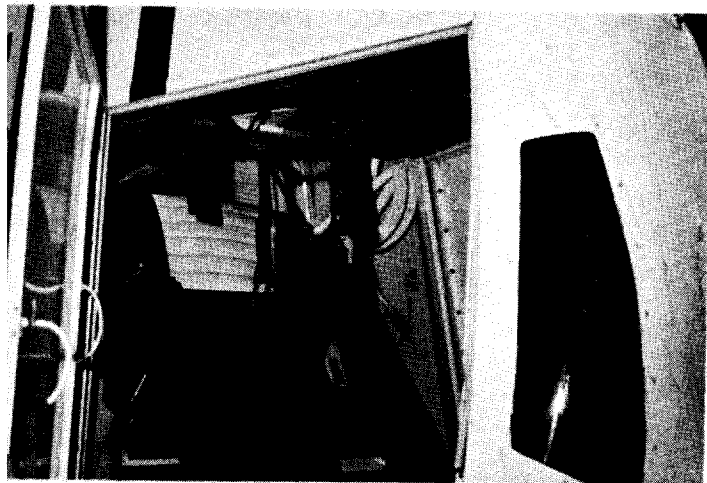
c. Aircraft was equipped with shoulder harnesses, but the pilot was not wearing them.

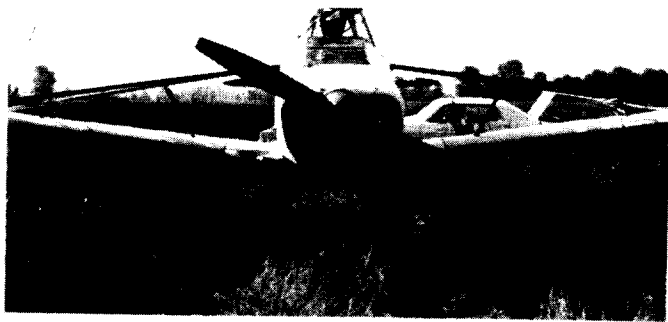
a. View of aircraft after being turned back right side up.

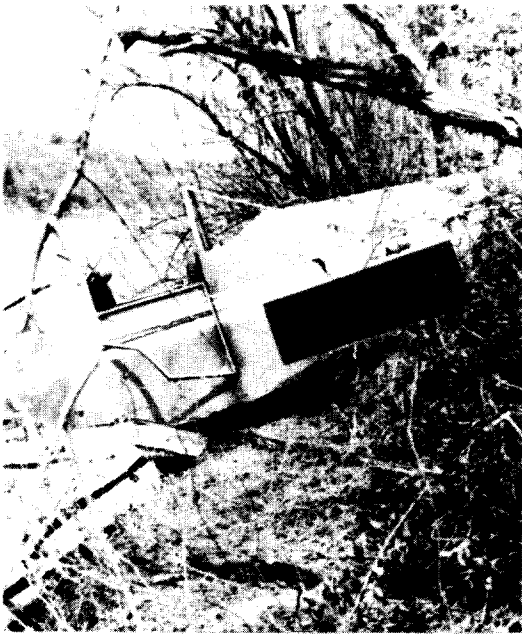
a. Side view of aircraft after being pulled out of the water.

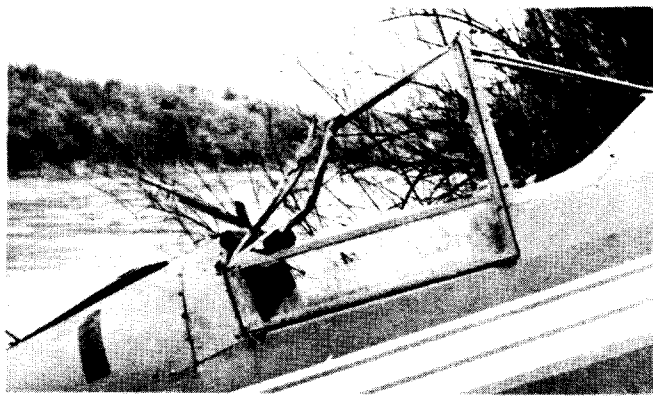
b. Close-up showing failure of roll bar structure.

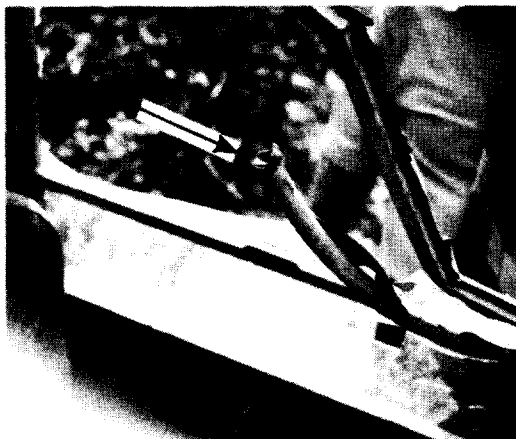
c. Broken weld joint of vertical bar formed sharp cutting edge (see arrow).

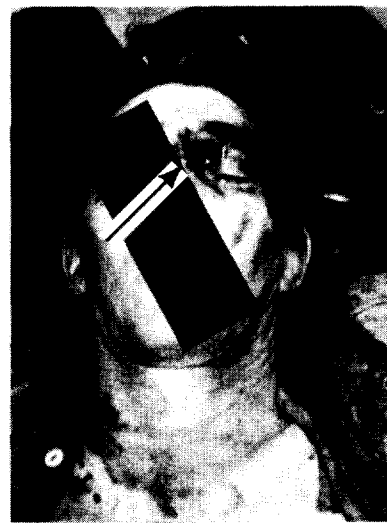
d. Puncture wound (fatal) just below edge of helmet inflicted as broken roll bar was forced down and to the rear into the cockpit.

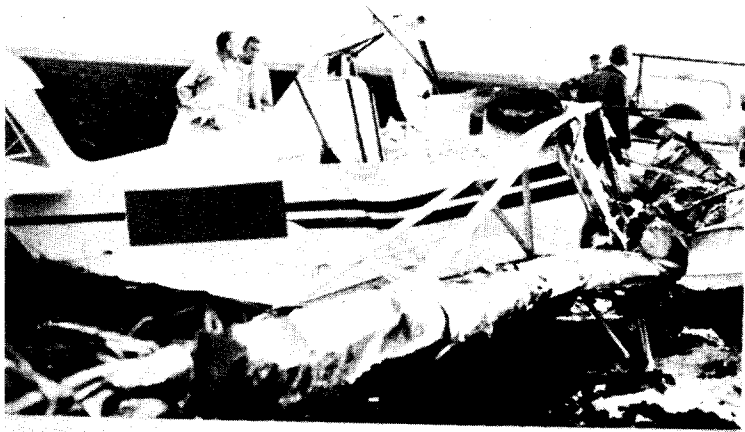
a. Side view of an aircraft involved in a severe crash.

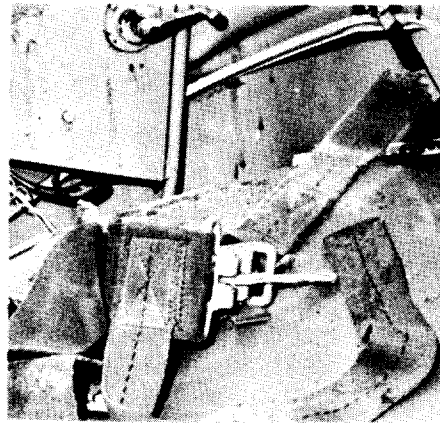
b. Both shoulder straps broken, lap belt held.

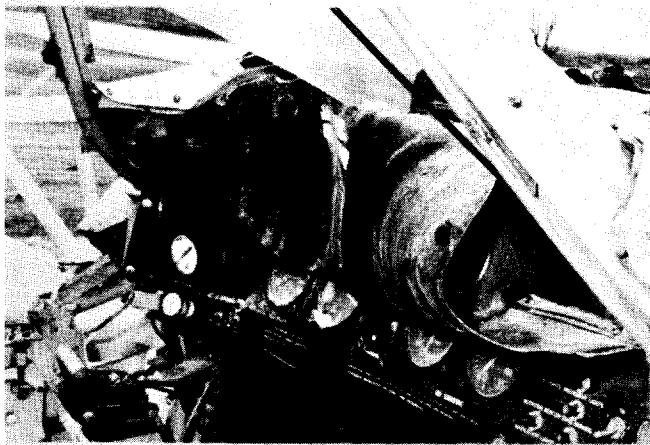
c. Dent in aluminum roll from head impact.

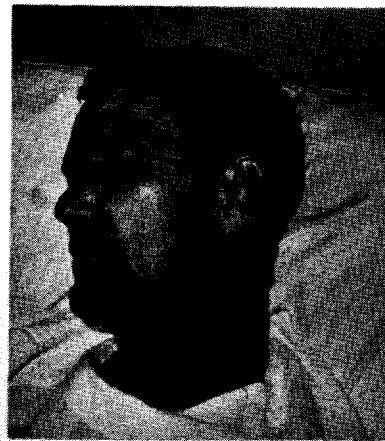
d. Photograph showing cut on pilot's chin from contact with altimeter reset knob.

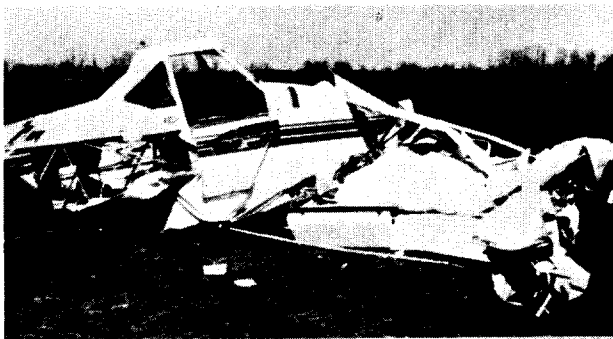
a. Side view of aircraft showing considerable damage to right wing, motor mount, and lower fuselage tubing to the rear of the cockpit.

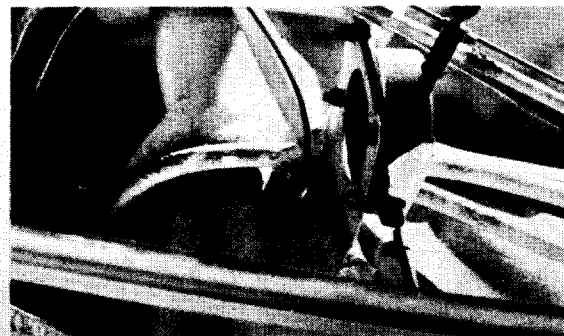
b. Upward bending of lower fuselage tubing at the attachment point of the inertia reel and right lap belt cable allowed 10 inches of slack and forward motion of the pilot.

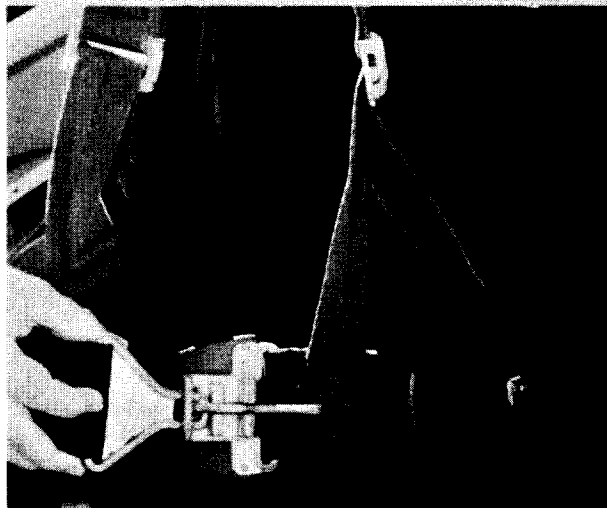
c. Photograph showing that restraint equipment remained intact.

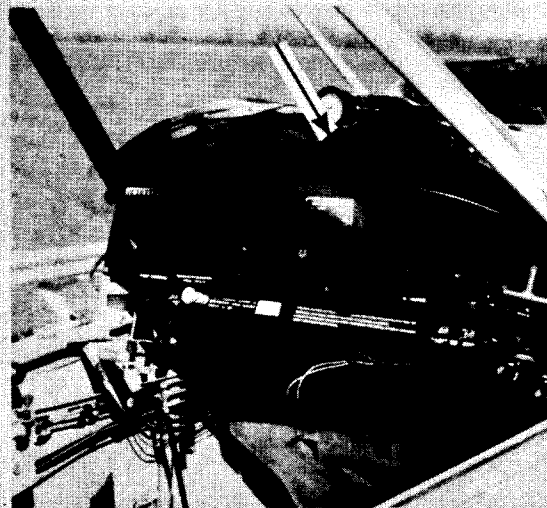
d. As the restrained pilot moved forward and to the right in the cockpit, his head impacted the light aluminum roll at the top of the instrument panel (see arrow indicating dent) and his right knee contacted the lower instrument panel to the right of the RPM gage.

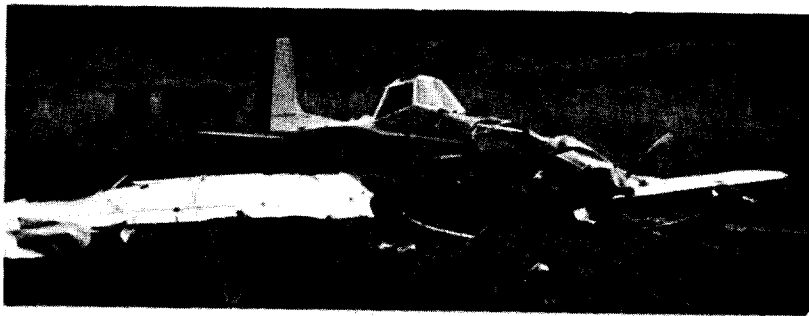
a. View of a moderately severe crash of a 1970 Cessna Agwagon (188B)

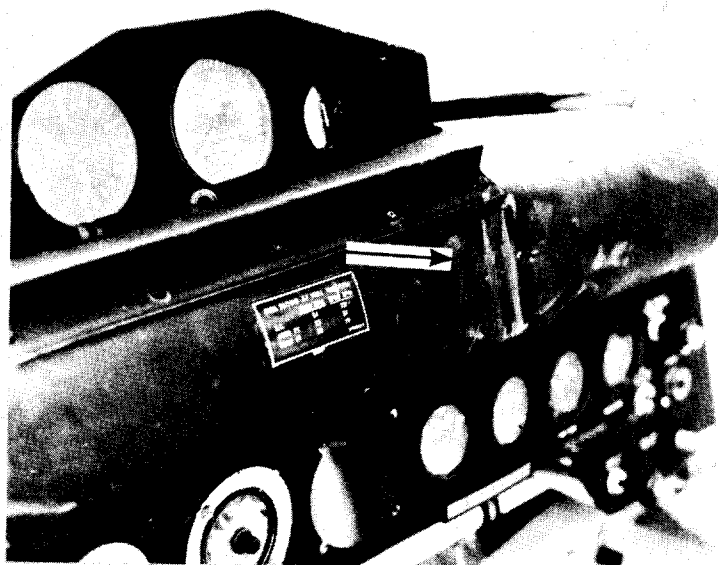
b. Pilot was wearing his shoulder straps loosely, allowing his head to strike the aluminum roll (see arrow).

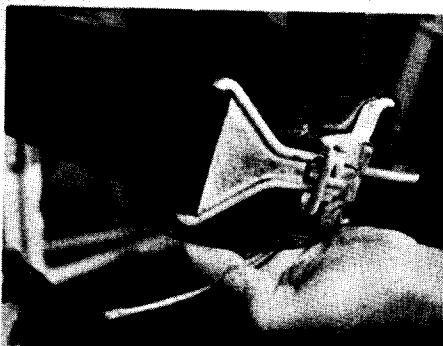
d. Restraint system was in use and held.

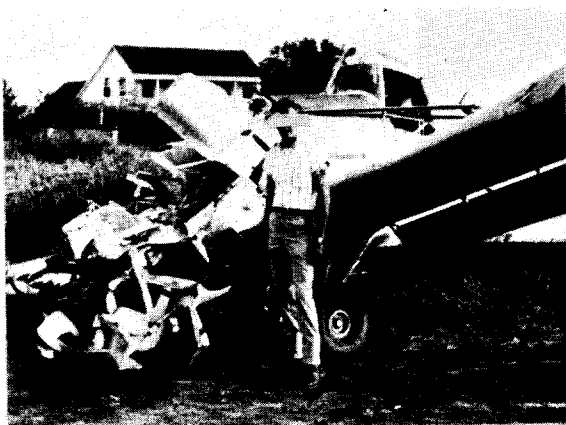
a. A moderately severe crash of a 1969 Aerocommander Callair A-9B and the uninjured pilot.

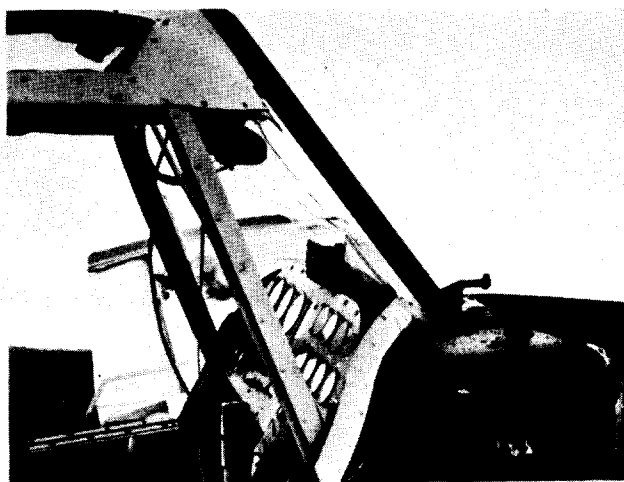
b. Rigid instrument panel without head impact protection.

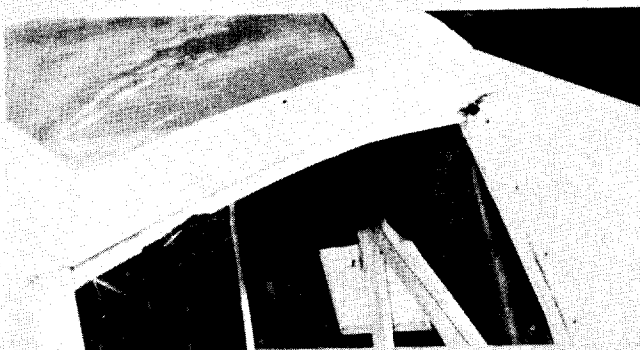
c. High strong attachment of shoulder harness.

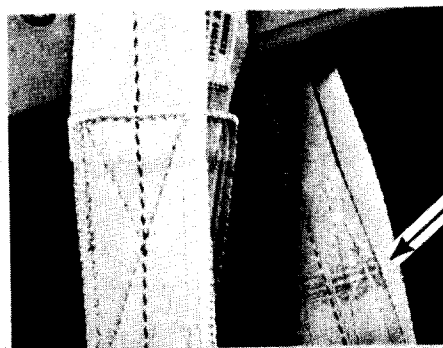
d. Shoulder strap webbing is becoming frayed and should be replaced.

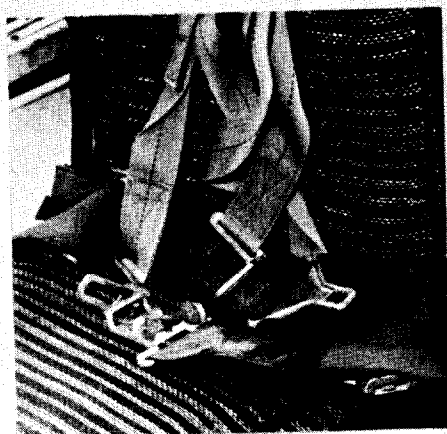
e. Metal-to-metal attachment of shoulder straps to lap belt forms a more reliable restraint system than sewing shoulder straps to one surface of the belt.

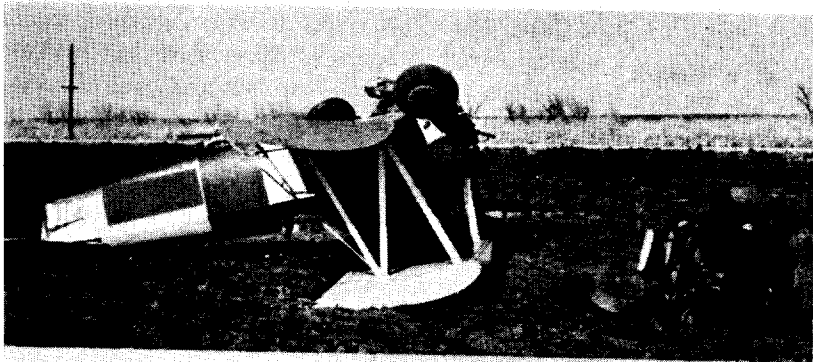
a. Moderately severe crash of a 1940 Boeing Stearman (B-75) that gouged into hard ground and flipped over.

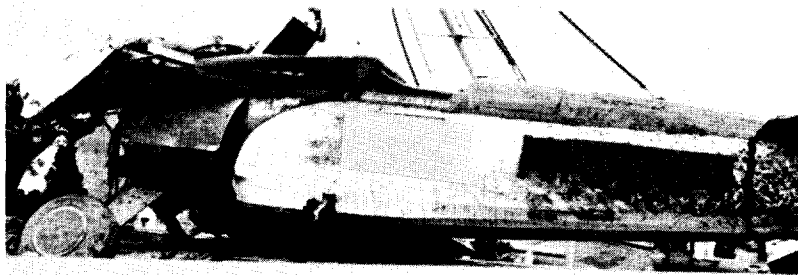
a. A 1943 Boeing Stearman A-75 crashed at a steep angle with sufficient force to drive the top wing forward but did not flip over.

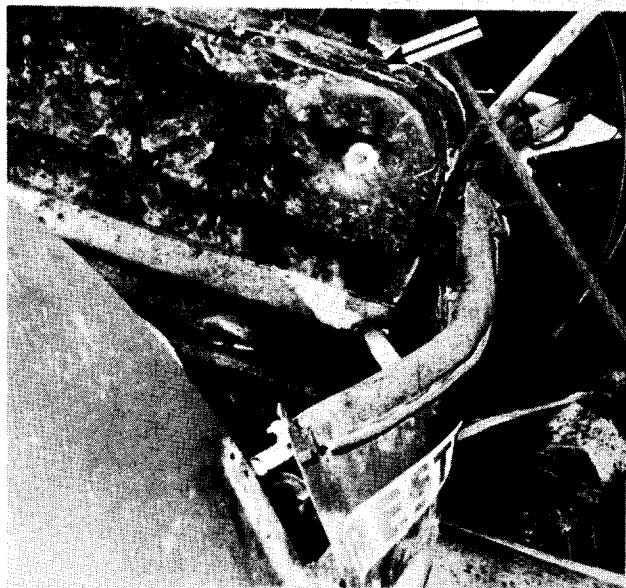
c. Pilot was thrown forward, hitting his neck on the top of the instrument panel (note arrow).

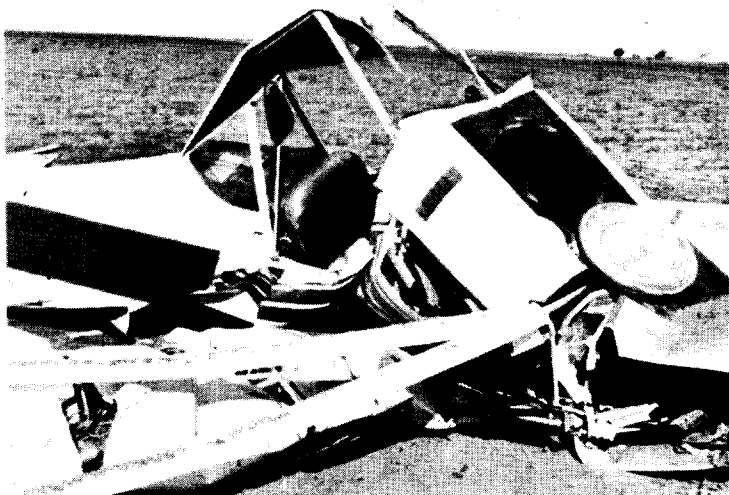
a. Side view of an aircraft involved in a severe crash. Severity of crash is indicated by failure of motor and its mounts, collapse of the hopper and partial collapse of cabin.

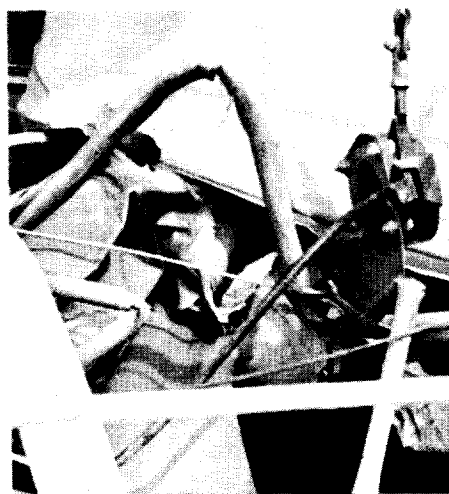
b. Upward bending of inertia reel attachment on lower fuselage tubing to rear of cockpit allowed slack in shoulder harness & forward movement of the pilot.

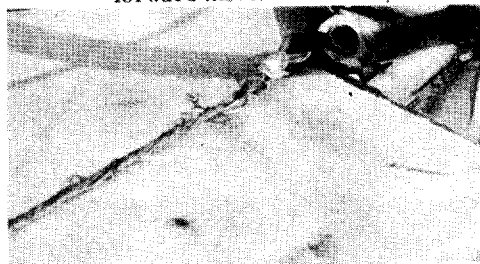
d. Right seat belt cable badly frayed but did not break.

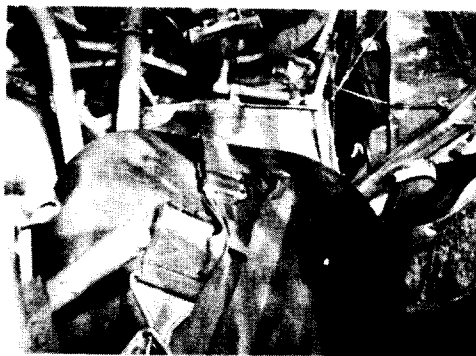
b. Force of impact was sufficient to break both shoulder straps and the 3-in. lap belt in two places.

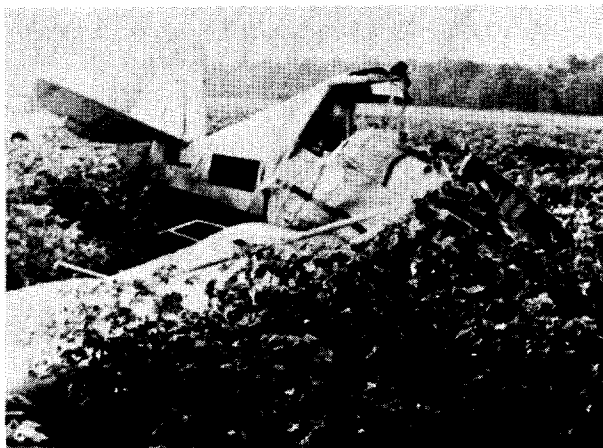
a. Overall view of a 1968 Aero Commander Callair A-9B involved in a severe crash.

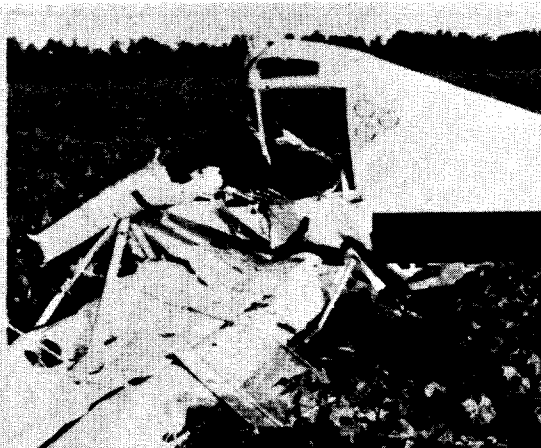
b. Severity of crash forces are indicated by the fact that the hopper has disintegrated and there is a partial failure of the cockpit.

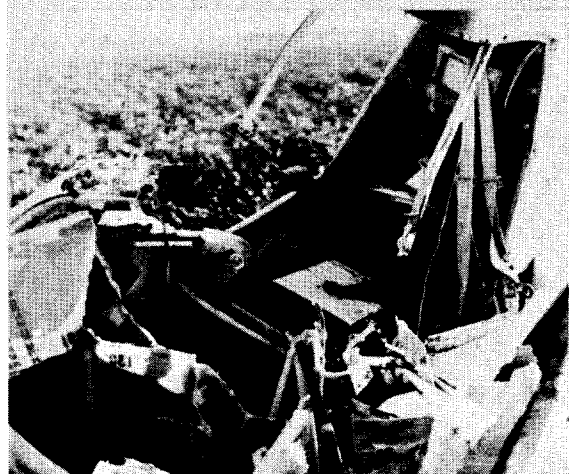
c. View into cockpit showing seat belt & shoulder straps. Pilot was utilizing only one shoulder strap tied to lap belt.

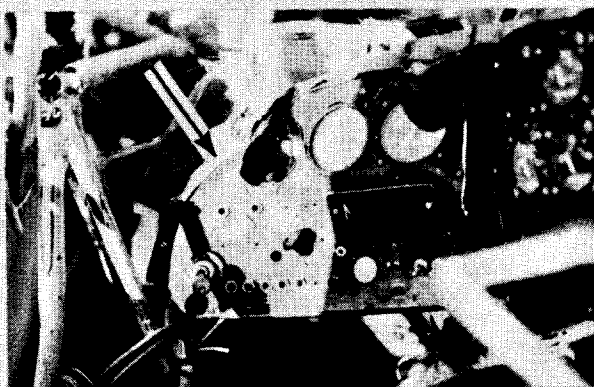
e. View of left instrument panel showing facial impact area. Note the absence of the protective aluminum semicylinder pointed out on the Pawnees & Callairs.

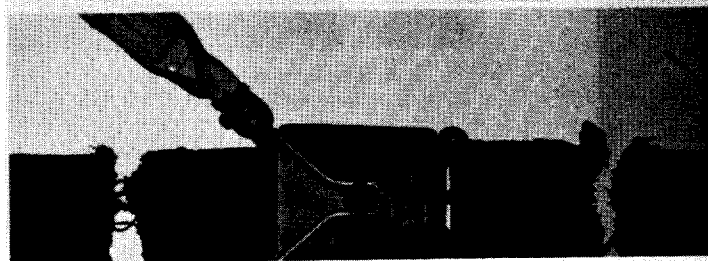
d. Single shoulder strap tied to lap belt. Note the 3-in. belt broke on both sides of buckle at approx. contact points of iliac crests of pelvis.

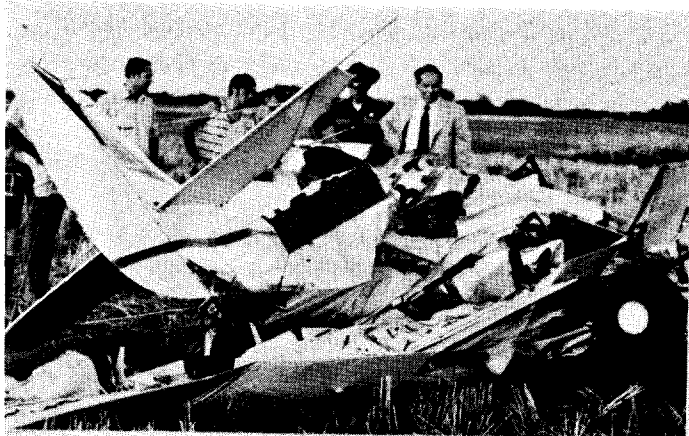
a. Side view of a very severe crash.

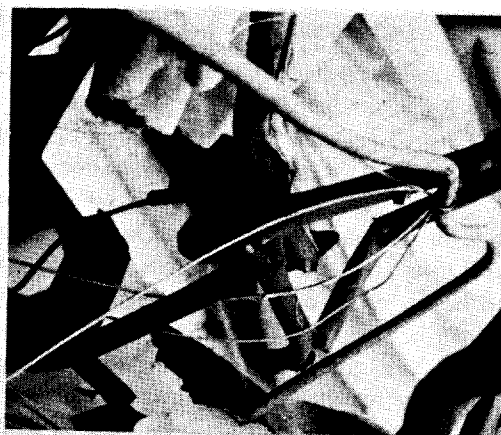
b. Upward bending of inertia reel and lap belt attachment points to lower fuselage tubing behind the cockpit.

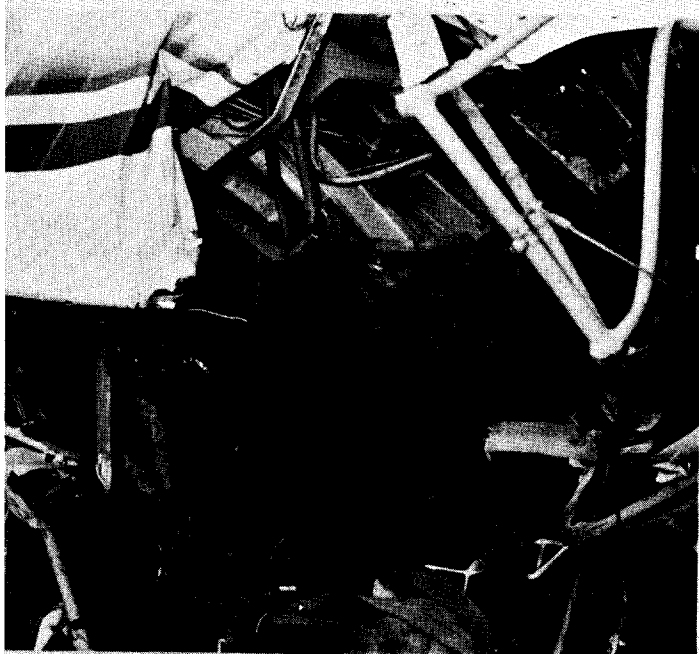
c. Almost complete failure of cockpit cabin integrity. Note that the lap belt did not fail.
