# INJURIES IN AIR TRANSPORT EMERGENCY EVACUATIONS

Donell W. Pollard  
Civil Aeromedical Institute  
Federal Aviation Administration  
Oklahoma City, Oklahoma

February 1979

1. Report No. FAA-AM-79-6	2. Government Accession No.	3. Recipient's Catalog No.	
4. Title and Subtitle  INJURIES IN AIR TRANSPORT EMERGENCY EVACUATIONS		5. Report Date

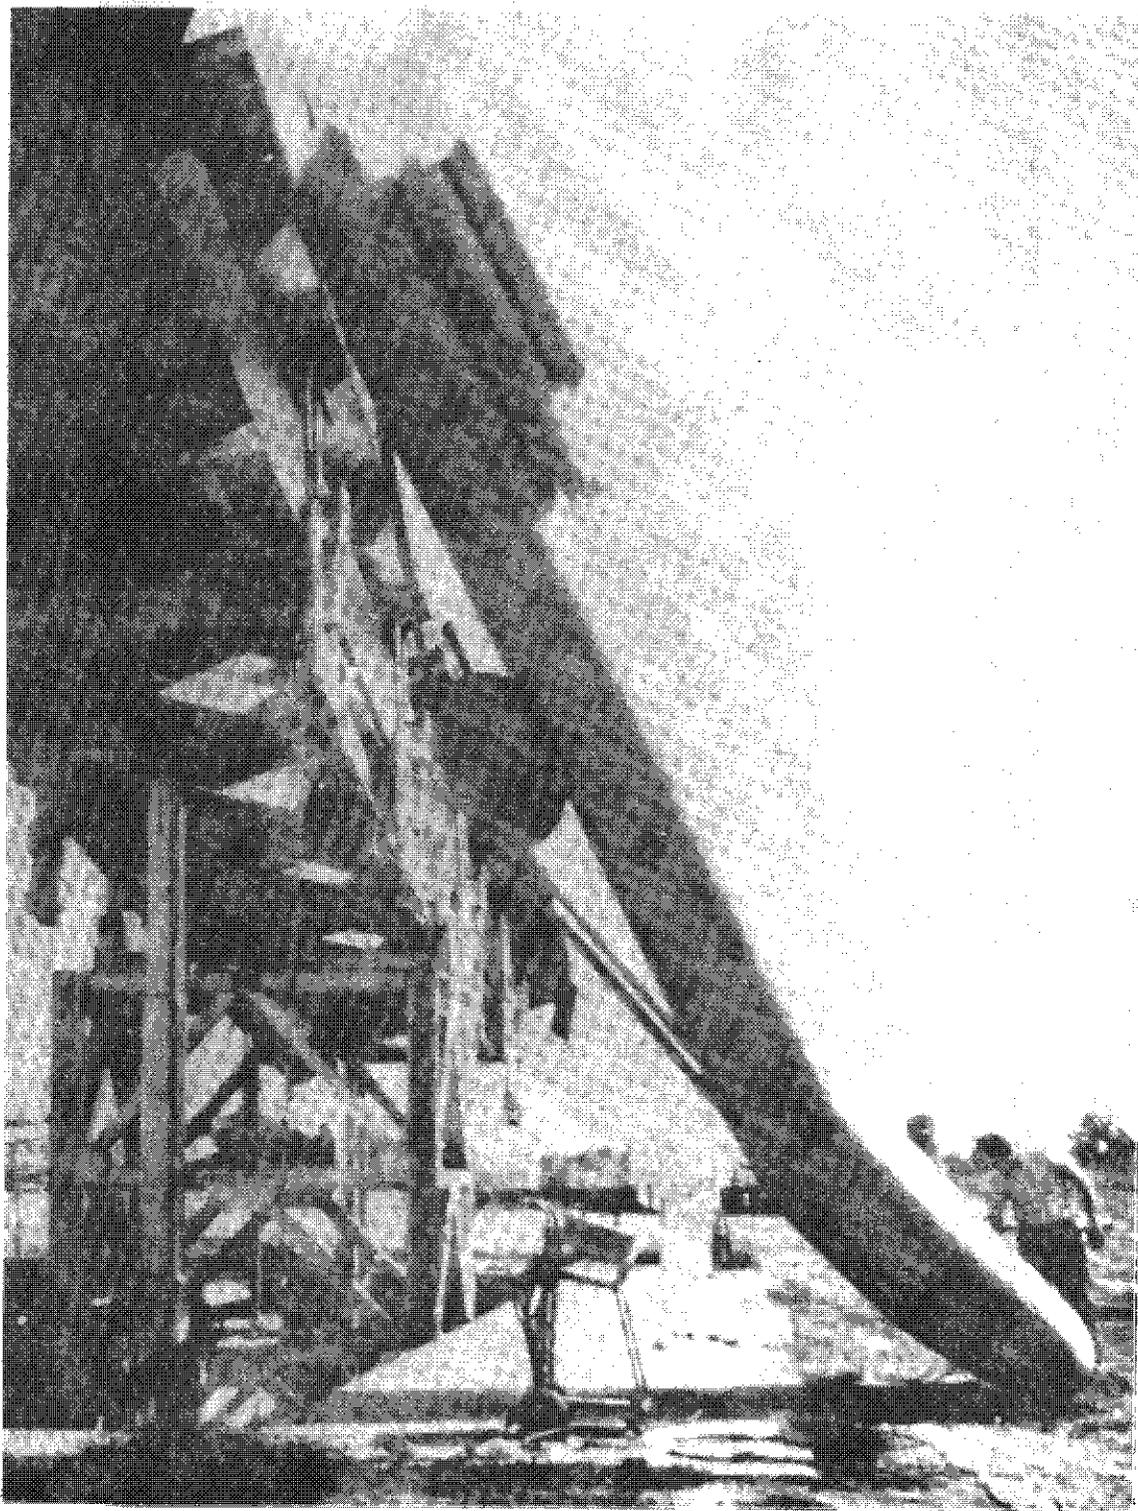
FIGURE 1. CAMI evacuation simulator showing slide deployed at a  $68^{\circ}$  angle.

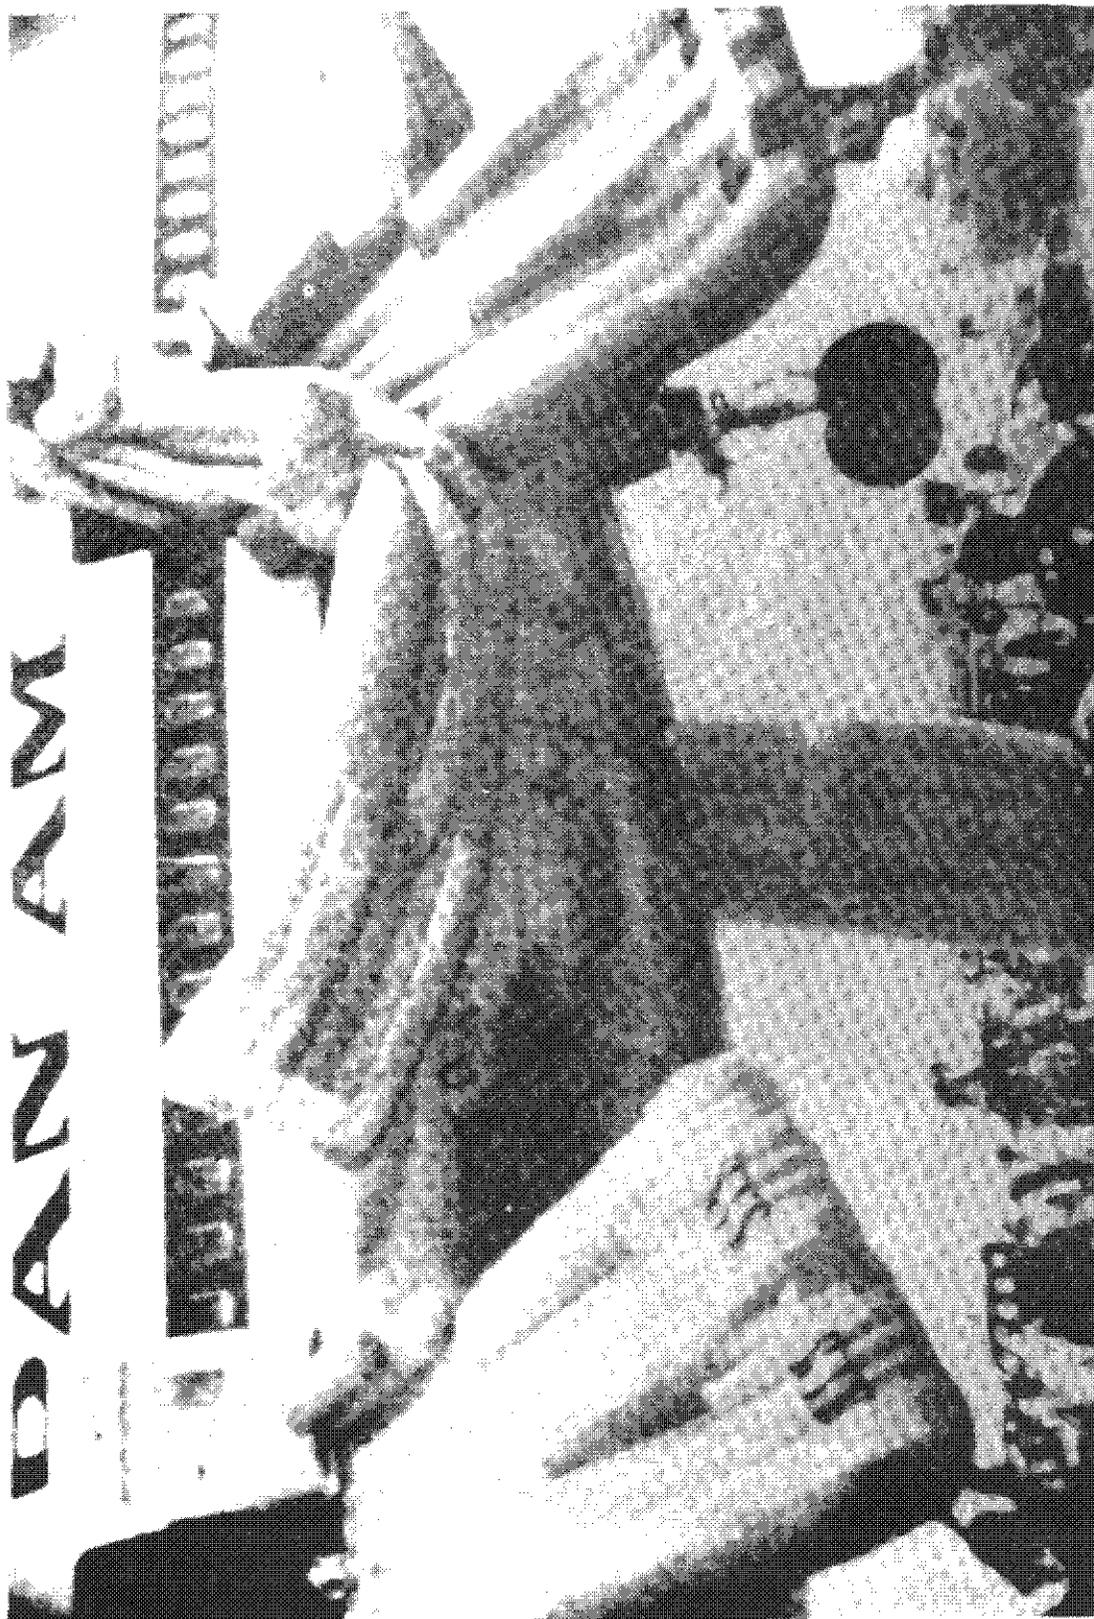
On July 30, 1971, after sustaining structural damage during takeoff, a Pan American World Airways (PAA) B-747 circled, landed at San Francisco International Airport and, after stopping, came to rest on its nose gear. It then gradually rotated and after 70 s rested in a nose-high attitude that caused the forward emergency slides to assume an angle of  $68^{\circ}$  as opposed to a normal angle of  $37^{\circ}$  to  $40^{\circ}$ . The crewmembers were confused about the responsibility and signal for evacuation initiation, and the evacuation did not start until 30 s after the airplane came to a stop. At this time the forward doors were opened by members of the flight deck crew. The other doors were then activated front to rear as cabin crewmembers observed the evacuation activity at the doors in front of their assigned positions. The aft doors were opened 70 s after the airplane stopped. "There is no record of the elapsed time to complete evacuation (3)." Motion picture film shows that at least four passengers used the right front door after the airplane rotated, and it is known that several other passengers also used the right front door at this time. However, the portion of the 199 total passengers who used the forward escape slides is not clear. Eight of those who did sustained serious back injuries and reported that the slide was quite steep.

FIGURE 2. PAA B-747 after rotation of aircraft and following evacuation. Slides at the right and left front doors, number 2 exit slide, and slide at lounge area exit are shown.
