AIRCRAFT ACCIDENT REPORT

CRASH DURING LANDING
FEDERAL EXPRESS, INC.
MCDONNELL DOUGLAS MD-11, N611FE
NEWARK INTERNATIONAL AIRPORT
NEWARK, NEW JERSEY
JULY 31, 1997

**NTSB/AAR-00/02
DCA97MA055
PB2000-910402
Notation 7047B
Adopted July 25, 2000**

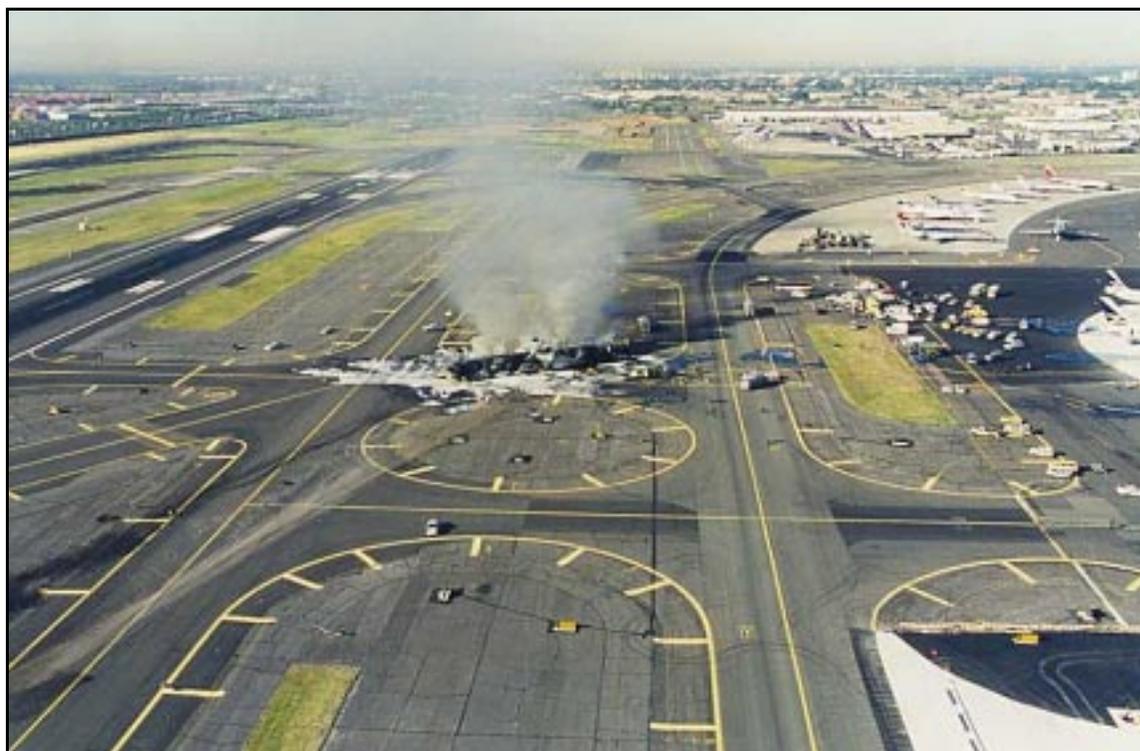
Figure 1. Aerial view of the accident site.

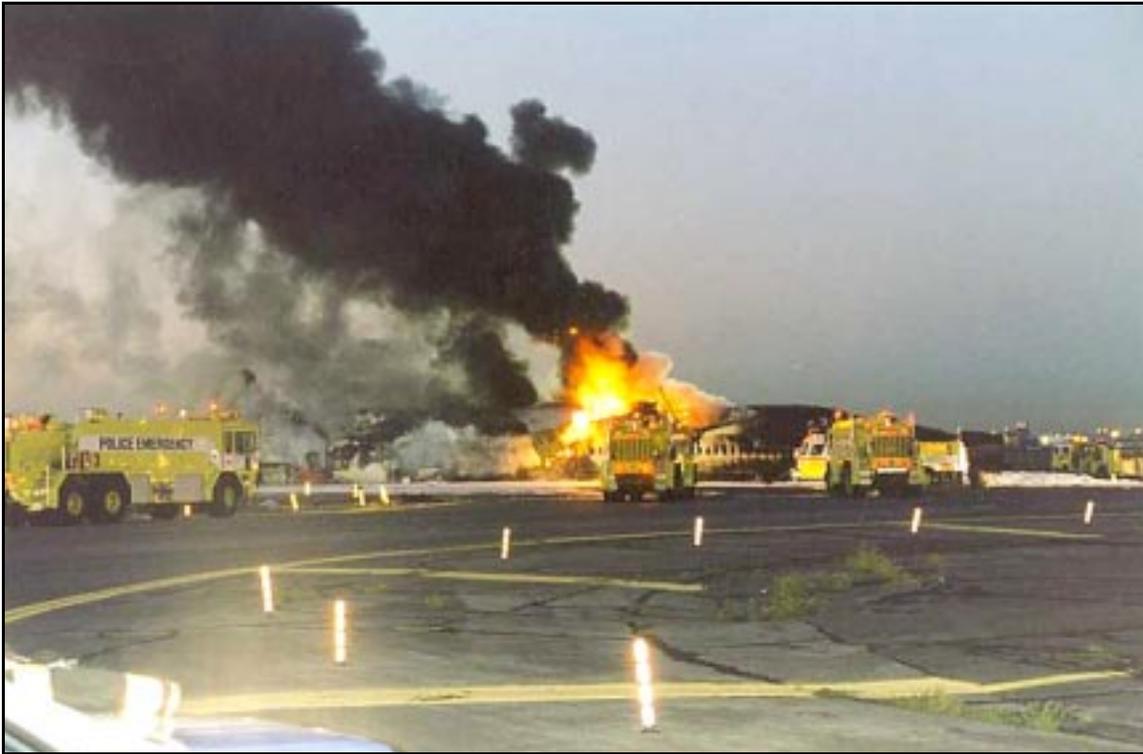
Figure 2. N611FE at the height of the firefighting effort.

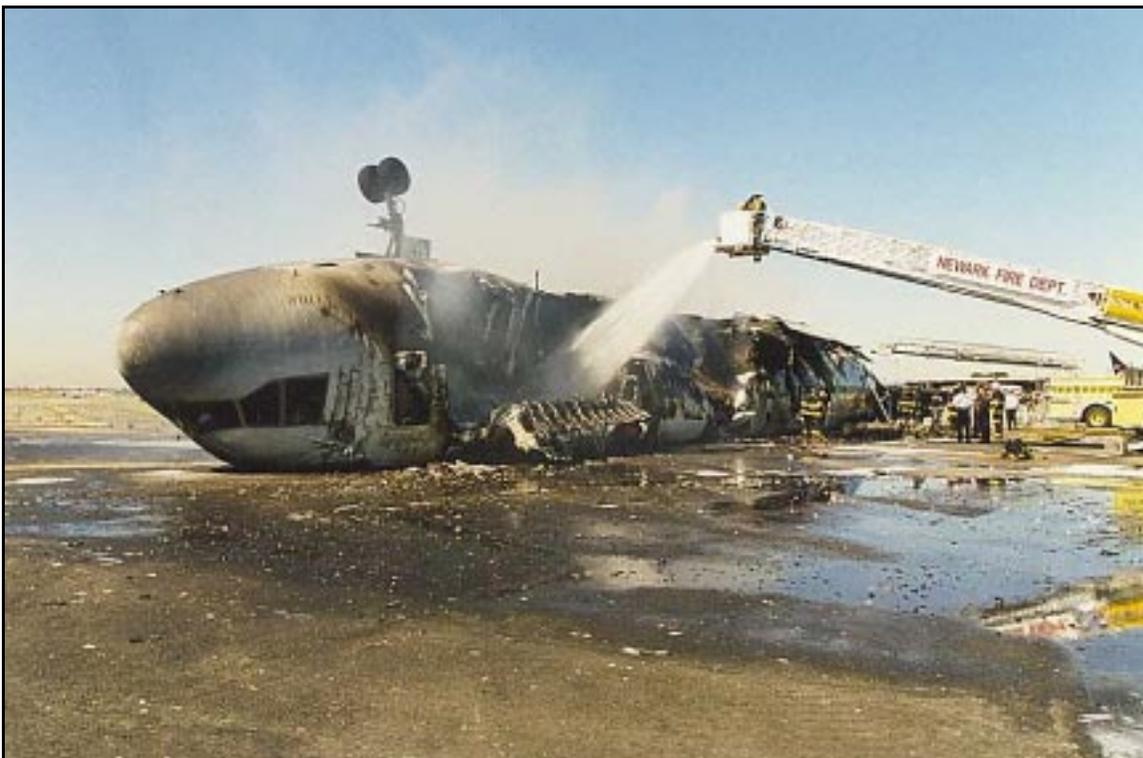
Figure 3. N611FE during the final portion of the firefighting effort.

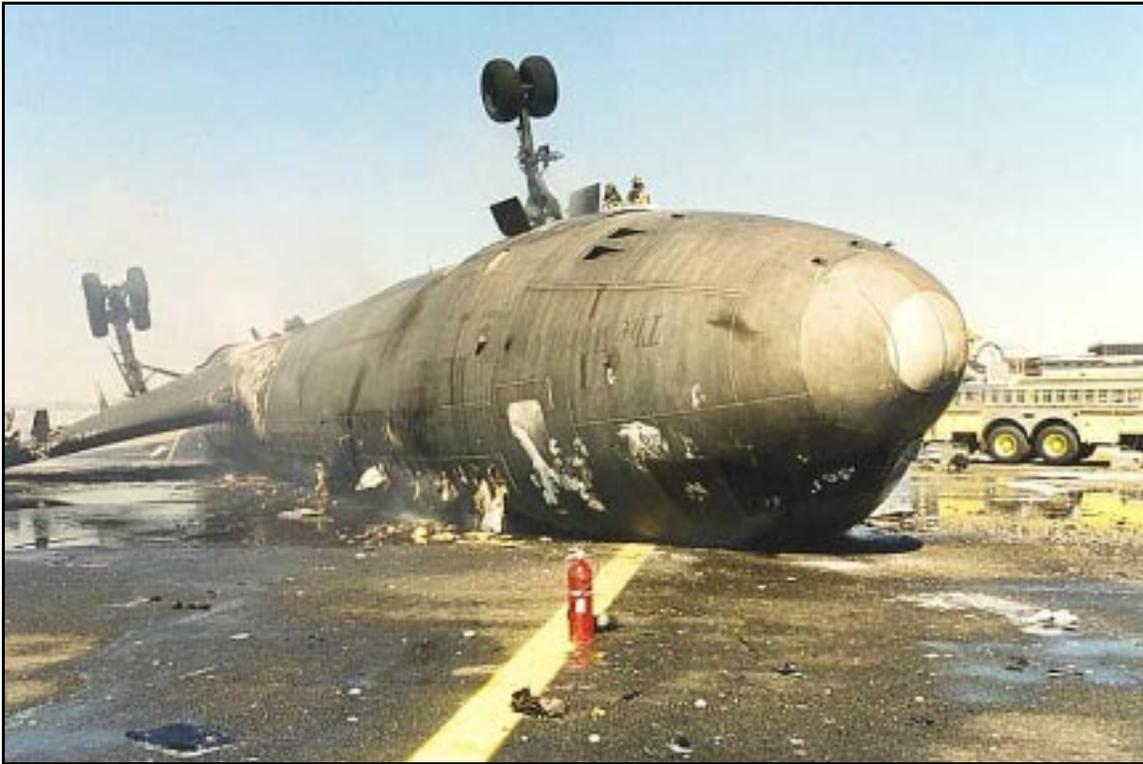
Figure 4. N611FE after the fire was extinguished.

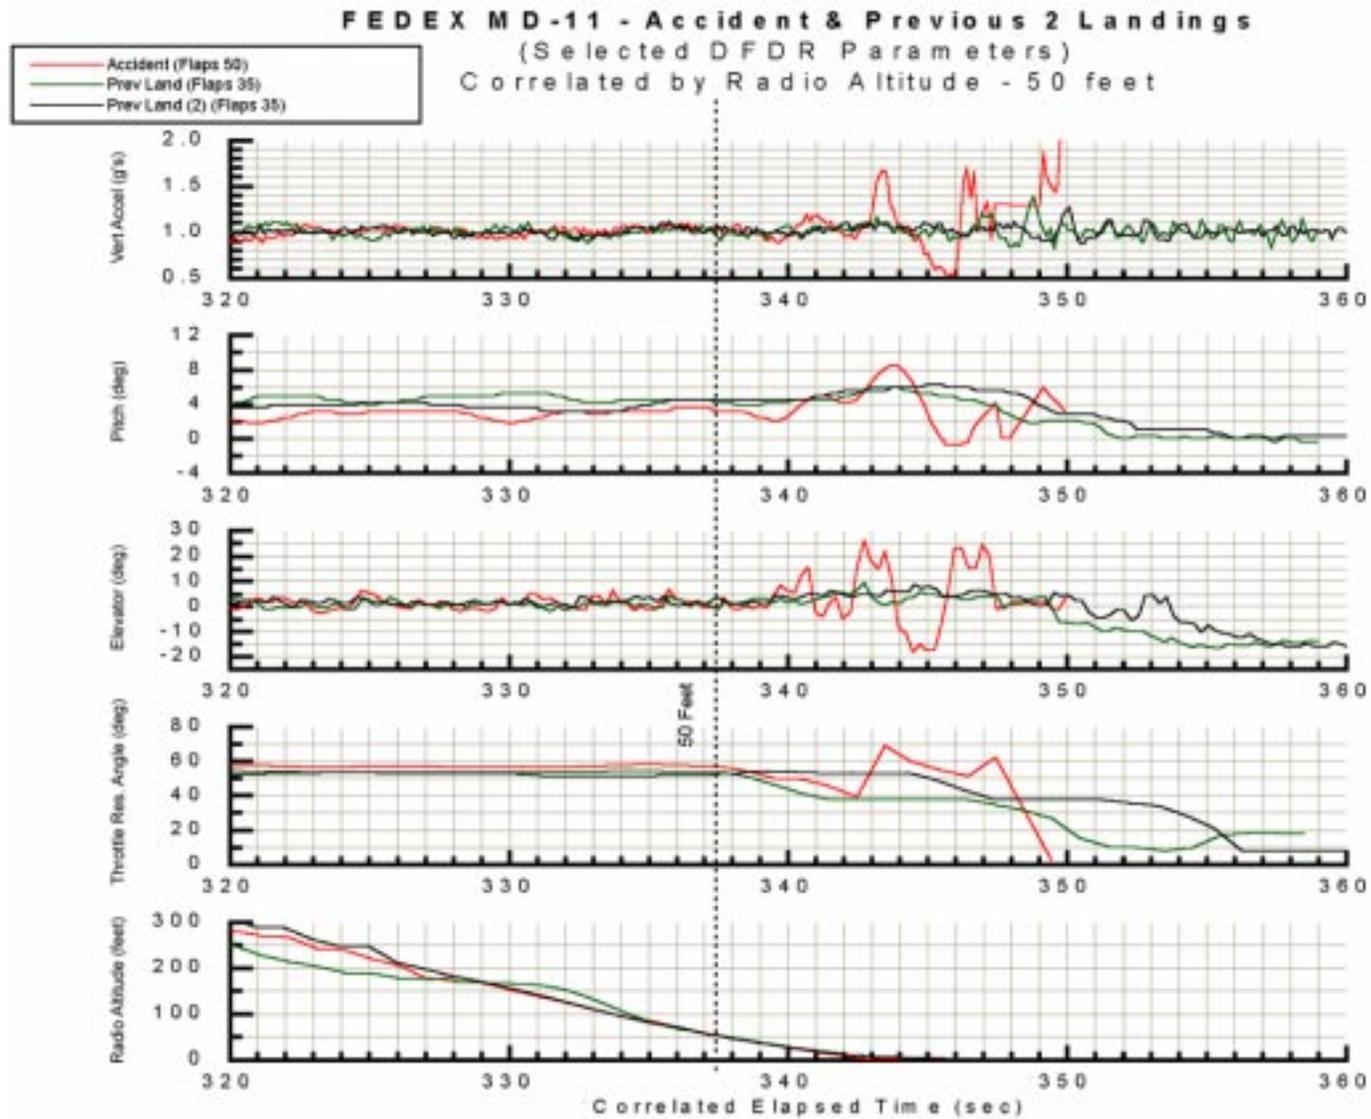
Figure 5. Comparison of selected FDR parameters for accident landing and previous two landings (correlated by radio altitude – 50 feet).

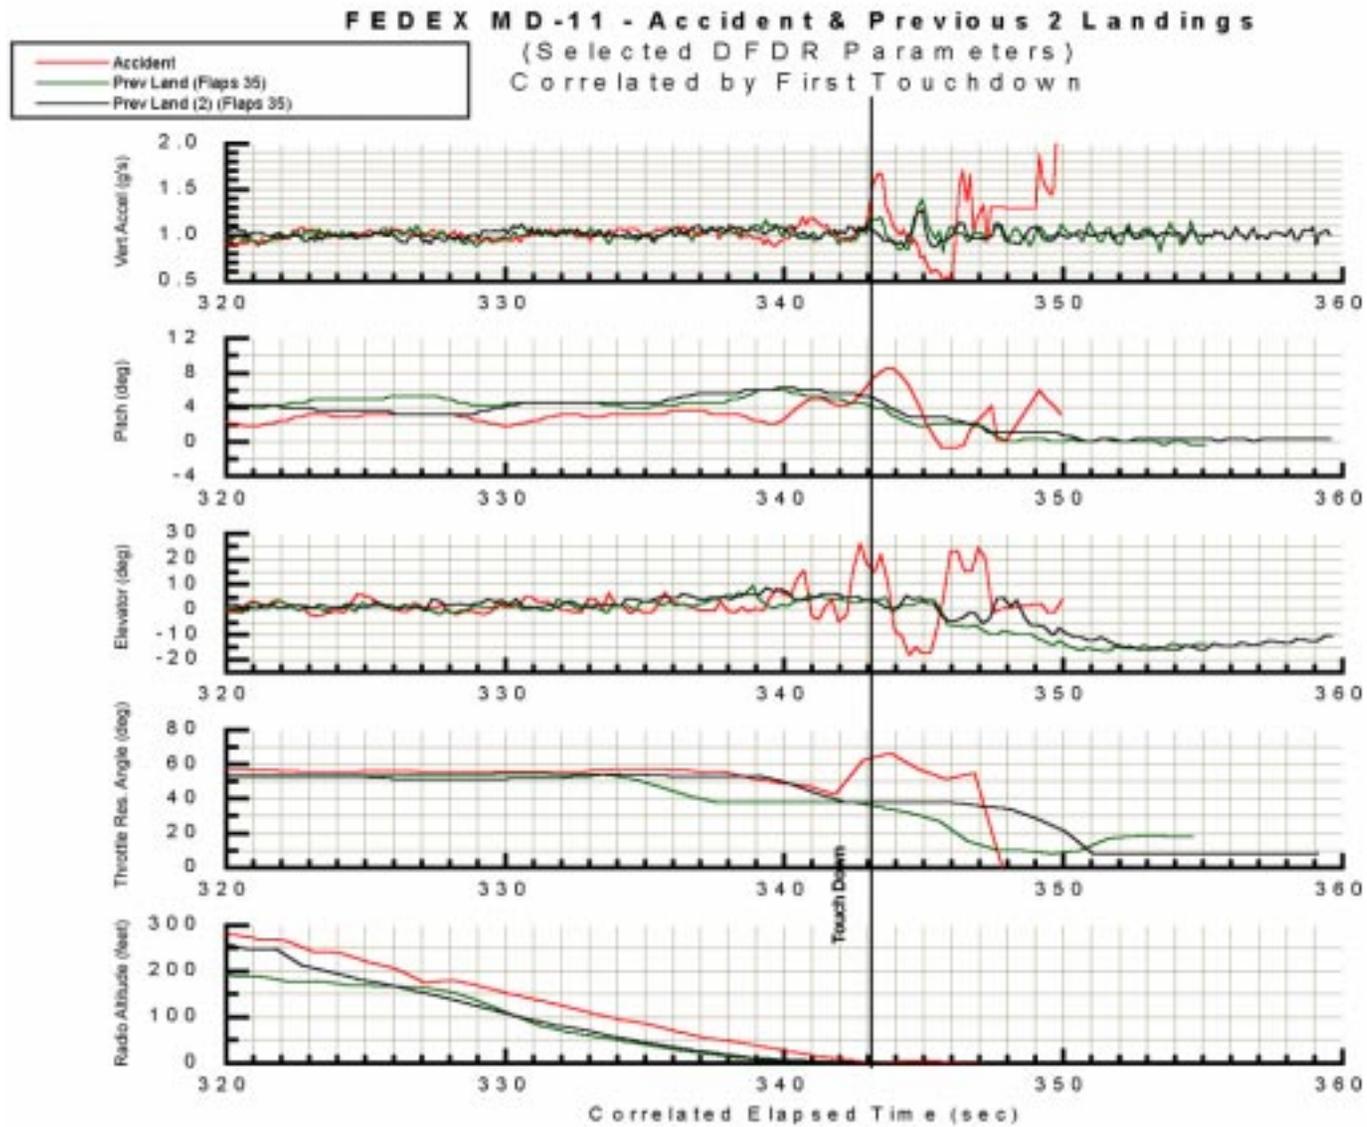
Figure 6. Comparison of selected FDR parameters for accident landing and previous two landings (correlated by first touchdown).

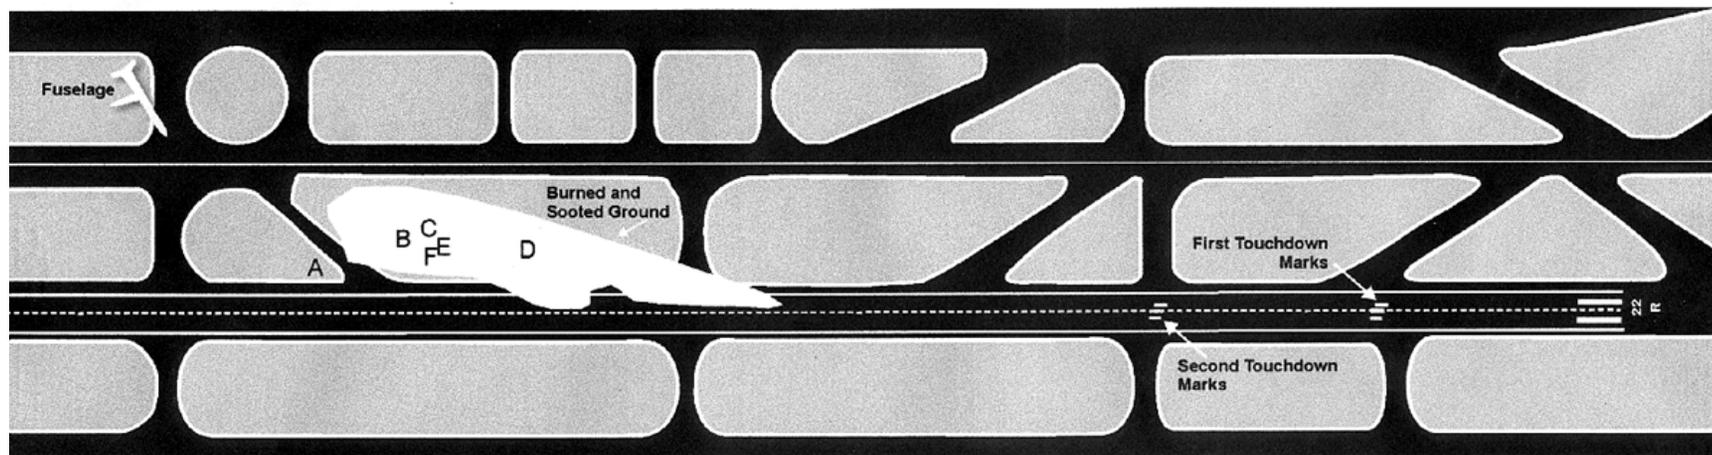
The airplane's wreckage was distributed along a 2,900-foot-long debris path that gradually arced to the right across runway 22R (see figure 7). Pieces of the right inboard trailing edge flap were found at the beginning of the wreckage path, about 2,226 feet from the runway's displaced threshold. The main wreckage, located about 5,126 feet from the runway threshold and 580 feet to the right of the runway centerline, comprised the fuselage, left wing, nose gear, left MLG, center MLG, and horizontal stabilizer. The fuselage came to rest inverted with the nose on a 95° heading. Other airplane components and structure separated from the airplane during the crash sequence and were located along the debris path.

Ground scarring consistent with the No. 3 (right) engine nacelle contacting the runway were found about 2,164 feet from the runway displaced threshold and continued to about 3,476 feet from the runway threshold. Runway scarring consistent with impact of the right inboard trailing edge flap was found about 2,299 feet from the runway threshold, ending about 2,376 feet from the threshold (where the right inboard trailing edge flap was found). Soot marks consistent with burning fuel were found about 2,506 feet from the threshold and continued to the end of the wreckage path. Runway scrape marks and purple paint⁴² consistent with the airplane's tail striking the runway were found about 2,644 feet from the runway threshold and ended about 3,060 feet from the threshold. About 2,826 feet from the threshold, runway scrapes, soot marks, and runway surface gouging began turning toward the right of the runway.

The right wing, the vertical stabilizer, and all three engines separated from the airplane and were found in a grassy area to the right of the runway, about 4,577 feet from the runway threshold, and had sustained fire damage consistent with a postaccident fuel fire. The right MLG strut assembly and two MLG wheels and tires were found on the right edge of the runway, about 4,805 feet from the runway threshold. The other two right MLG wheels and tires were found about 235 feet to the right of the runway centerline and about 4,957 feet from the threshold.

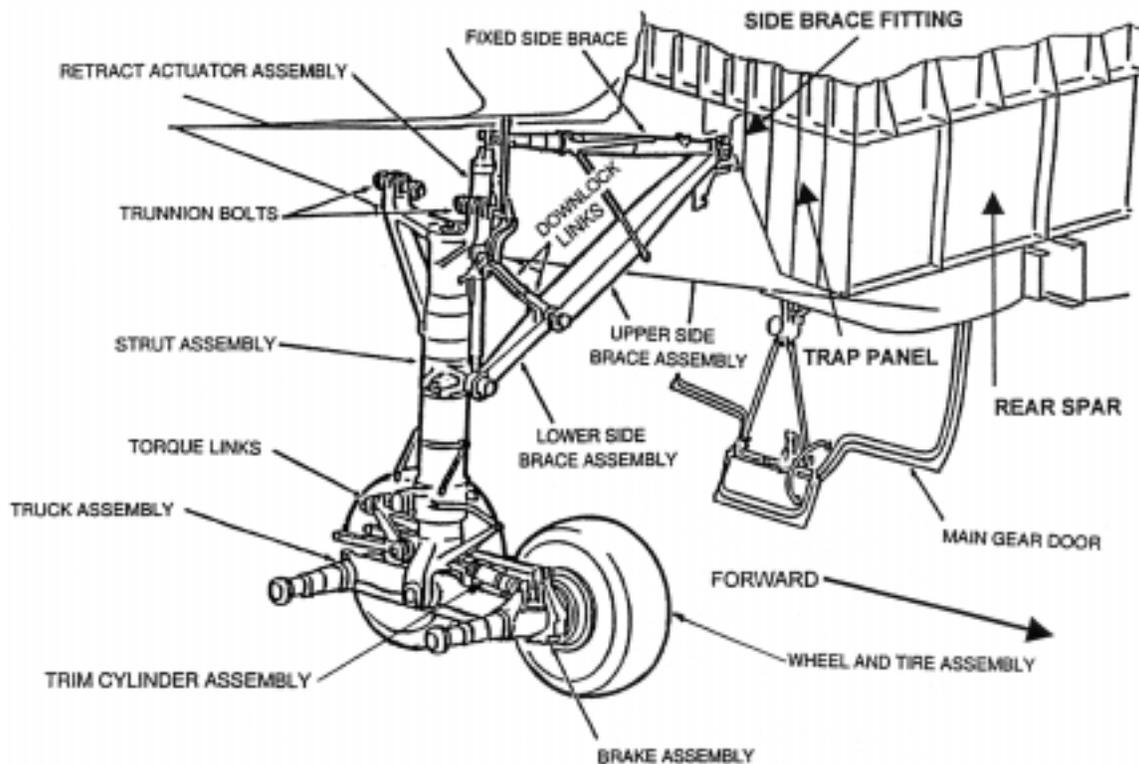
The right MLG was separated from its attach points on the right wing (see figure 8).⁴³ The attach points were broken from the wing, except for the forward lug, which remained attached to the wing with no evidence of failure. The right MLG truck assembly⁴⁴ was found separated into four parts: one part was attached to the aft axle, where the wheels and tires were found intact; a second part was found on the runway; a

Figure 8. Right MLG components.

third part was found attached to the forward axle, where the No. 3 and No. 4 wheels were found intact; and a fourth part was found attached to the strut assembly. The pivot pin was found intact between the truck beam and the oleo piston assembly. The oleo piston and cylinder were found intact, and the piston was fully extended. The torque links were intact and had no structural damage. Parts of a wing-to-gear fitting were found on the aft trunnion⁴⁵ bolt. The forward trunnion bolt, or fuse pin,⁴⁶ failed and had broken into two pieces along the shear plane.⁴⁷ The aft portion of the forward trunnion bolt was found on the runway, and the forward portion was found in the right wing-to-gear-fitting forward trunnion lug.

Scraping damage was found on the forward trunnion lug's forward face. The fixed side brace (to) folding side brace fitting joint was found intact with the side brace, the fixed brace, the side brace fitting (commonly referred to as the "pillow block"), and the pillow block hinge joint pin assembly (see figure 8). The inboard attach bolt was found intact with the pillow block and a part of the trapezoidal panel assembly. The remaining bolt was found detached and in two pieces. One piece was found in the remaining part of

the trapezoidal panel that had broken off from the fuselage and the pillow block assembly. The other bolt piece was found on the runway. The fixed side brace was found fractured about 6 inches from the wing fitting lug and was bent in the aft direction where it failed.

A metallurgical examination of the recovered right MLG components determined that all fracture surface evidence was consistent with overload failure. No evidence of fatigue cracking or corrosion was found. In addition, the examination found no indications of preimpact failures or anomalies. An examination of the right MLG tires found no evidence of pretouchdown failures or malfunctions.

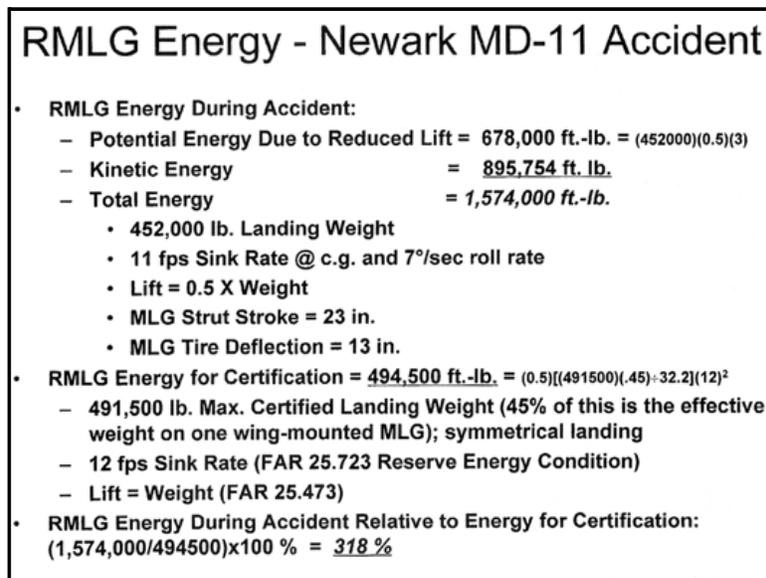
Figure 9 shows Boeing's calculations of the energy imparted to the right MLG in the Newark accident.

Figure 9. Boeing calculations of right MLG energy in the Newark accident.

The Boeing submission concluded that a “sink rate of approximately 13.5 fps (11 fps at the [c.g.] plus the [right-wing-down] roll rate) at touchdown impact is, by itself, outside the design envelope; a 13.5 fps sink rate landing on a single [MLG] is even further outside the design envelope; [and] a 13.5 fps sink rate landing on a single [MLG] with a net 0.5 g downward acceleration is yet further outside the design envelope.”⁵⁹

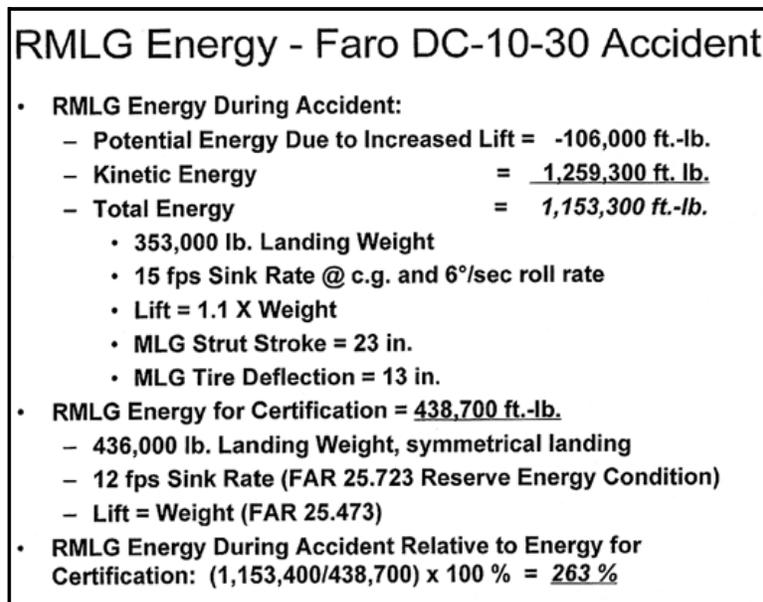
Figure 10 shows Boeing’s calculations of the energy imparted to the right MLG in the Faro accident.

Figure 10. Boeing calculations of right MLG energy in the Faro accident.

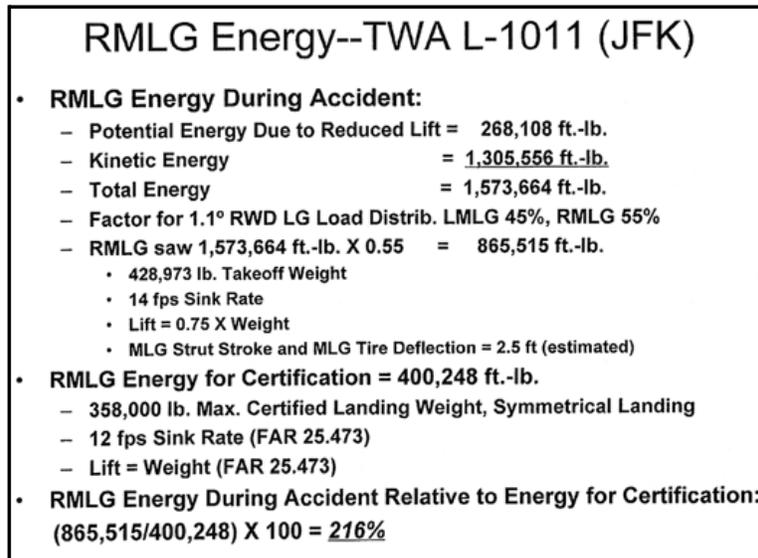
Figure 11. Boeing calculations of right MLG energy in the TWA L-1011 accident.
