## Appendix E

### Accident Airplane Maintenance Records

## **Appendix F**

### **Sooting and Fracture Diagrams**

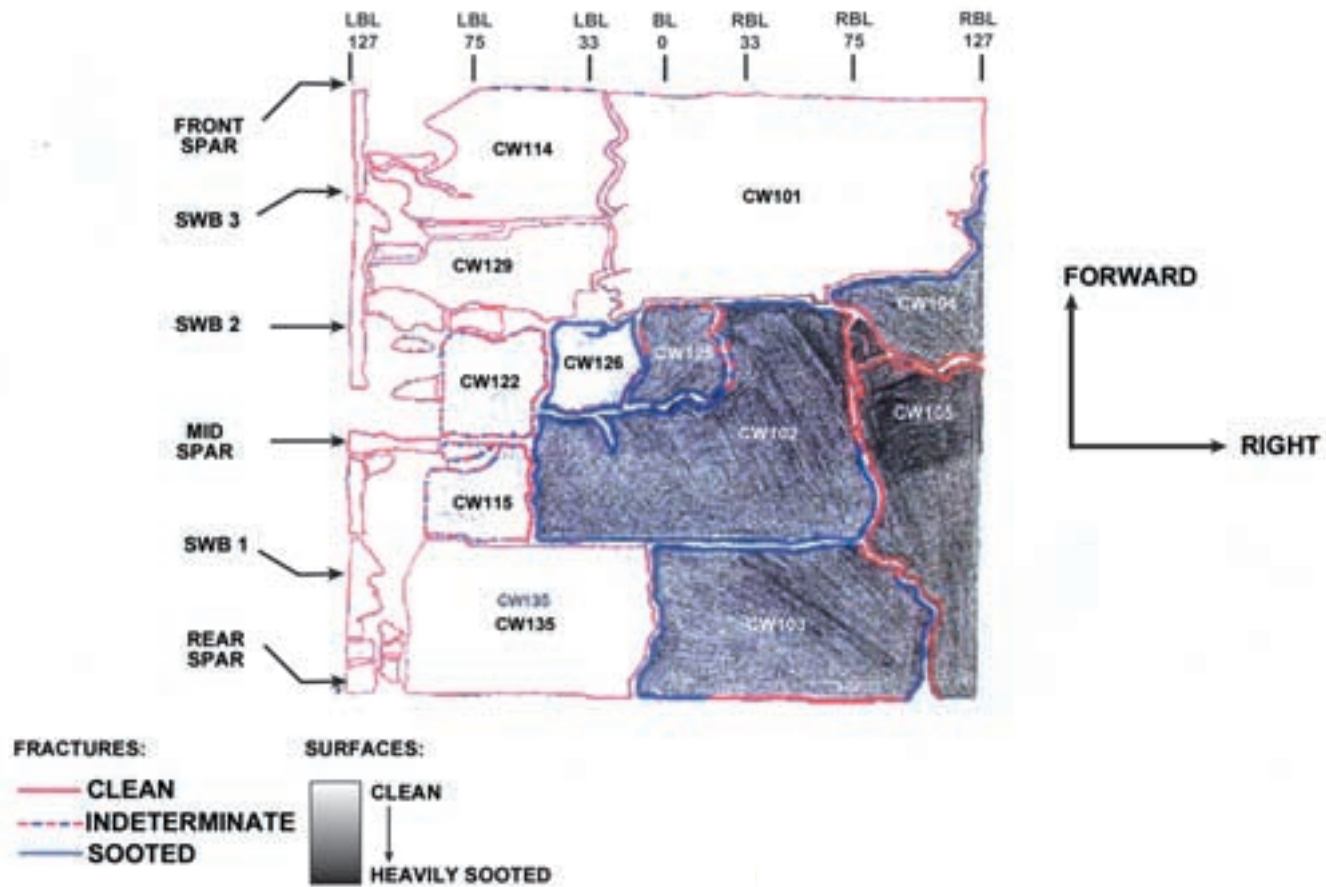
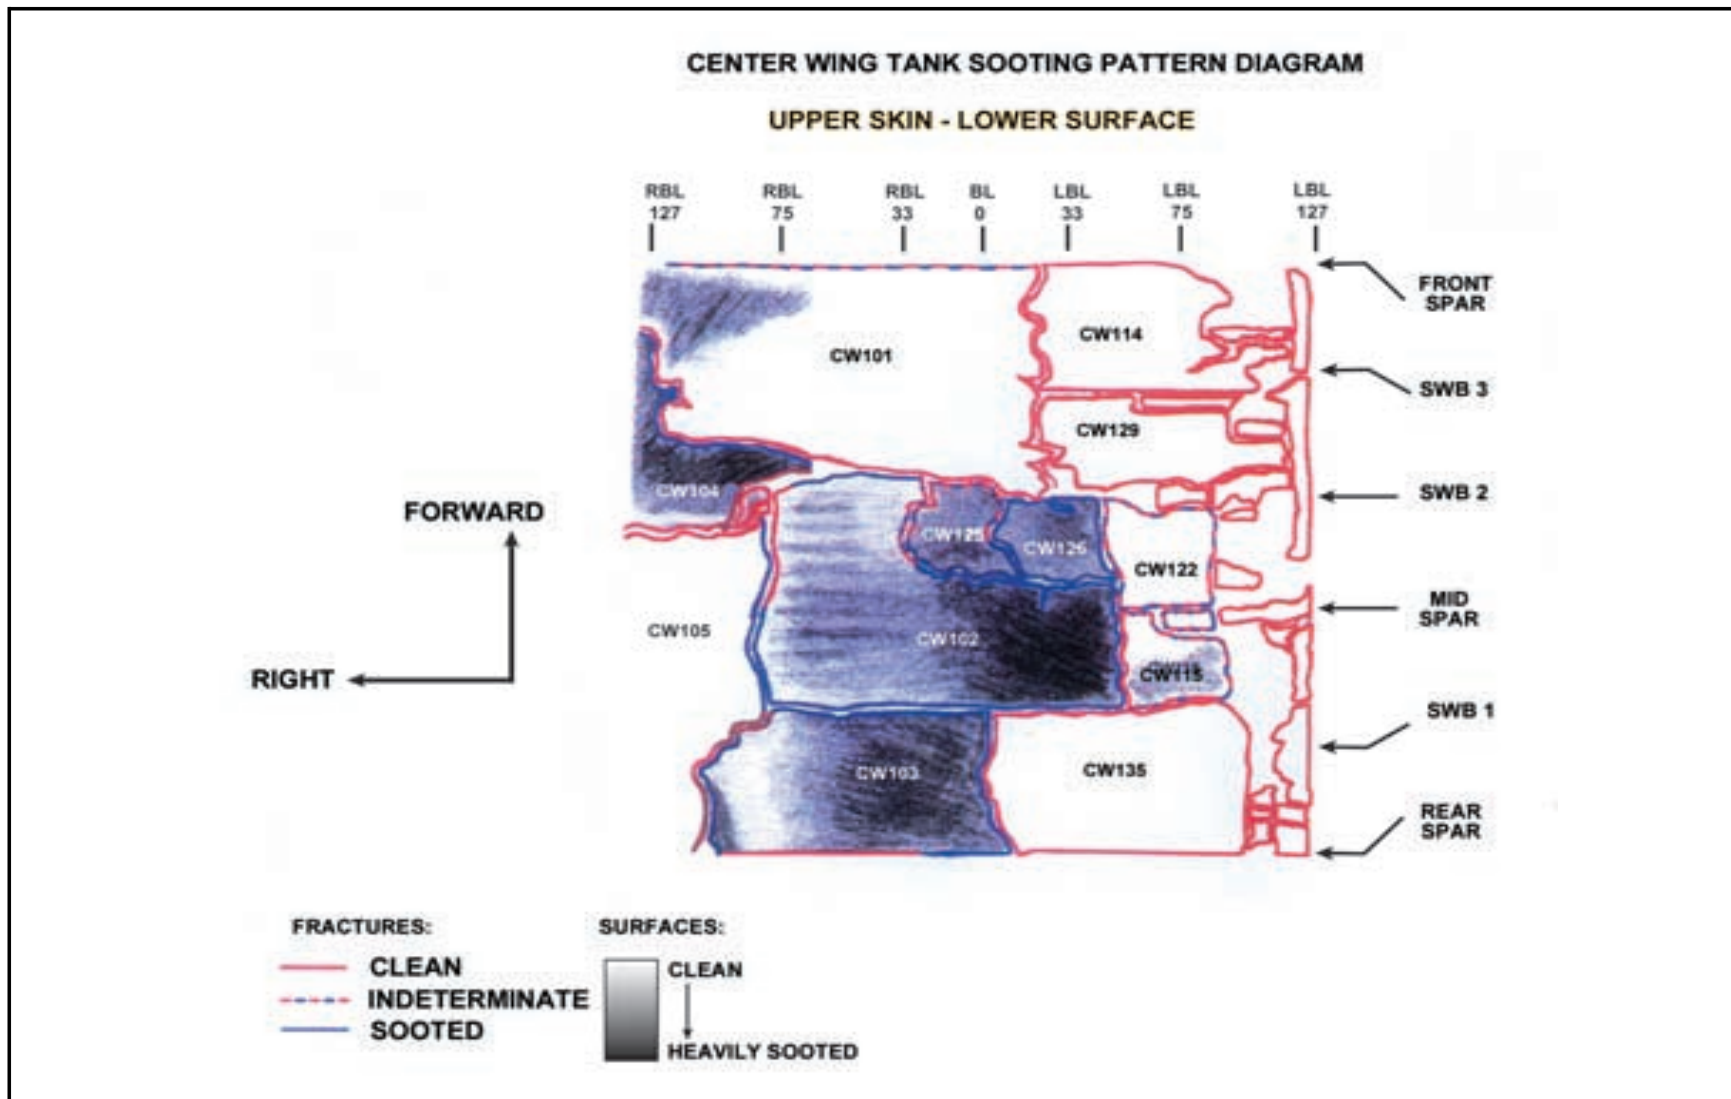
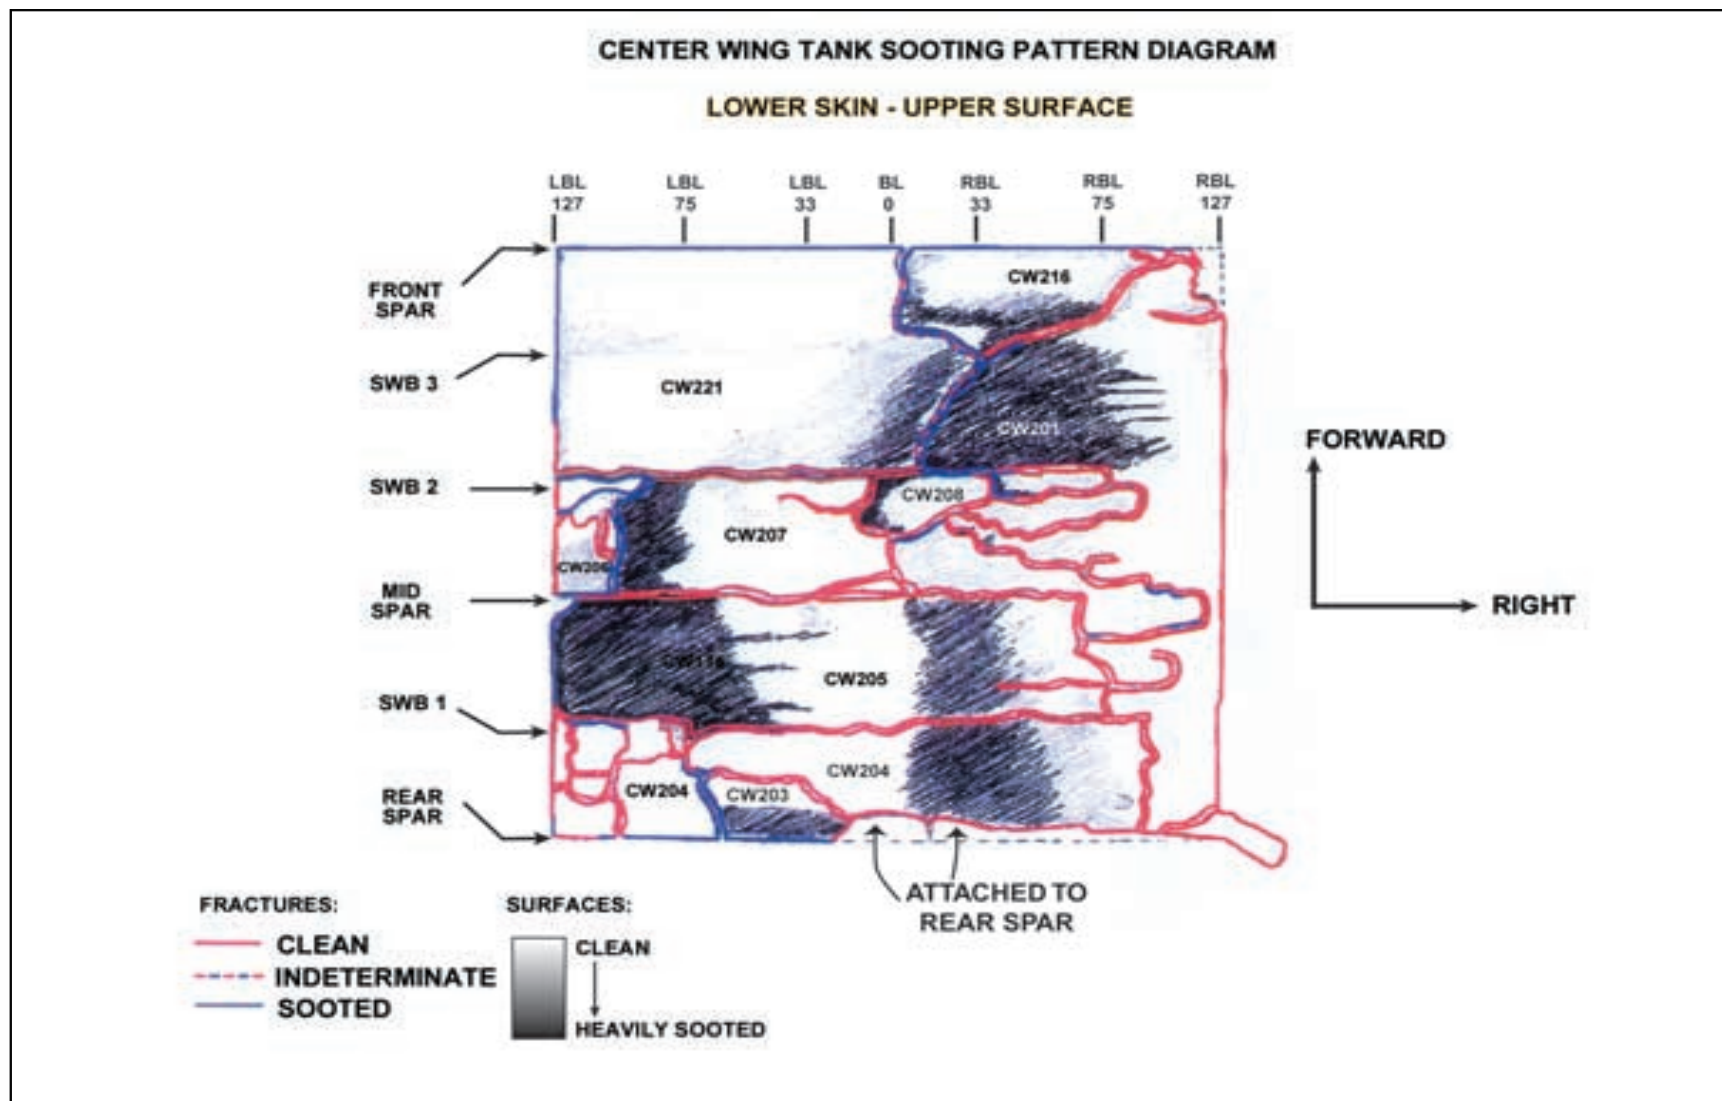
## UPPER SKIN - UPPER SURFACE

## CENTER WING TANK SOOTING PATTERN DIAGRAM

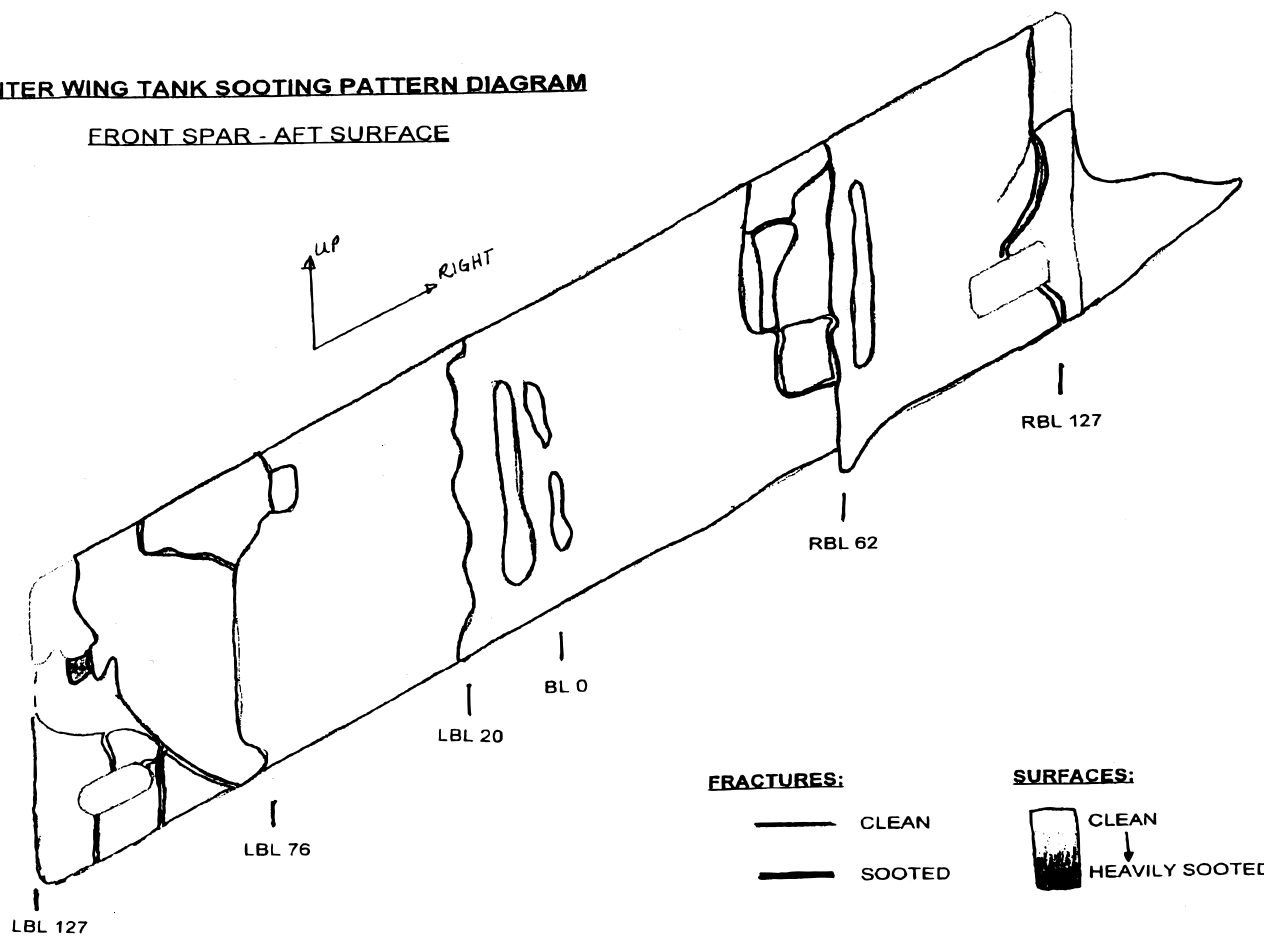
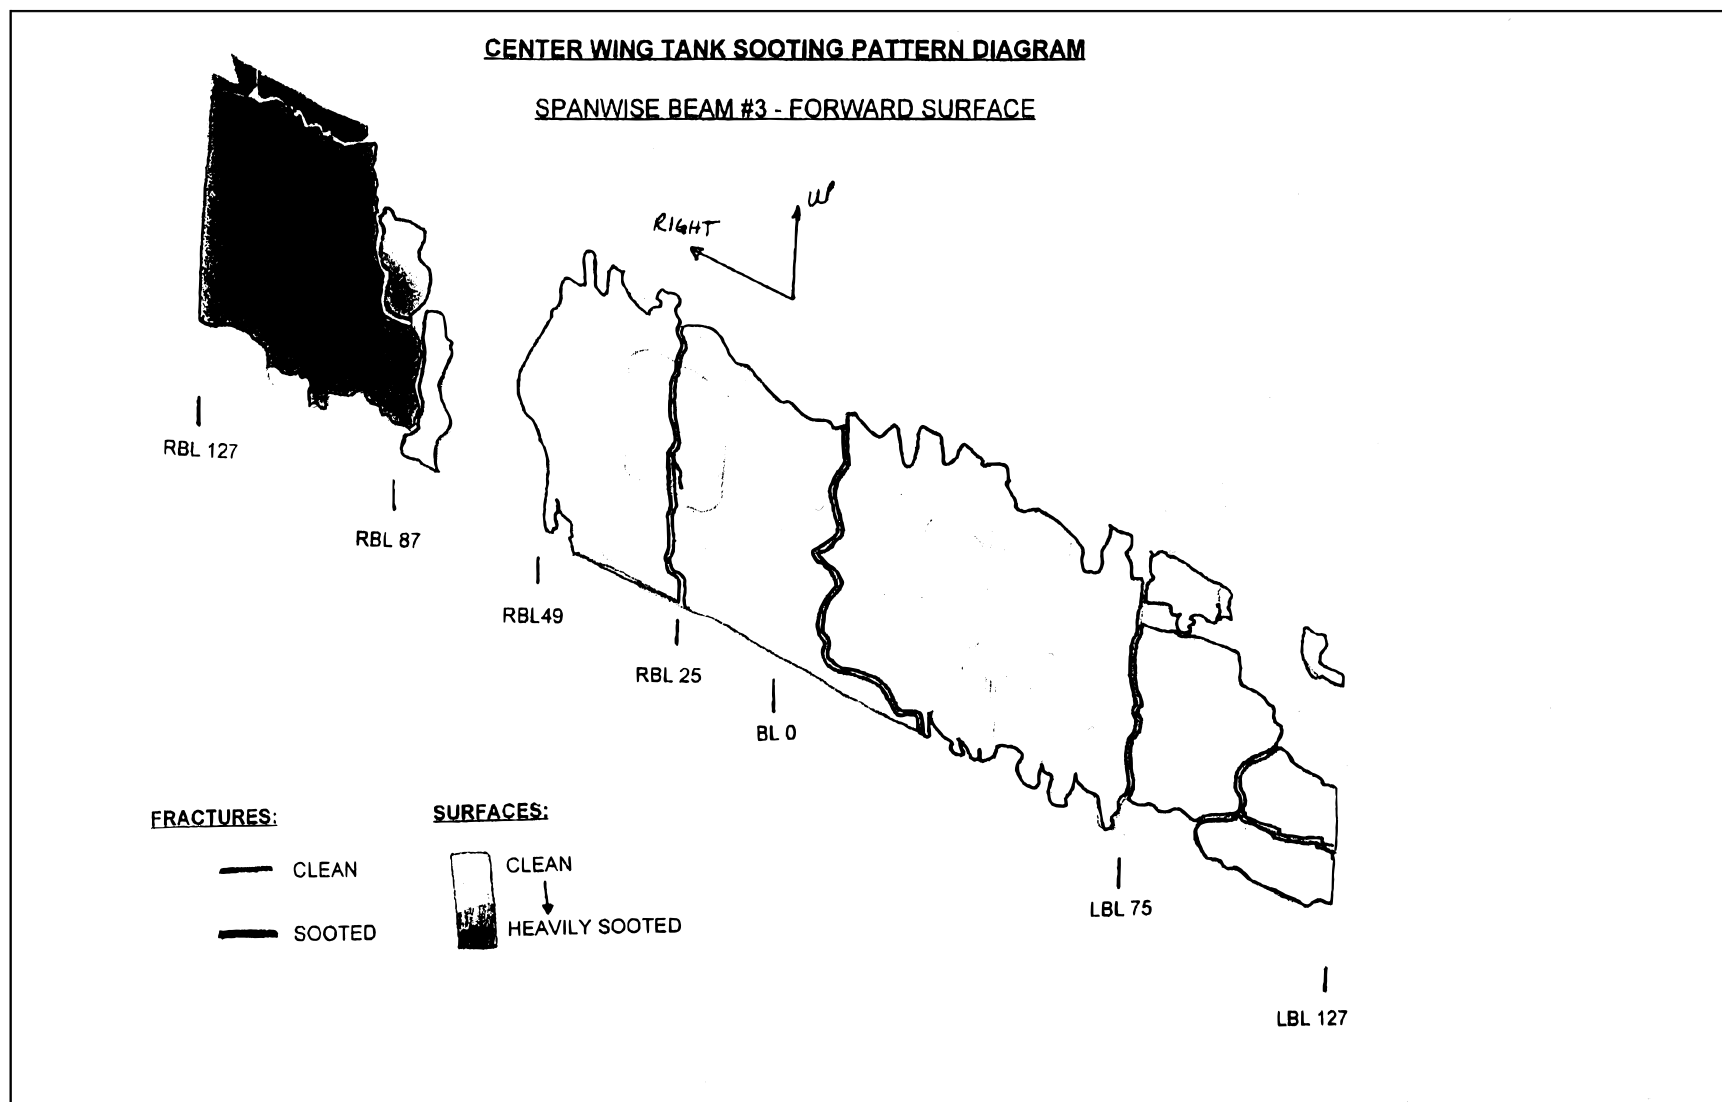
FRONT SPAR - AFT SURFACE

**CENTER WING TANK SOOTING PATTERN DIAGRAM**

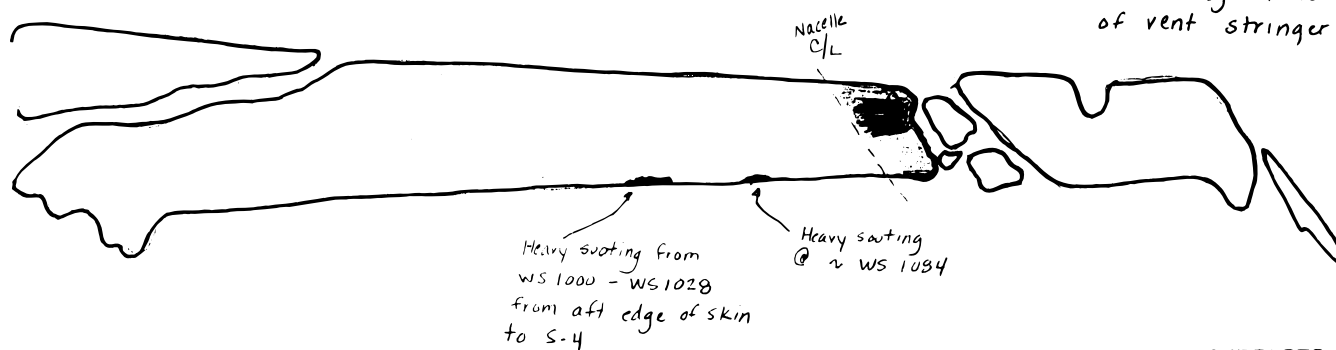
## UPPER SKIN - INTERNAL SURFACE

NOTE: See Vent Stringer  
soot diagram for details  
of vent stringer sooting.

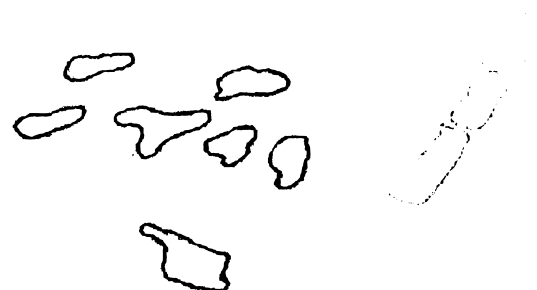
**UPPER SKIN - EXTERNAL SURFACE**

NOTE: Many small pieces of the upper skin are not shown on the diagram.

NOTE: With the exception of the piece noted, the external surface of the upper skin is clean. The control surfaces do show sooting and fire damage to the composite parts.

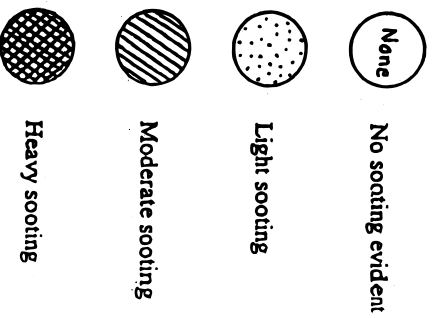
### Fuselage sooting diagrams

Surveyed panels are all recovered from the Green debris field and are located from approximately STA 910 to STA 1600. Aft of STA 1600, no sooting is evident internally. On the exterior, there is light to moderate sooting extending aft along the entire length of the fuselage from approximately the main deck window belt on the RHS to approximately S-8 on the LHS

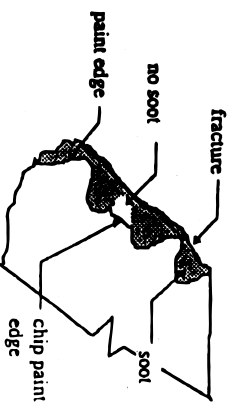
Determination primarily made by examining external paint failures near the fracture edge. Soot deposits remain on underlying paint when the top layer peels near fracture.
