**Crash During Landing
Executive Airlines (doing business as
American Eagle) Flight 5401
Avions de Transport Regional 72-212, N438AT
San Juan, Puerto Rico
May 9, 2004**

NTSB/AAR-05/02

**NTSB/AAR-05/02
PB2005-910402
Notation 7650A
Adopted September 7, 2005**

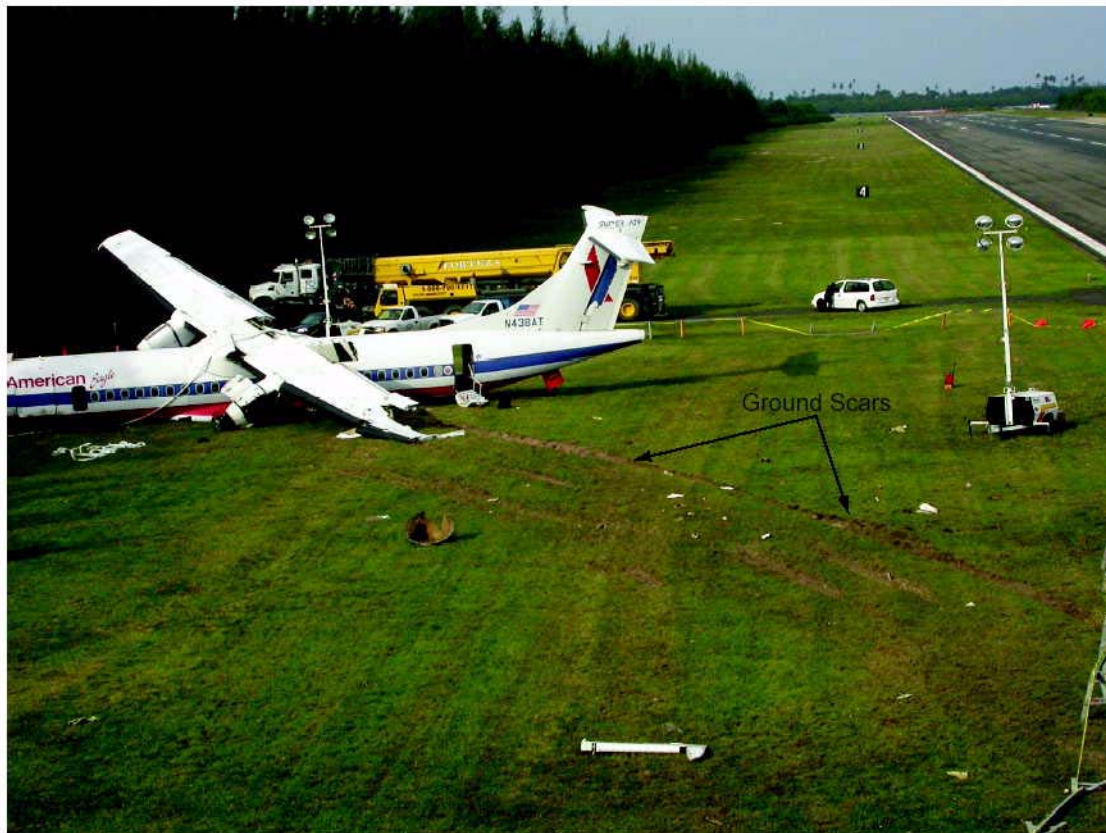
Figure 3. Ground scrape marks and the main wreckage.

The main wreckage was located about 217 feet left of the runway 8 centerline and about 4,317 feet beyond the runway threshold. The main wreckage consisted of most of the airplane structure, except for the lower section of the left MLG tire assembly, which was found about 302 feet left of the runway 8 centerline and 3,944 feet beyond the runway threshold (about 373 feet from the main wreckage). Figure 3 shows ground scrape marks and the main wreckage.

A section of about 13 feet of the forward, left side of the lower fuselage was severely crushed. The left forward cargo door and surrounding structure were severely deformed and buckled. A section of about 8 feet of the forward, right side of the lower fuselage was crushed. The damage on both the left and right sides of the lower fuselage extended from the belly to the floor line, and the left side exhibited some evidence of scrape marks just below the floor line.

Most of the left belly fairing forward and aft of the left MLG was found crushed and deformed, and a portion was missing. The aft, lower surface of both sides of the fuselage exhibited evidence of scraping, minor crushing damage, and skin wrinkling. The aft fuselage just forward of the tail cone was found wrinkled around its circumference.
