Crash During Attempted Go-Around After Landing  
East Coast Jets Flight 81  
Hawker Beechcraft Corporation 125-800A, N818MV  
Owatonna, Minnesota  
July 31, 2008

NTSB/AAR-11/01  
PB2011-910401

# Aircraft Accident Report

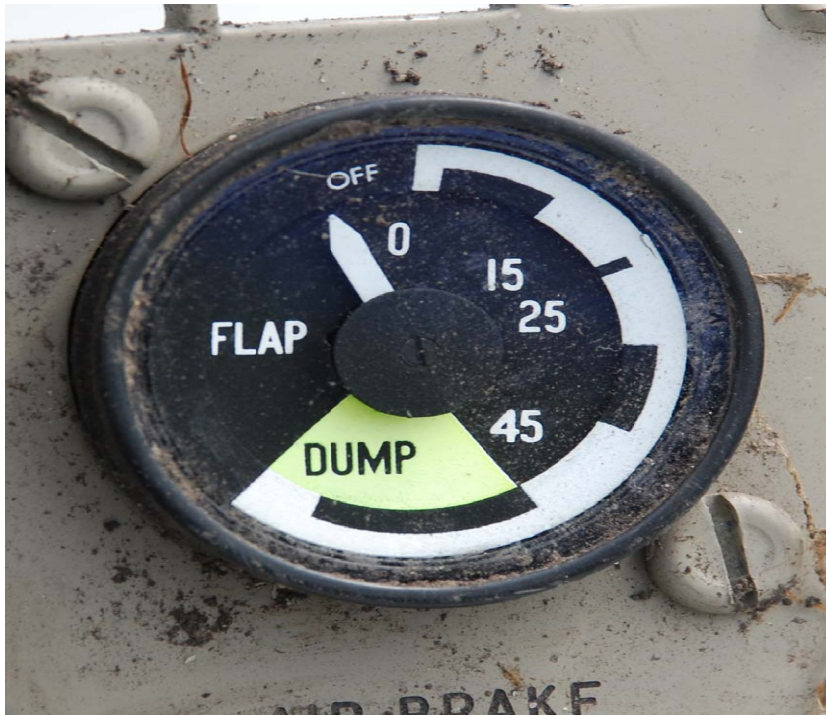
**Figure 2.** Photograph showing the accident airplane's mechanical flaps indicator.

Postaccident examination of the flaps indicated that they were fully retracted (that is, set at 0°). The two flap cables were found intact to a point near the structural separation damage, and both cables were broken at this point. The breaks exhibited a splayed appearance. The pedestal exhibited impact damage, and the airbrake handle could not fully deploy to and lock in the DUMP position, but the flap handle could move through its entire range. The FCU was found in its normal position in the aft fuselage, and all hydraulic connections to the FCU remained intact. The FCU was removed and sent to APPH Houston Inc., Houston, Texas, for testing under NTSB supervision. The unit was functionally tested and operated normally throughout the normal and lift-dump ranges and was within specifications for a newly overhauled unit.

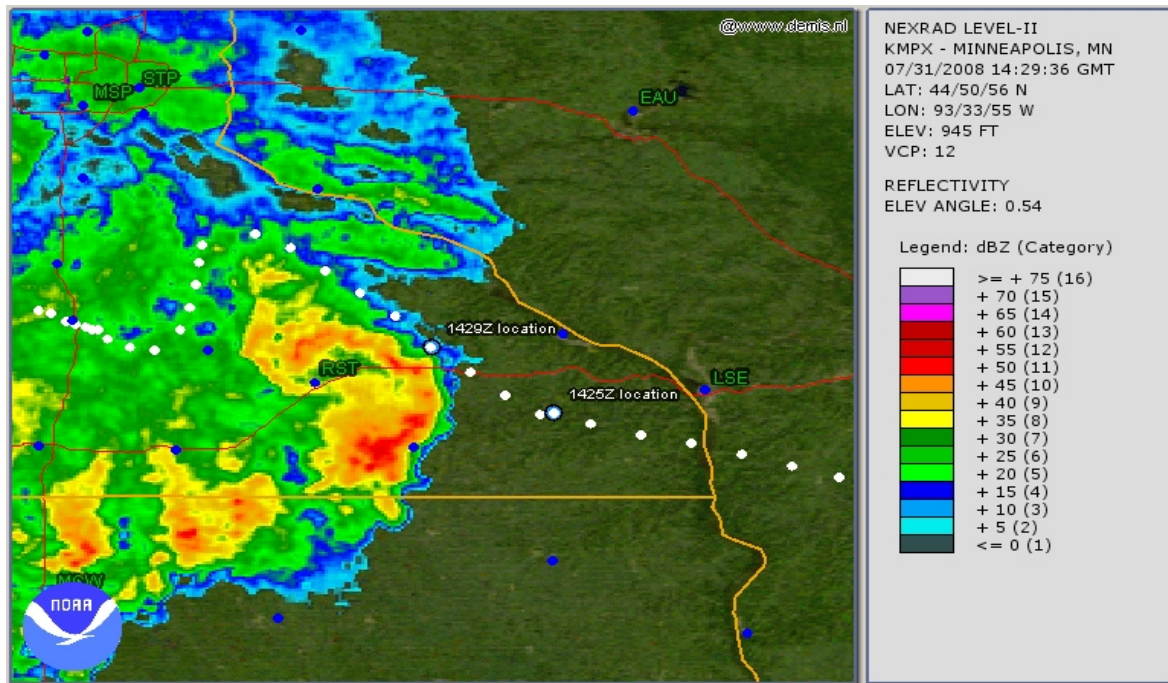
**Figure 3.** The flight track of the accident airplane overlaid on the 0929 base reflectivity data.

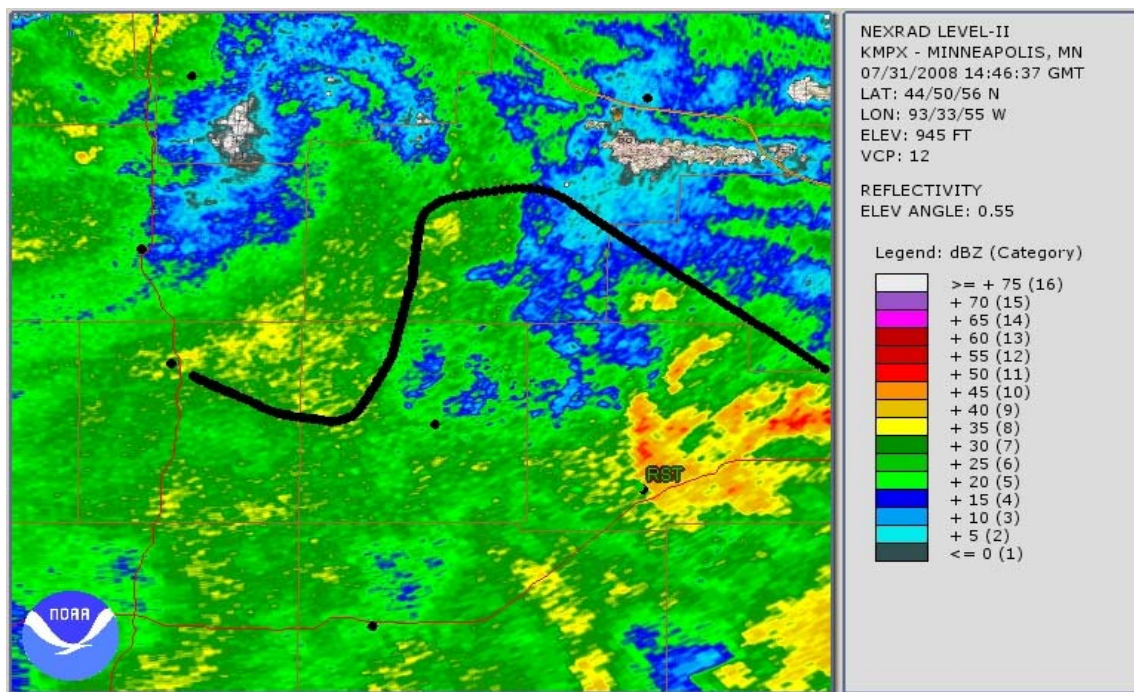
**Figure 4.** The flight track of the accident airplane overlaid on the 0946 base reflectivity data.

The WSR-88D base velocity data for the same period also showed a band of strong westerly winds behind the intense leading edge associated with the bow echo with maximum winds of 65 knots. The NWS Local Analysis and Prediction System upper air sounding (that is, a vertical profile of atmospheric conditions) for 0930 indicated calm surface winds, winds at

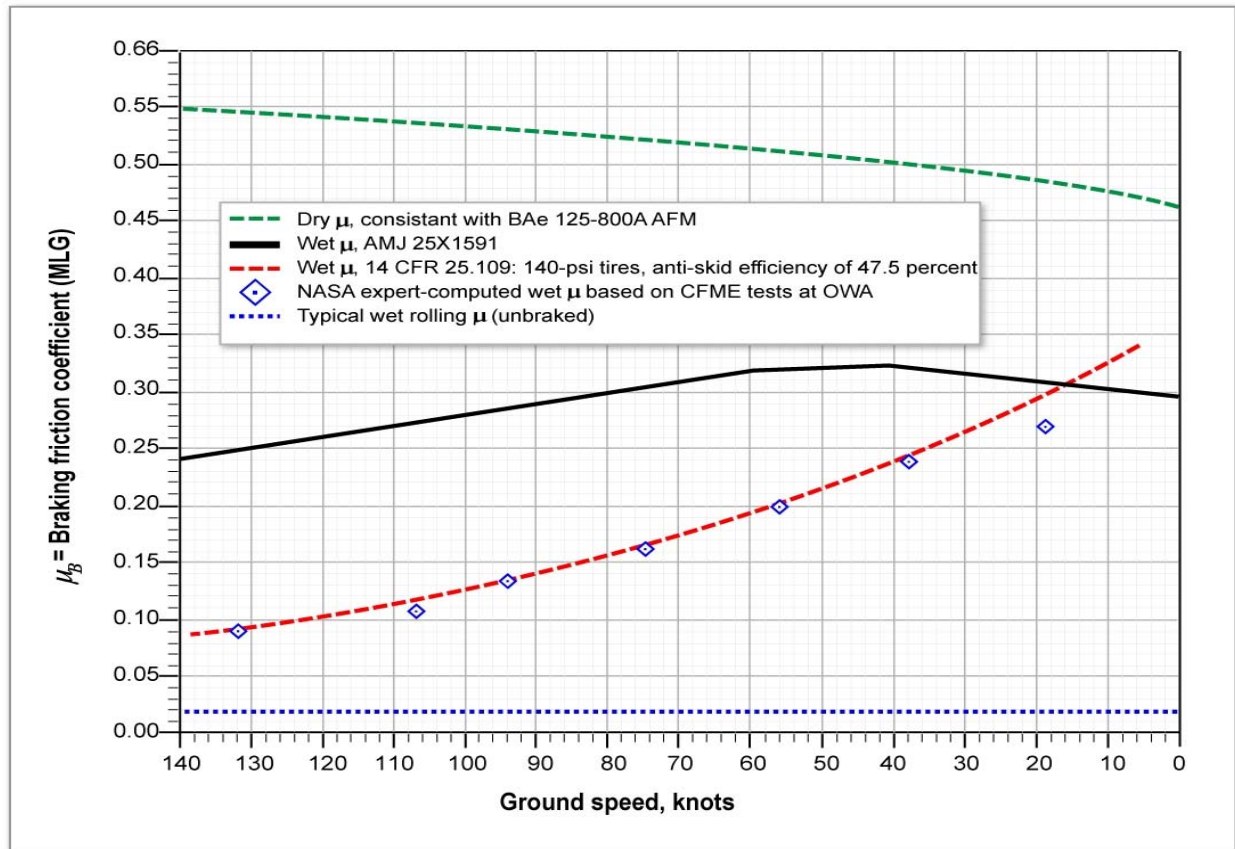
**Figure 5.** Comparison of calculated wet, ungrooved runway MLG effective braking friction coefficient values as a function of ground speed using the BAe 125-800A AFM, NASA CFME-based, and 14 CFR 25.109 methods. BAe 125-800A AFM dry runway and unbraked rolling friction coefficient values are shown for reference.
