Runway Overrun
American Airlines Flight 2253
Boeing 757-200, N668AA
Jackson Hole, Wyoming
December 29, 2010

NTSB/AAR-12/01
PB2012-910401

Aircraft Incident Report

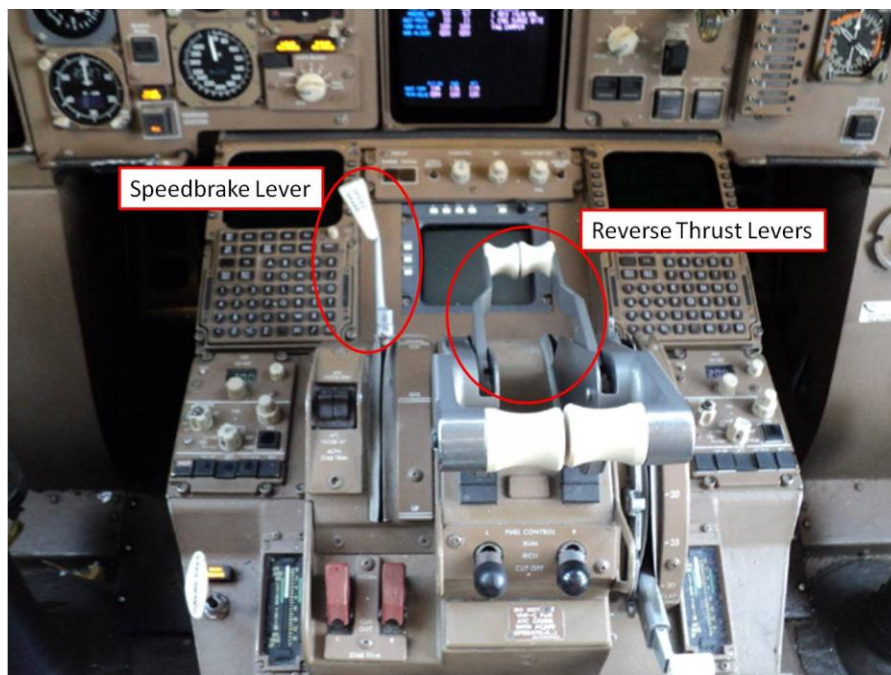
American Airlines’ procedures indicate that the pilot monitoring is to monitor the speedbrake lever and the thrust reverser and autobrake systems during the landing roll. Specifically with regard to the speedbrake lever, the procedures indicate that the pilot monitoring should observe and call out the position of the speedbrake lever after landing and that, if the speedbrakes do not automatically deploy, the captain should manually deploy the speedbrakes (regardless of which pilot had monitoring responsibilities). American Airlines’ 757/767 Operating Manual states, “Pilot awareness of the speedbrake lever during the landing phase is important in the prevention of overrun.” Further, American Airlines’ 757/767 Operating Manual also states, “Without speedbrakes deployed after touchdown, braking effectiveness may be reduced initially by as much as 60 [percent].” Figure 3 shows the throttle console in the incident airplane’s cockpit, with the reverse thrust lever and speedbrake levers marked.

Figure 3. A photograph of the center console in the incident airplane’s cockpit, with the reverse thrust lever and speedbrake levers marked.

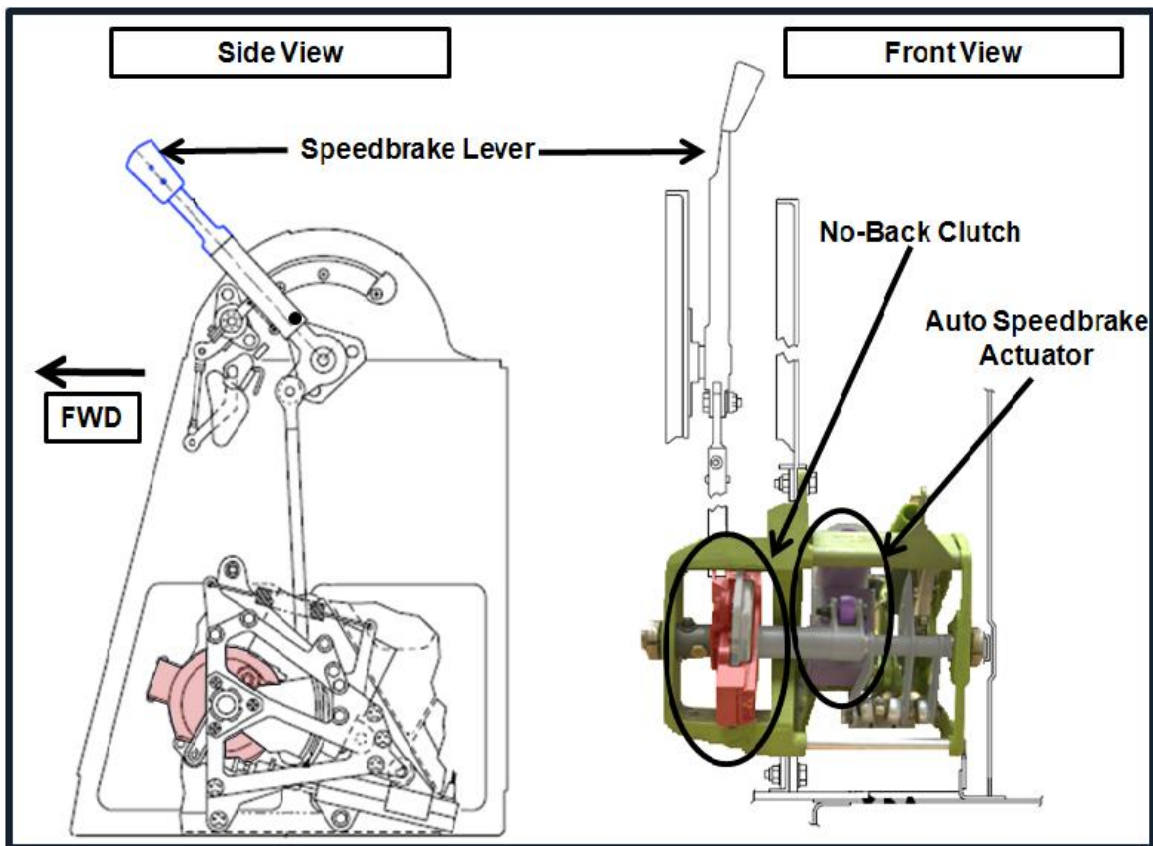
Initial examination and testing of the incident airplane’s automatic speedbrake system and its components revealed no evidence of a malfunction that would have prevented normal operation during the incident landing.³³ However, the automatic speedbrake mechanism was removed and examined after the incident airplane experienced another automatic speedbrake system nondeployment on March 31, 2011.³⁴ This examination revealed a latent assembly defect in the no-back clutch mechanism³⁵ that intermittently prevented the speedbrake actuator from automatically driving the speedbrake lever beyond its armed detent to extend the speedbrakes. Specifically, one of the four speedbrake lever braking pins was improperly secured, which allowed it to intermittently rotate within its assembly and prevented the no-back clutch from transmitting the torque from the automatic speedbrake actuator to the speedbrake lever. Additional testing showed that this condition would only occur when the actuator was attempting to drive the speedbrake lever towards the “up” (speedbrakes extended) position and would not occur when the actuator was retracting the speedbrake lever. Further, it was noted that this defect only affected the speedbrakes’ automatic deployment function and would not have prevented the pilots from manually deploying the speedbrakes. Figure 4 contains two diagrams showing the cockpit center console, the speedbrake lever and its linkages, and components of the automatic speedbrake system. The no-back clutch mechanism has been highlighted in the side view

Figure 4. Two diagrams showing the cockpit center console, the speedbrake lever and its linkages, and components of the automatic speedbrake system. The no-back clutch mechanism has been highlighted in the side view diagram on the left. A photograph of the speedbrake actuator and no-back clutch mechanisms has been superimposed on the front view to show those components' relative positions within the center console.

Because the effects of this defect were intermittent and the defect's visual detection would require disassembly of the no-back clutch mechanism (a function usually performed by the manufacturer or another external facility, not the operator), an operator would not likely have detected the defect during normal maintenance testing. When this assembly defect in the no-back clutch was identified, the manufacturer of the no-back clutch told NTSB investigators that the company was not aware of any instances involving similar anomalies in other no-back clutch units.³⁶ As a result of this investigation, the manufacturer clarified its documentation to ensure proper assembly of the no-back clutch units. In addition, in its March 7, 2012, submission for

The NTSB concludes that a manufacturing defect in the incident airplane’s speedbrake no-back clutch mechanism prevented the speedbrakes from automatically deploying during the incident landing.
