Crash Following In-Flight Fire
Fresh Air, Inc.
Convair CV-440-38, N153JR
San Juan, Puerto Rico
March 15, 2012

NTSB/AAR-14/04
PB2015-101257

Aircraft Accident Report

Crash Following In-Flight Fire

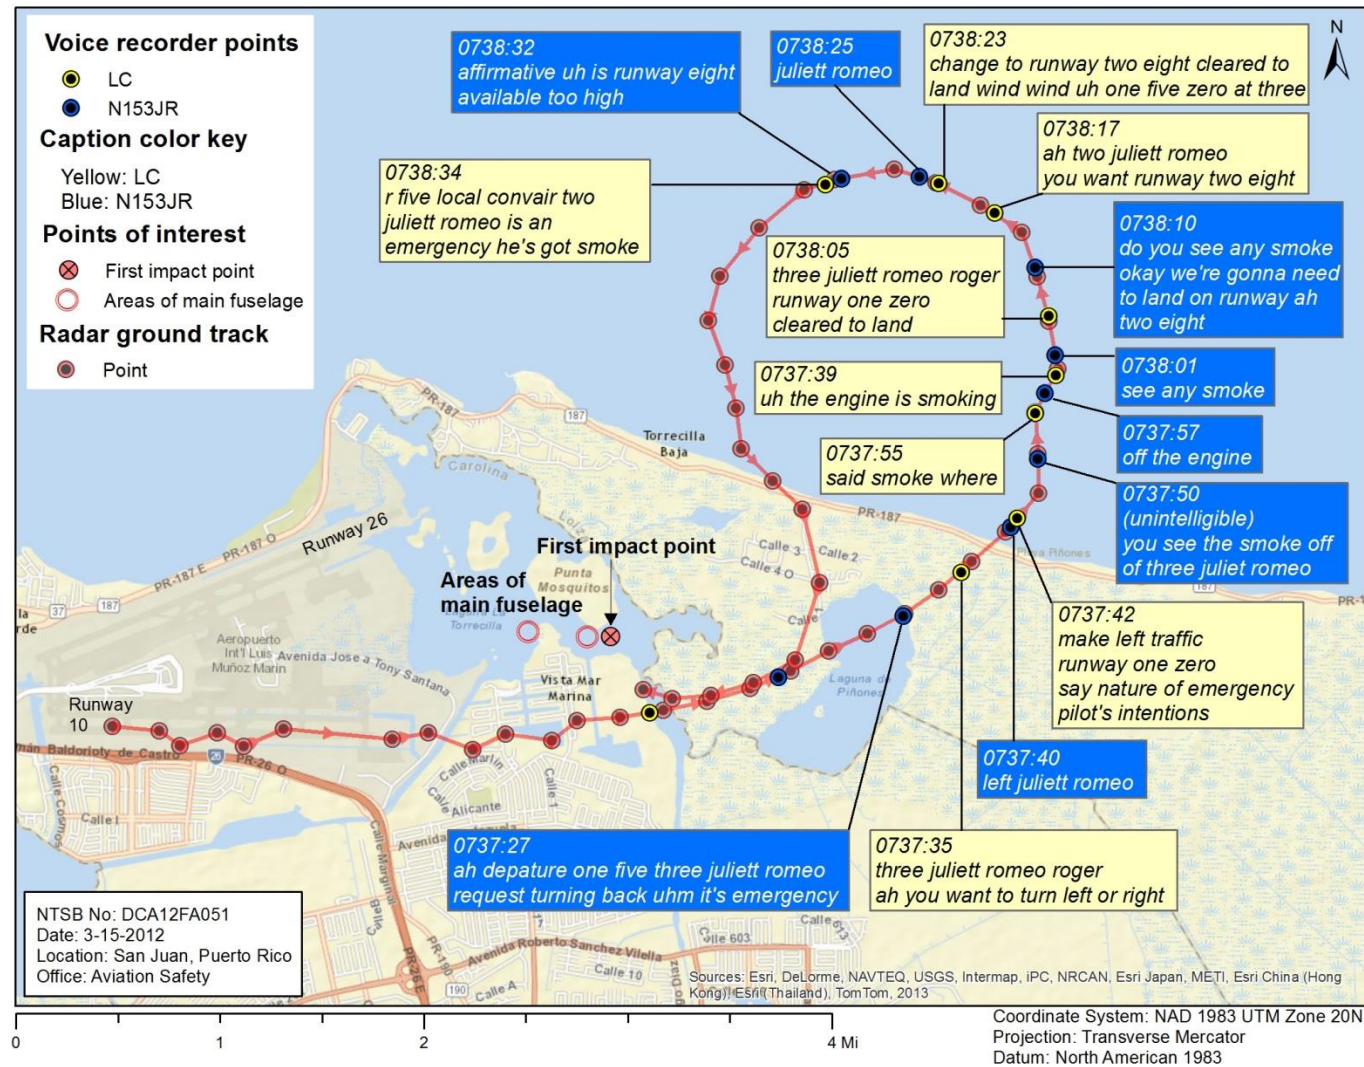
Radar data indicate that as the airplane continued to climb, the airspeed varied between 140 and 160 knots. The captain then asked again if tower personnel could see any smoke coming from one of the airplane's engines before stating, "...we're gonna need to land on runway, ah, two eight (unintelligible)." The airplane reached a maximum altitude of about 935 ft mean sea level (msl) at 0738:14 during an approximate 30° left-banked turn back to the airport. The tower controller cleared the airplane to land on runway 28. At 0738:32, the captain replied, "...affirmative, uh, is runway eight available, to[o] high...", which was the last transmission from the accident airplane; the airplane then descended to 500 ft msl. The airplane banked to the right starting at 0739:10; the airspeed was about 140 knots. The airplane continued to bank to the right. Before radar contact was lost at 0739:53, the last estimated airspeed was 88 knots, and the altitude was 110 ft msl. The controller reported that the airplane crashed at 0740:23. Figure 1 shows the radar ground track and air traffic control (ATC) communications during the accident airplane's takeoff and attempted return to SJU.

Figure 1. Radar ground track and ATC communications during N153JR's takeoff and attempted return to SJU.

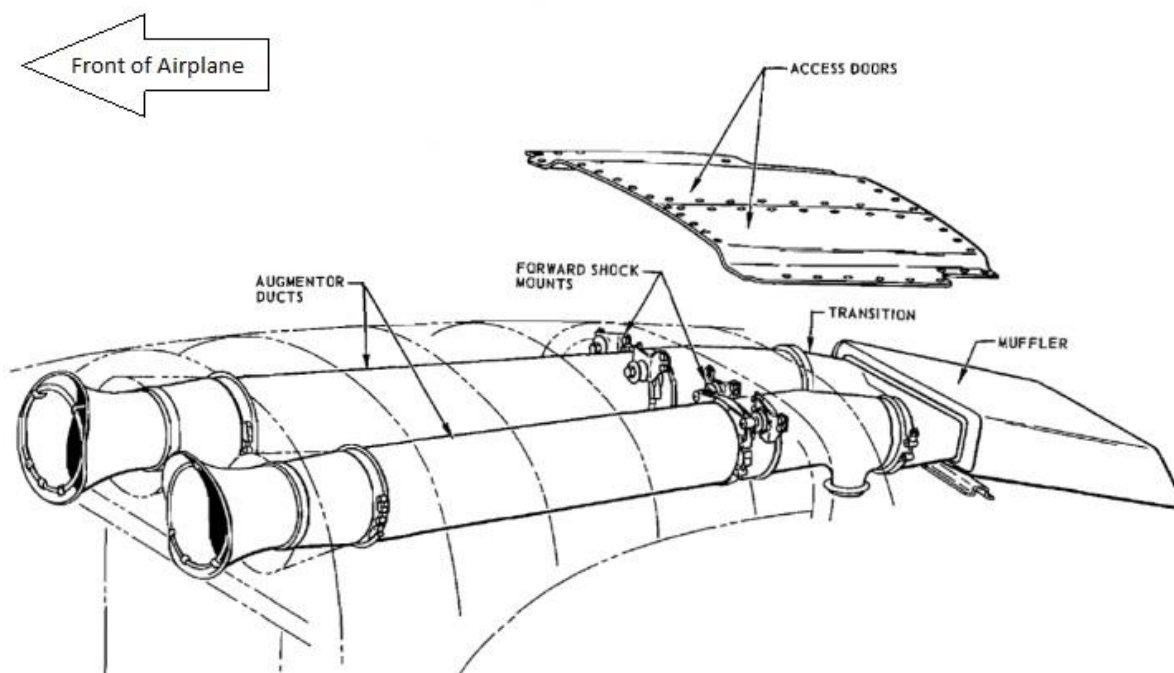
The CV-440 exhaust system includes two manifold assemblies, two tubular thrust augmentor assemblies, a transition assembly, and a muffler for each engine, as illustrated in figure 3. The augmentor tubes are located in the upper body section of the engine nacelle; their purpose is to channel engine exhaust gases and cylinder cooling air from the power section and exhaust them through a muffler. The augmentor tubes also serve as heat exchangers by circulating air through the spaces between the airplane's inner and outer skin. This heated air is used directly for thermal anti-icing and as the source of heat for the cabin heat exchanger. A mechanic familiar with the Convair CV-440 noted that exhaust fires can occur in the augmentors on this type of airplane. Under normal conditions, the fire is exhausted out the muffler assembly and into the air, resulting in little or no damage to the airplane. However, the mechanic noted that oil and fuel leaks at the augmentor/muffler junction do occur.

Figure 3. View of the Convair CV-440's augmentor and exhaust muffler assemblies.

Statements from mechanics familiar with this type of airplane indicate exhaust fires do occur in the augmentors on this type of aircraft. Under normal conditions, the fire is exhausted out the muffler assembly, resulting in little or no damage to the aircraft. A fire leaking out of the augmentor assembly at the junction with the muffler assembly would have produced the damage that was found on the accident aircraft. Although the source of fuel for the fire could not be determined, oil or fuel leaks into the exhaust system are capable of igniting in the presence of the high heat within the augmentors and would have led to the exhaust fire. Thus, the NTSB concludes that the thermal damage to the airplane resulted from the ignition of a flammable liquid in one of the right augmentors, and a leak in the vicinity of the augmentor/muffler junction allowed the fire to exit the junction and damage portions of the right wing.

4. The thermal damage to the airplane resulted from the ignition of a flammable liquid in one of the right augmentors, and a leak in the vicinity of the augmentor/muffler junction allowed the fire to exit the junction and damage portions of the right wing.

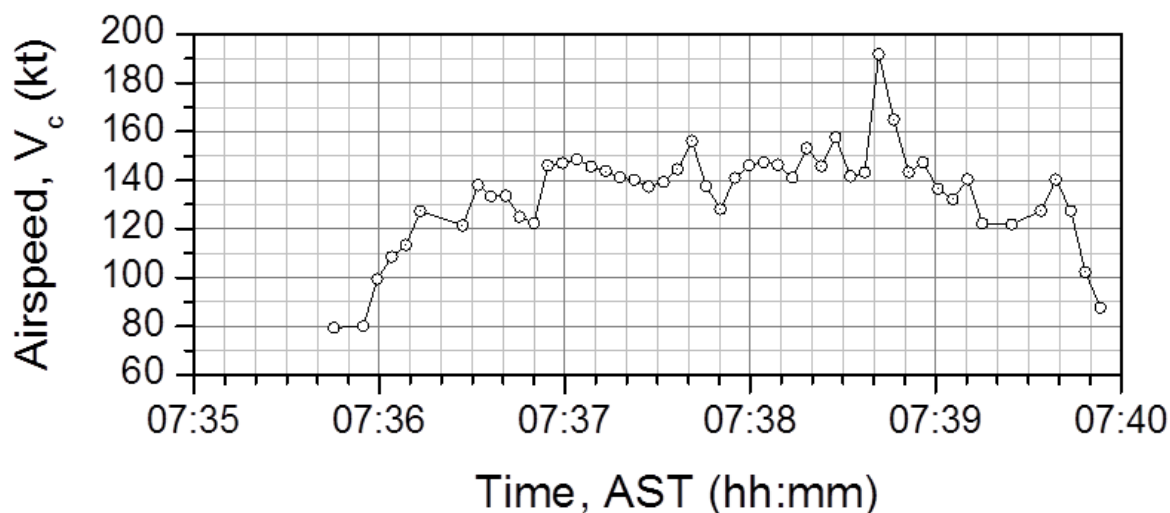
According to ATC communications, the flight crew declared an emergency about 2 1/2 min after being cleared for takeoff on runway 10. The airplane reached a maximum altitude of about 935 ft msl during an approximate 30° left-banked turn back to the airport. The airplane continued to climb throughout the flight until it was cleared to land. As seen in figure 4, the flight's airspeed was nominally between 140 knots and 160 knots for most of the flight, except for a brief moment when the airplane descended to 500 ft msl and again in the final 15 seconds before radar contact was lost. The last estimated airspeed was 88 knots at an approximate altitude of 110 ft msl.

Figure 4. N153JR's airspeed.

According to the Convair CV-440 AFM, at an altitude just above sea level, the minimum control speed is 87 knots indicated for the Convair CV-440 and the stall speed for level flight¹⁴ is 97 knots. The estimated airspeed at the final radar point, 88 knots, was 9 knots below the published stall speed and close to the minimum control speed. However, minimum control speeds increase substantially for a turn into the operative engine, as the accident crew did in the final seconds of flight. As a result, the airplane was operating close to both stall and controllability limits when radar contact was lost.
