Runway Overrun During Rejected Takeoff
Gulfstream Aerospace Corporation G-IV, N121JM
Bedford, Massachusetts
May 31, 2014

NTSB/AAR-15/03
PB2015-105492

Aircraft Accident Report

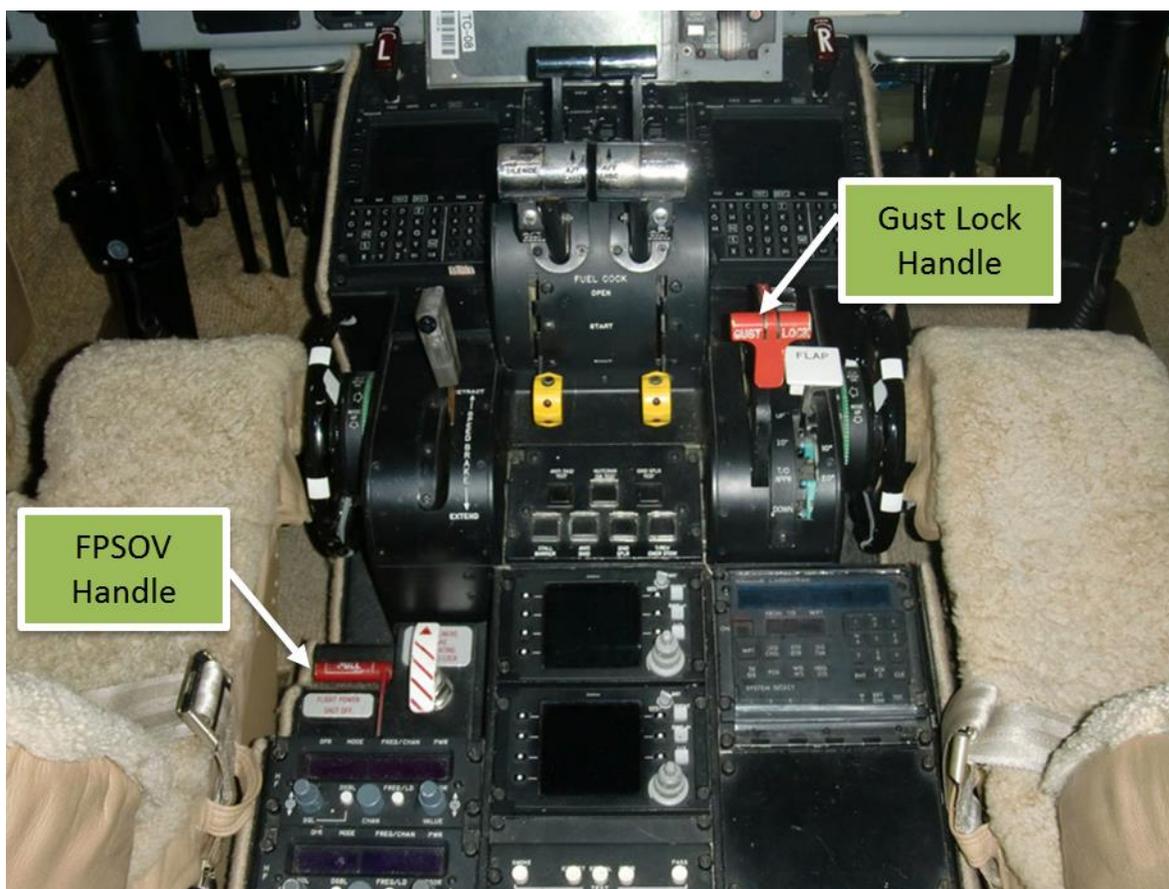
Figure 1. Exemplar G-IV control pedestal showing the gust lock handle in the ON (up) position and the flight power shutoff valve handle (FPSOV) in the OFF (down) position.

In addition, the flight crew did not notice that the gust lock handle was in the ON position during taxi, line up, or the initial portion of the takeoff roll. Pilots are faced with many demands for visual attention during the taxi and takeoff phases of flight; therefore, they would likely not inspect the gust lock handle unless they were specifically checking its status, a step the accident flight crew did not perform during engine start. Further, although the gust lock handle was painted red, a color that is visually conspicuous in daytime lighting conditions, the accident occurred at night in lower lighting conditions, when the color red is less conspicuous and would, therefore, be less easily noticed by either pilot.

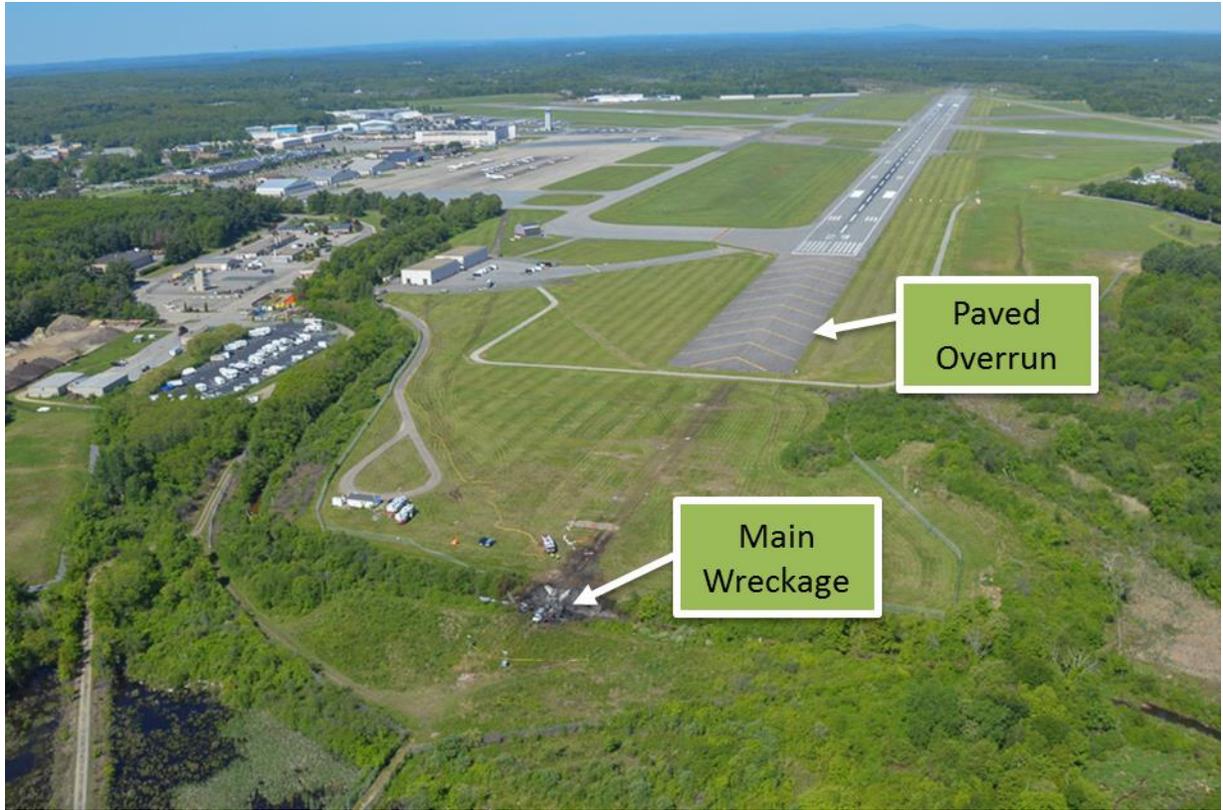
The two air traffic controllers on duty in the BED air traffic control tower (ATCT) observed the airplane rolling down the runway at “high speed” but not lifting off. They saw the airplane exit the runway and pass through the paved overrun area, and they immediately began accident notification procedures. One of the controllers stated that the airplane was engulfed in flames “almost instantaneously” with it coming to a stop.

Figure 2. Aerial photograph of the accident site.

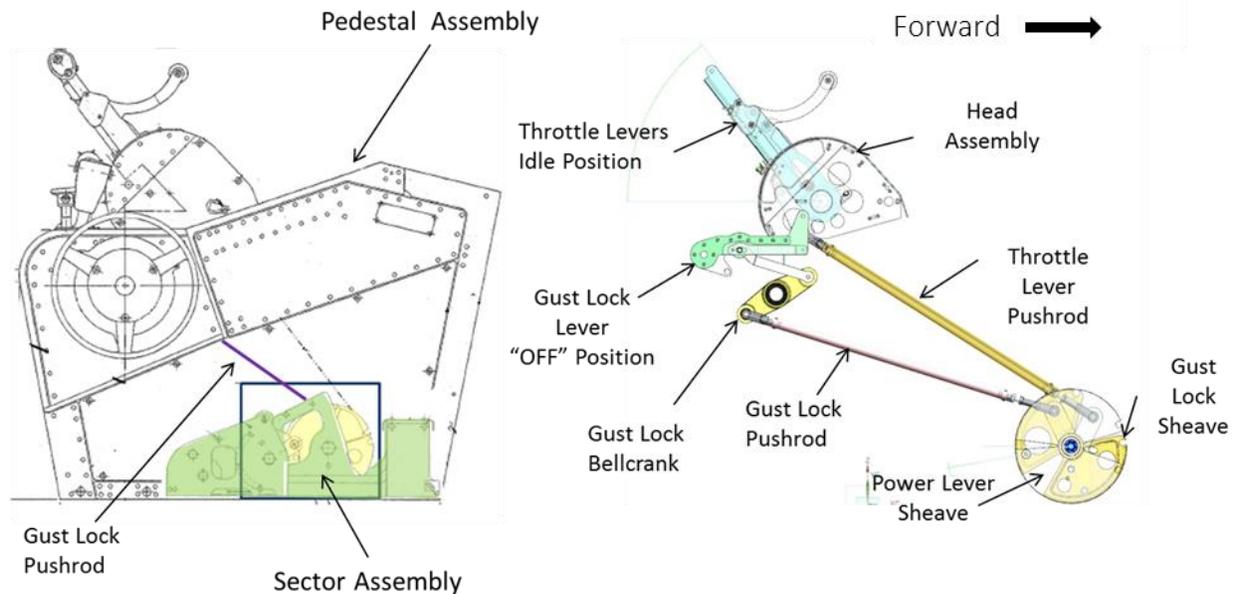
A mechanical interlock between the gust lock handle and the throttle levers restricts the movement of the throttle levers when the gust lock handle is in the ON position. The interlock is incorporated into the sector assembly below the pedestal, as shown in figure 5.

Figure 5. Diagrams of a pedestal assembly showing the location of the sector assembly and the gust lock/throttle lever interlock mechanism.

At the NTSB’s request, Rockwell Collins (the manufacturer of the pedestal assembly) performed a mechanical tolerance analysis of the G-IV gust lock/throttle lever interlock mechanism and determined that the worst-case maximum TLA achievable with the gust lock handle in the ON position was 23°. Additionally, Rockwell Collins found that, if incorrect rigging procedures were used, the maximum TLA achievable could be as much as 26°. ²⁵

The NTSB performed testing on the accident airplane’s pedestal assembly to determine the TLA achievable when the gust lock handle was in the ON position. Initially, the throttles could be advanced to a TLA of 27° before resistance was felt from contact with the interlock. The NTSB later discovered that the lock pin in the handle’s slider assembly was broken and that only stubs remained on both sides of the slider assembly. These stubs provided enough contact force to prevent gust lock handle travel to the OFF position when using light-to-medium hand force. As greater hand force was used, the handle moved farther forward, eventually reaching the OFF position. ²⁶ The gust lock handle was replaced with another gust lock handle that had an

According to Gulfstream and FAA representatives, as of the date of this report, Gulfstream was actively working on a modification to the G-IV gust lock/throttle lever interlock designed to limit the amount of throttle movement with the gust lock system engaged to the intended certification limits. In addition to limiting throttle movement, the modification was expected to replace the lock pin in the gust lock handle with a pin made from a material with a defined strength and include recurring compliance checks to ensure that the interlock system would continue to function as intended. FAA representatives stated that the FAA would begin the process of mandating the modification immediately after Gulfstream completes it and that this process typically takes 6 to 12 months.

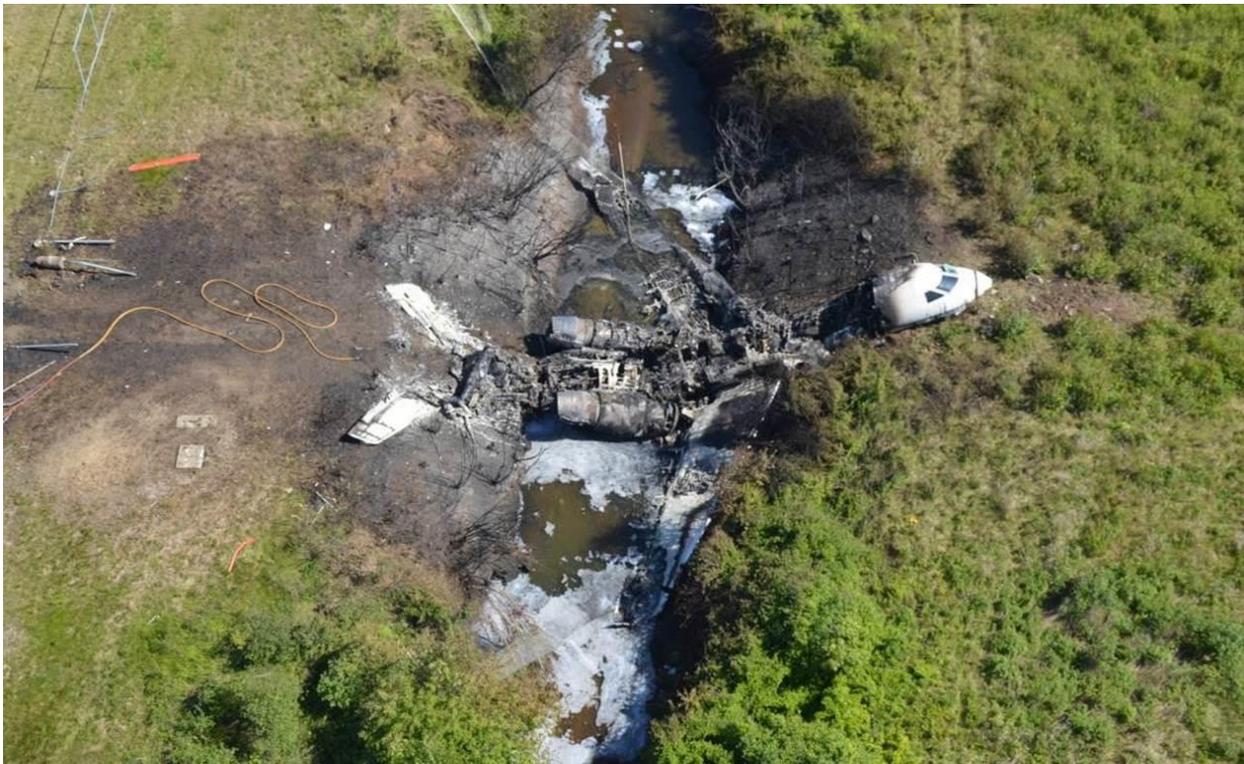
past the road and about 55 ft from the end of the paved overrun area, three distinct sets of ruts consistent with the nose, left main, and right main tires were dug into the grass. The main gear ruts continued for about 40 ft and then abruptly became shallower. The nose gear rut continued for about 85 ft, and the lower portion of the nose gear assembly was found at the end of the rut.

Shallow ground scarring led from the ruts to the main wreckage, which was located in a ravine about 850 ft from the end of the paved overrun area. The left main gear door, a 6-ft-long inboard section of the left flap, and the left main gear assembly were found along the debris path. Three approach light structures located along the debris path were knocked down and broken.

The localizer antenna located about 670 ft from the end of the paved overrun area was knocked down and broken. Multiple localizer antenna support poles were severed about 17 to 18 inches above their bases. The grass between the localizer antenna and the ravine was blackened and charred. Just before the ravine, the airport's chain-link perimeter fence was knocked down. The airplane was found spanning the width of the ravine with the tail on the airport side; the engines, wings, and fuselage in the ravine; and the cockpit on the far side of the ravine (see figure 6). Most of the airplane was destroyed by fire, with the greatest fire damage occurring near the wing root area of the fuselage. All major portions of the airplane were accounted for at the accident site.

Figure 6. Aerial photograph of the accident site showing the main wreckage.

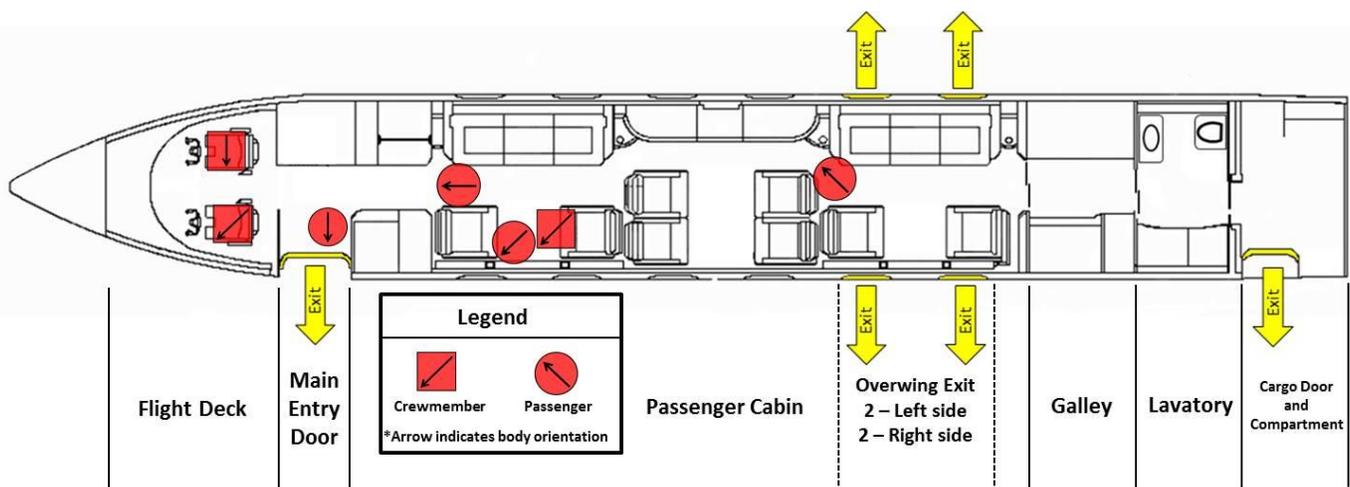
The PIC was found in the cockpit kneeling on the left seat with his head against the left cockpit wall. The left oxygen mask compartment in the cockpit was found open with the oxygen mask lying on the floor in front of the left seat near the PIC. The SIC was found sitting in the right cockpit seat facing inboard with one foot on the forward entry floor and the other on the center console. One passenger was found kneeling in the aisle facing the main entry door, and another was found lying in the aisle between the cabin and the main entry door. A third passenger and the flight attendant were found near the front of the cabin on the left side of the airplane between two seats. The fourth passenger was found lying in the center aisle between the seats just forward of the wing. Figure 7 depicts this information.

Figure 7. Diagram of the seating configuration showing occupant location and orientation.

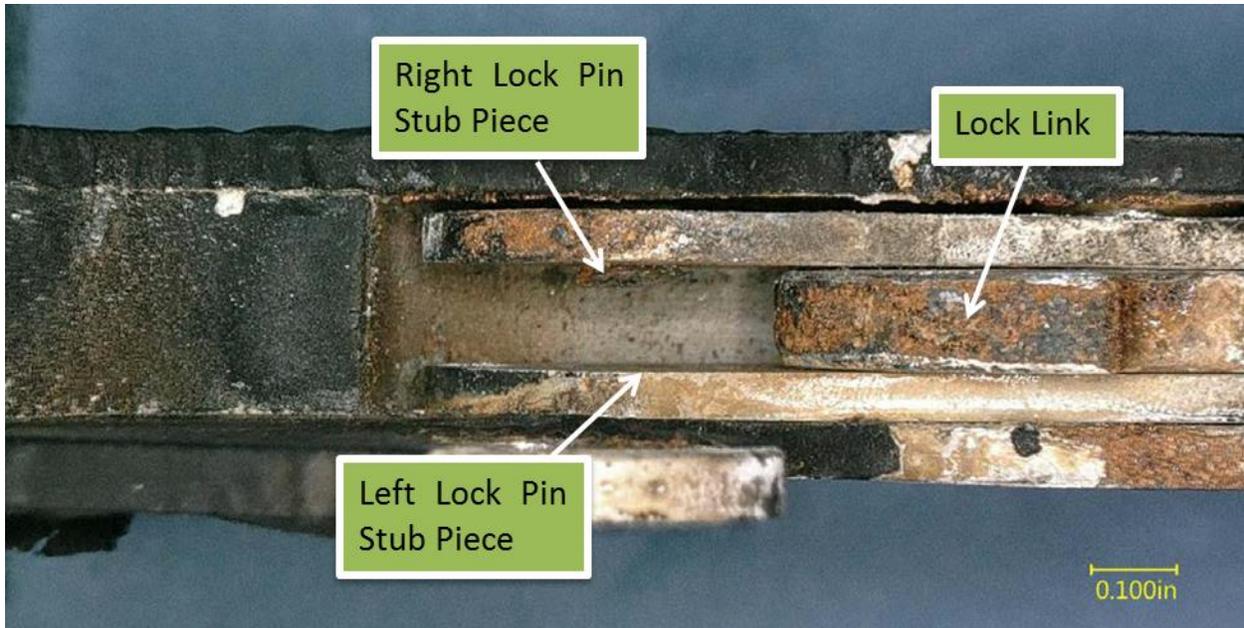
As previously mentioned, the lock pin in the gust lock handle's slider assembly was broken. The NTSB's laboratory examination revealed that the pin had fractured into at least three pieces with the middle section missing and only small stubs remaining on both sides of the slider assembly. As shown in figure 9a, the left stub piece was recessed into the pin hole in the left side of the slider assembly bracket, and the right stub piece protruded from the pin hole in the right side of the slider assembly bracket into the path of the lock link's travel. Figure 9b shows an exemplar gust lock handle pin.

Figure 9a. Photograph of the left and right lock pin stub pieces.

The flat fracture surface of the left stub piece was examined using a scanning electron microscope in the as-received condition before cleaning. Heavy corrosion deposits obscured the fracture surface features. The piece was then cleaned and reexamined, and flattened and smeared areas were observed on the fracture surface. No distinguishing features indicative of fatigue cracking were noted.

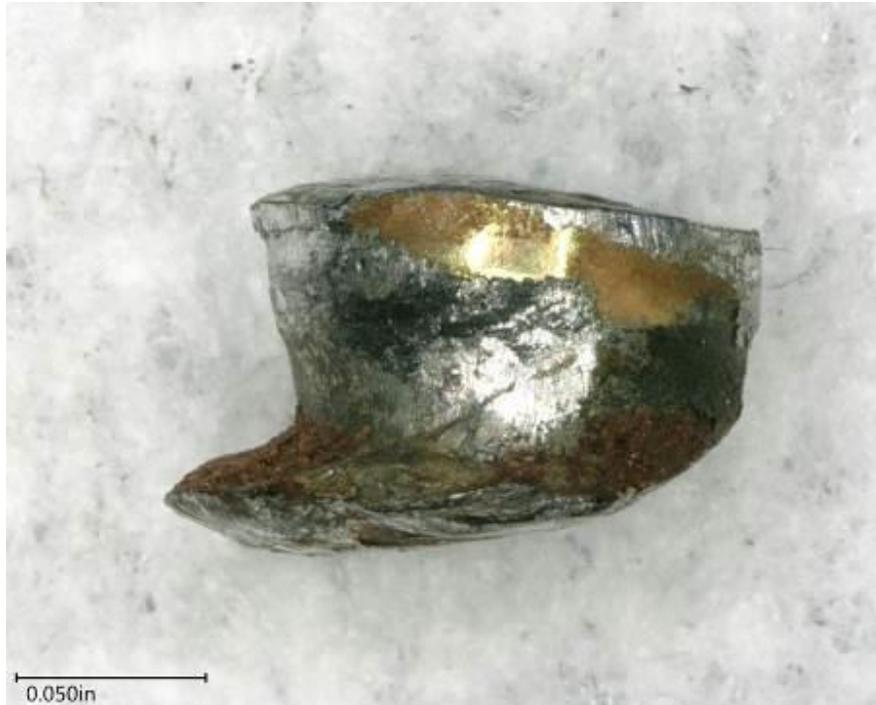
The right stub piece was significantly deformed with smearing damage consistent with the gust lock handle going from the ON position to the OFF position (see figure 10).²⁸

Figure 10. Photograph of the right lock pin stub piece.
