Collision with Terrain  
Promech Air, Inc.  
de Havilland DHC-3, N270PA  
Ketchikan, Alaska  
June 25, 2015

NTSB/AAR-17/02  
PB2017-102178

# Aircraft Accident Report

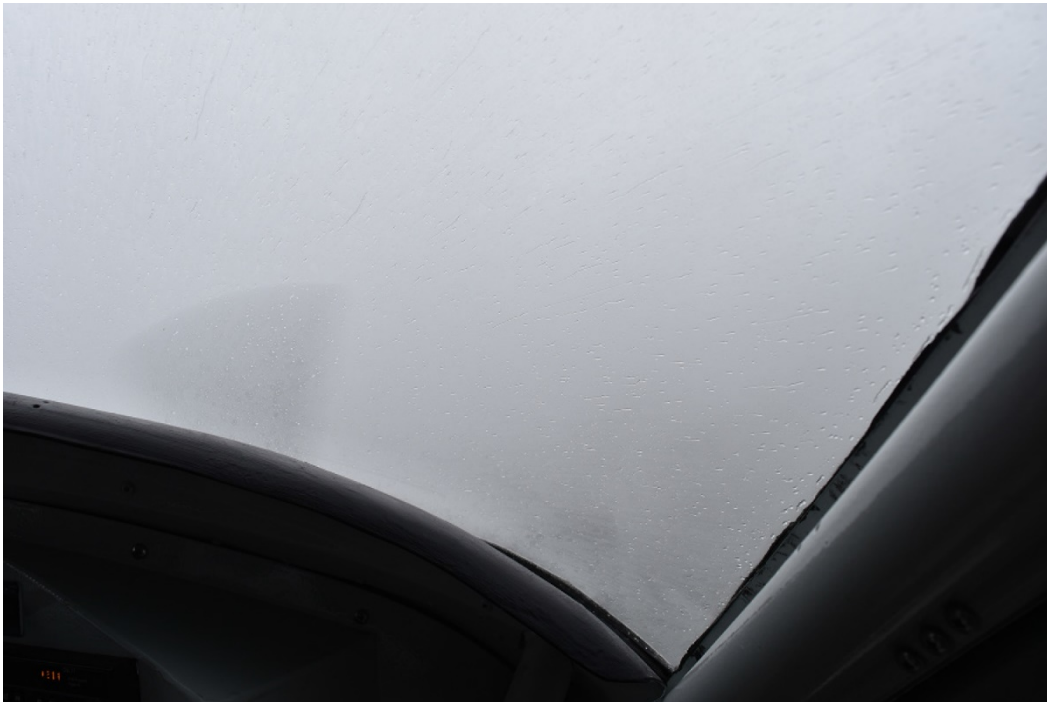
**Figure 4.** Forward-looking photograph through part of right cockpit windscreen. Rain on the windscreen and the propeller arc are visible. The lower right portion of windscreen shows a darker area, similar to mostly obscured terrain.

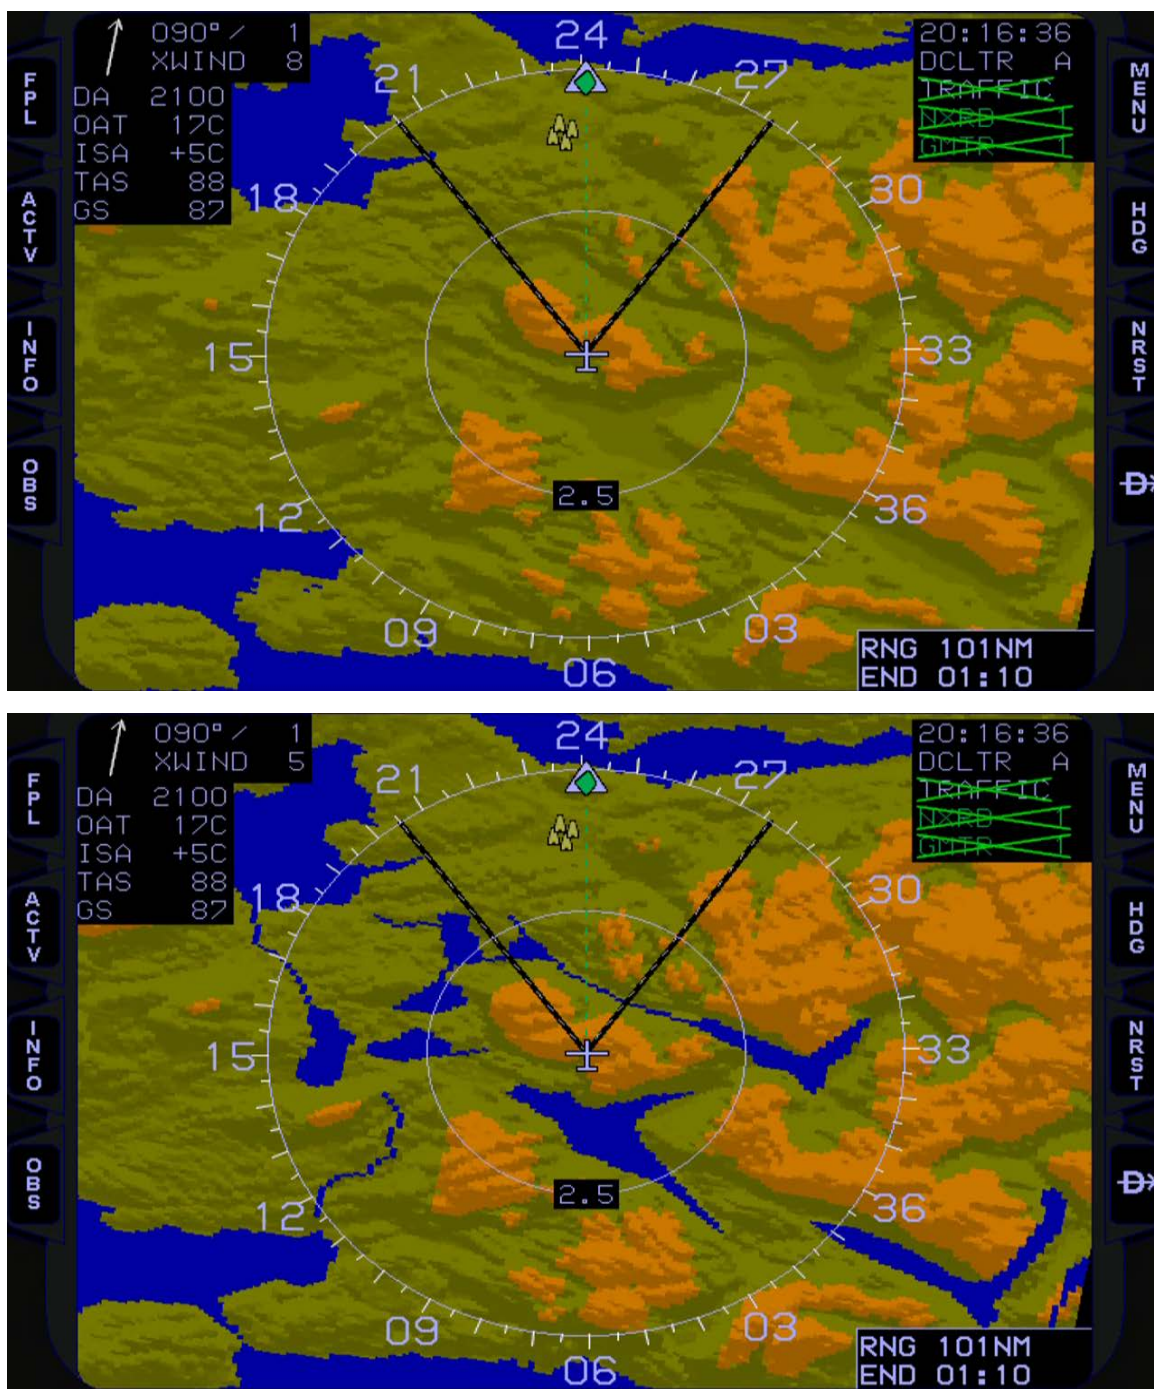
database did not show bodies of water on the display, whereas another does. The original 2003 database does not distinguish inland bodies of water, but the 2007 database update displays them in blue. (See figure 7.)

**Figure 7.** The top image shows how the Chelton EFIS's original 2003 database depicts the Ella Lake area, and the bottom image shows how the 2007 database update depicts the same area. Note that, in the most current database, the inland bodies of water are shown in blue.

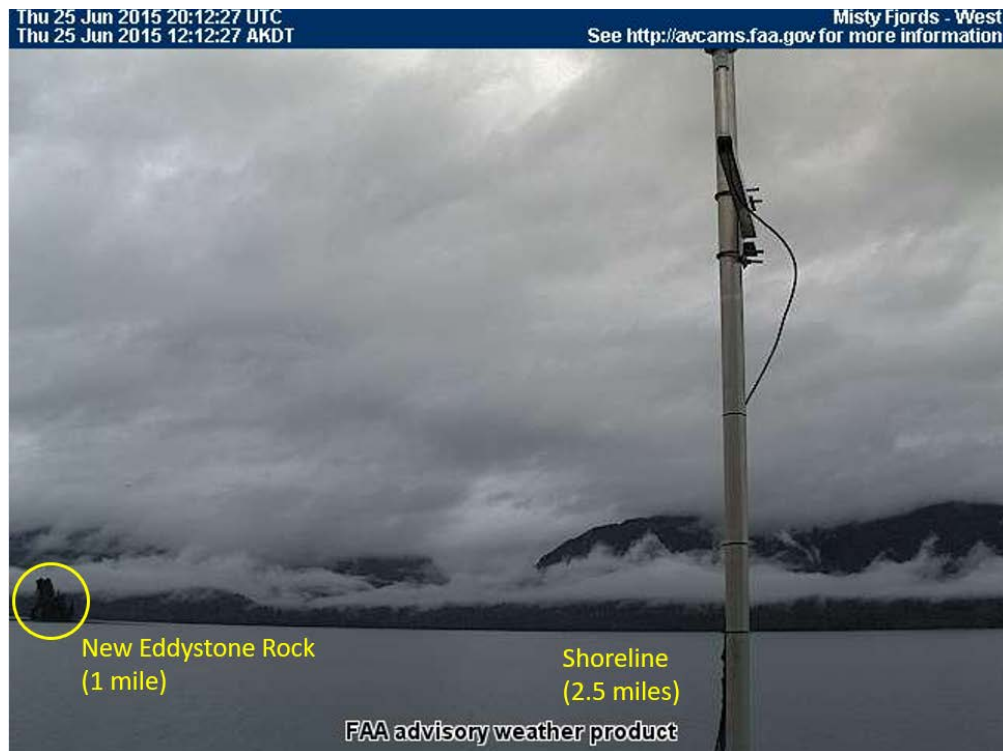
**Figure 11.** Image from west-facing (196°) Misty Fjords camera at 1212, about 3 minutes before the accident.

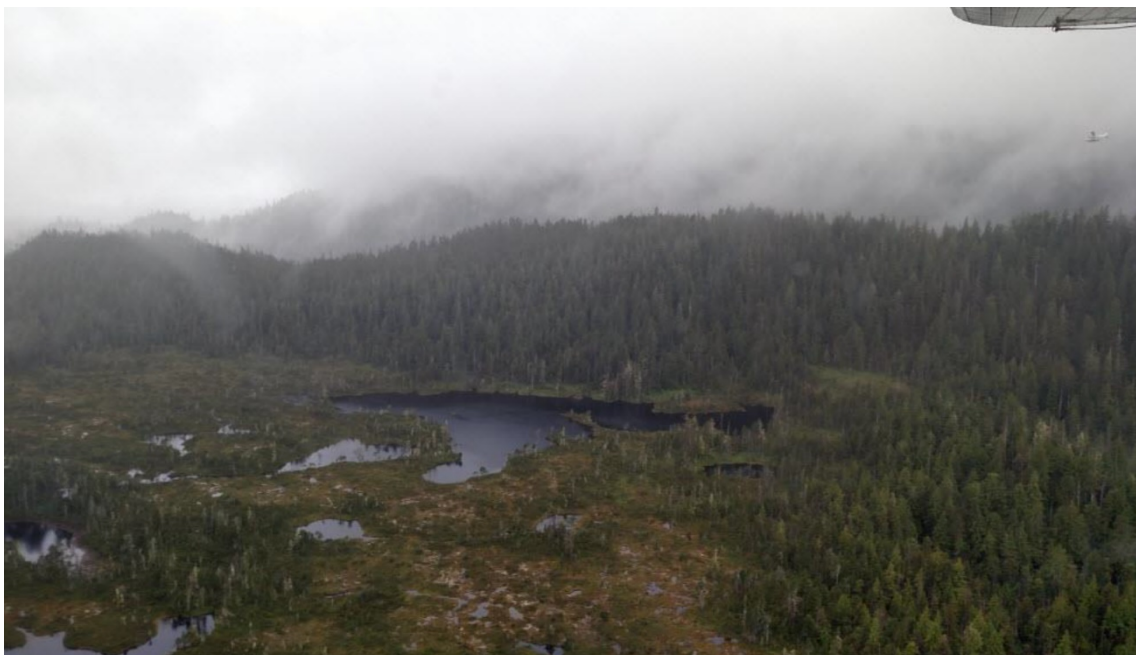
Digital photographs taken by a passenger on board this first Promech flight provided information about the weather conditions encountered when the airplane was about 0.5 nm south of Ella Lake. The most distant landmarks visible in the photographs are estimated to be about 1.5 nm away. Landmarks in the photographs provide a basis to estimate that the first Promech airplane transited this area about 300 to 400 ft agl. The southeast face of a large mountain is visible in the photographs and is completely obscured by clouds above about 1,000 ft msl, with some scattered clouds hanging down the mountainsides to lower elevations. This is the same mountain that the accident airplane subsequently struck about 1 nm to the north. A DHC-2 airplane operated by another tour company is visible in the upper right corner of the photograph. (See figure 14.)

**Figure 14.** Southwest-looking photograph taken about 0.3 nm south of Ella Lake and 1.3 nm south of the accident location by a passenger on board the first Promech airplane.

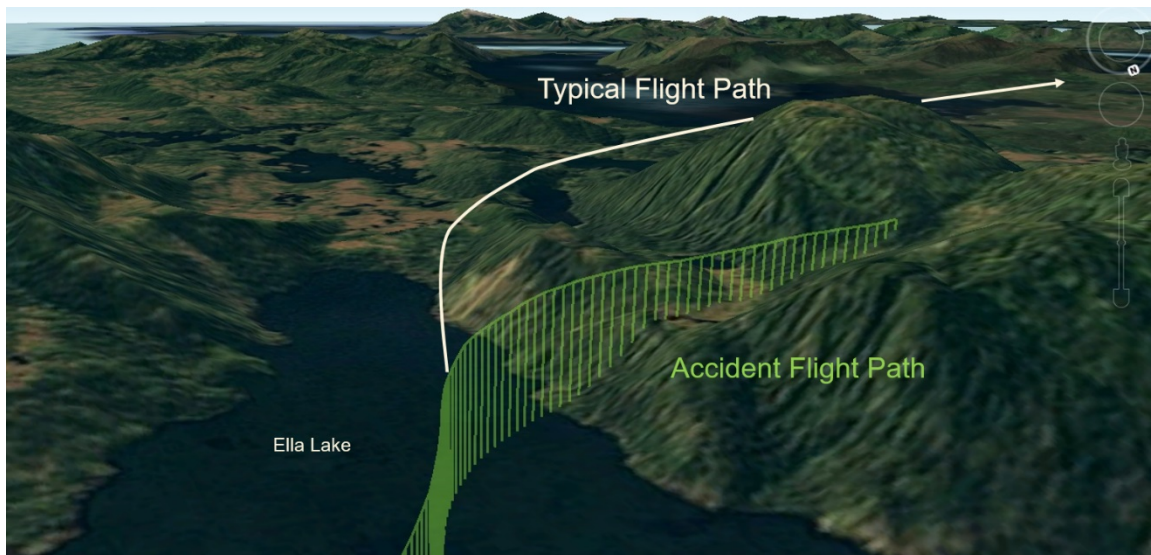
Despite the deteriorating weather conditions in the Ella Lake area, the two other Promech pilots on the short route (one who departed before the accident flight and one who departed after) successfully completed their trips. In reduced visibility weather conditions, Promech pilots typically fly southwest over Ella Lake and proceed beyond the south end of the lake before turning west. This route allows the flights to avoid the high terrain located west of the lake, which includes two similarly shaped mountains. (See figure 16.)

**Figure 16.** The typical flight route (white) passes two similarly shaped mountains before turning west. For comparison, the path flown by the accident pilot is shown in green.

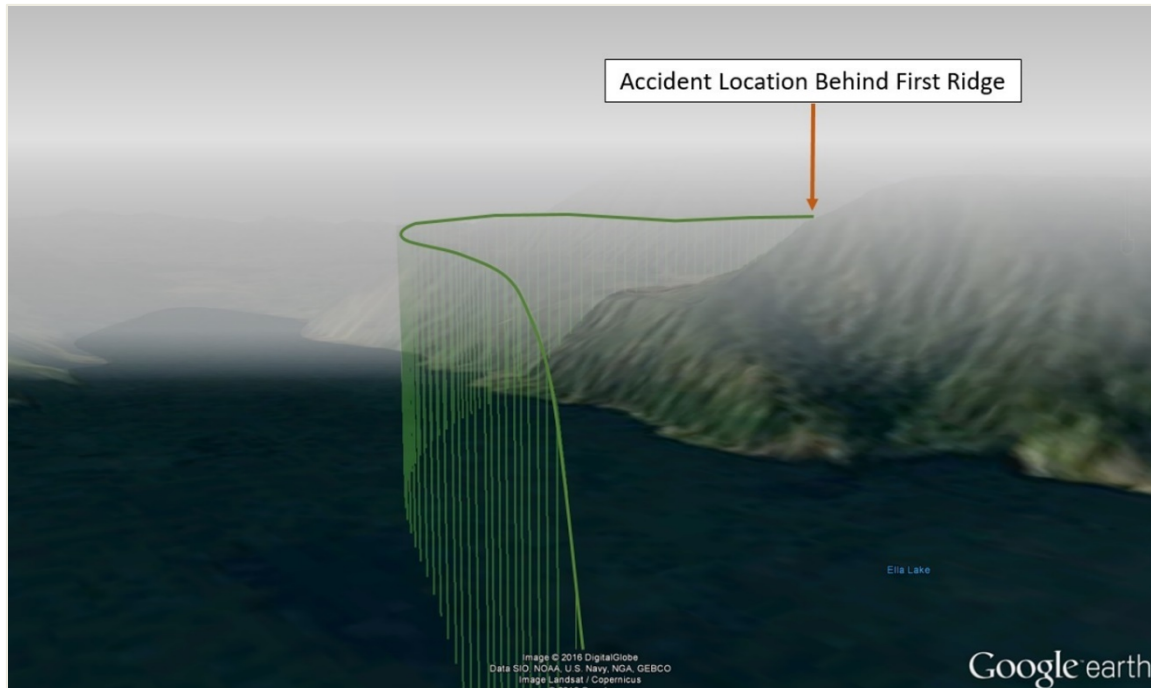
Although the accident pilot climbed the airplane to an altitude that would have provided safe terrain clearance along the typical route, he deviated from that route and turned the airplane west after it passed only the first of the two mountains. The pilot's route deviation placed the airplane on a collision course with the 1,900-ft second mountain, which it struck at an elevation of about 1,600 ft msl. (See figure 17.)

**Figure 17.** The path flown by the accident pilot (green), viewed from the approximate altitude of the accident airplane, is shown turning to the west (right) after passing the first mountain.
